Optimisation of survey procedures and application of integrated digital tools for seismic risk mitigation of cultural heritage: The Emilia-Romagna damaged theatres.

APPEDIX B: DAMAGE SURVEY

B PD form - Social Theatre of Novi (Modena)

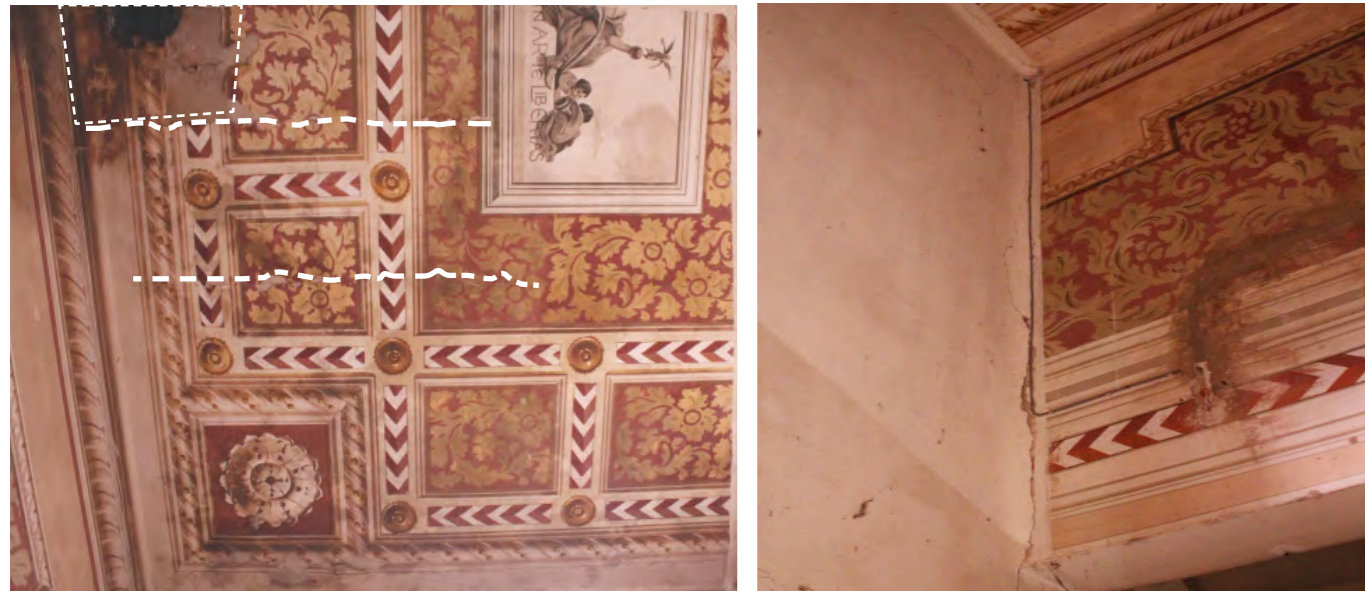
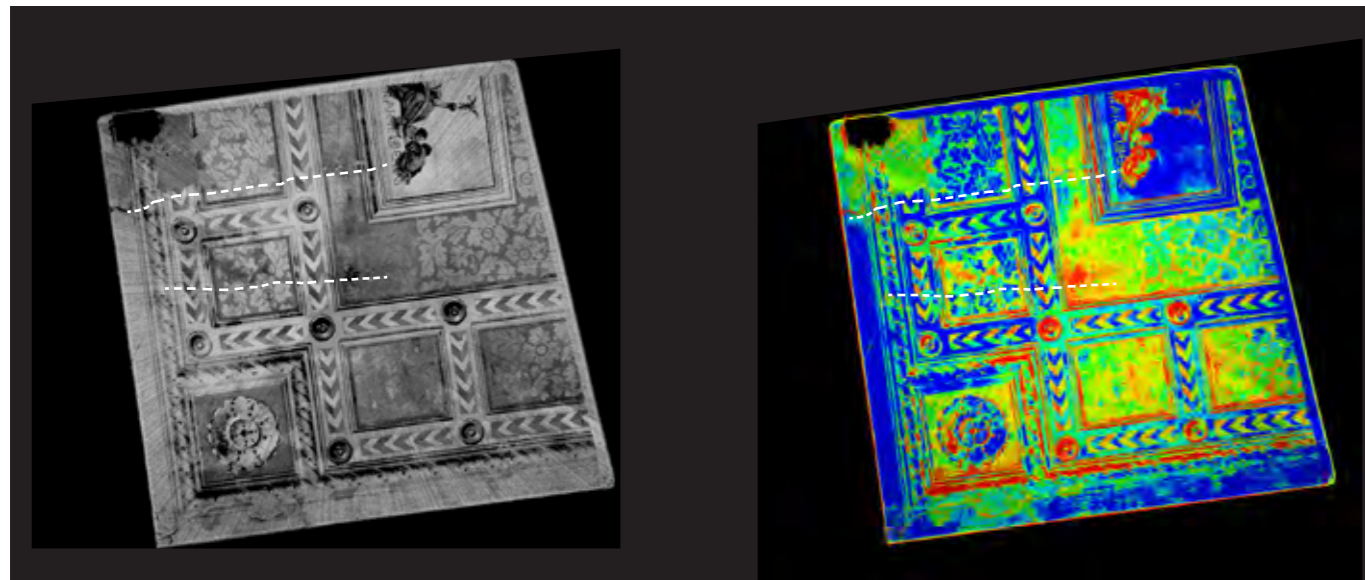
M20
US 0.1
02_01_003

Significant damage and excessive deformability of the horizon affected the rooms of the ridotto (unit 02; second-order; rooms 003, 004, 005), which were affected by partial collapses of the ceiling and a significant cracking framework. Since these rooms were subject to alterations to adapt the theatre's functions to the cinema, significant cracks are visible along the partition walls, indicating that they are not well bonded to the load-bearing masonry. In addition, partial collapse of the roof affected Body A, which occurred in correspondence with the rooms described above.

Detail views of the cracking framework of the space intra-slab 02_01_003

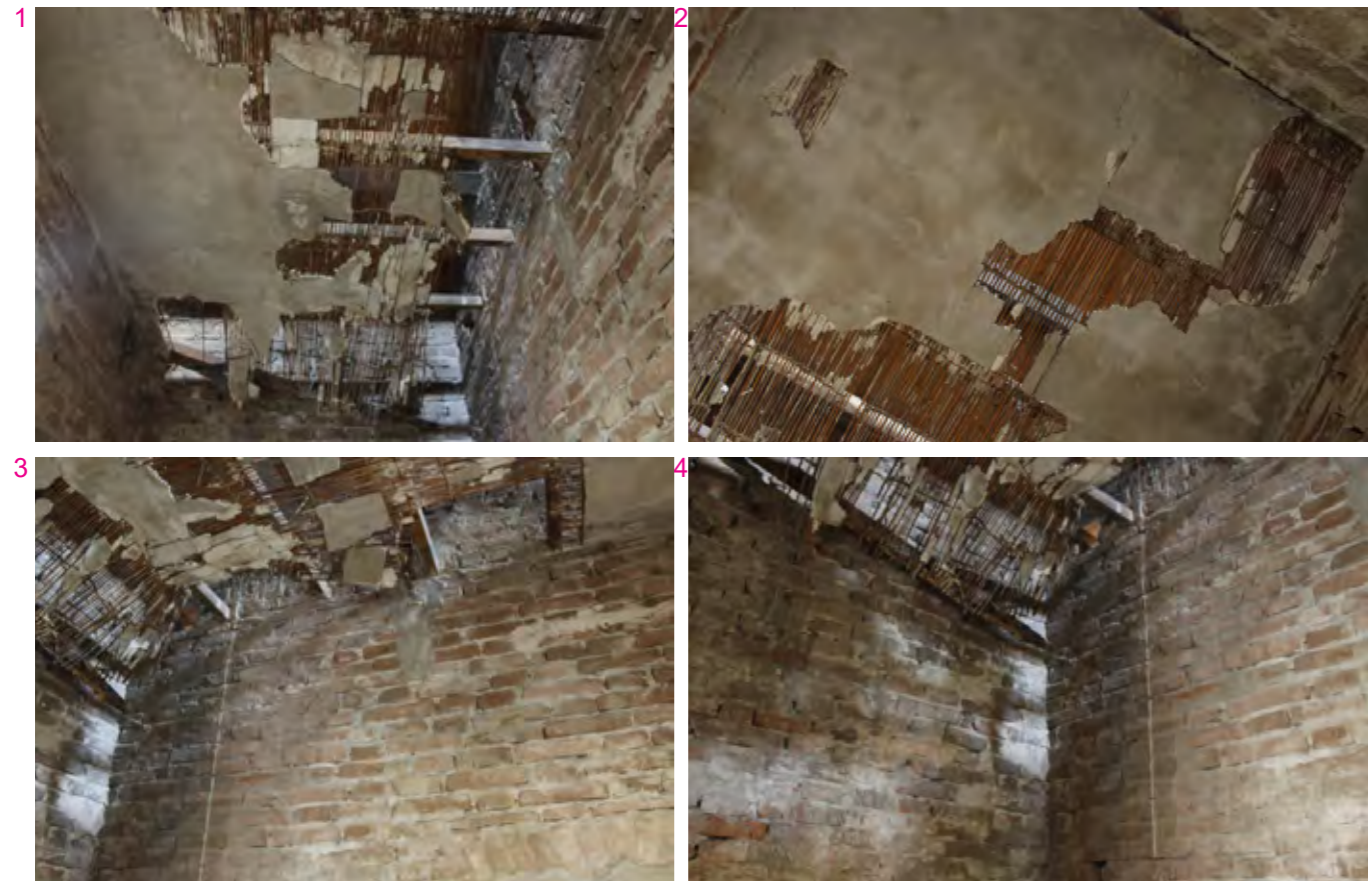
M16
US 0.3
03_0.3.004

Note: A comparable cracking pattern is found in the diametrically opposite space 03_0.3.004

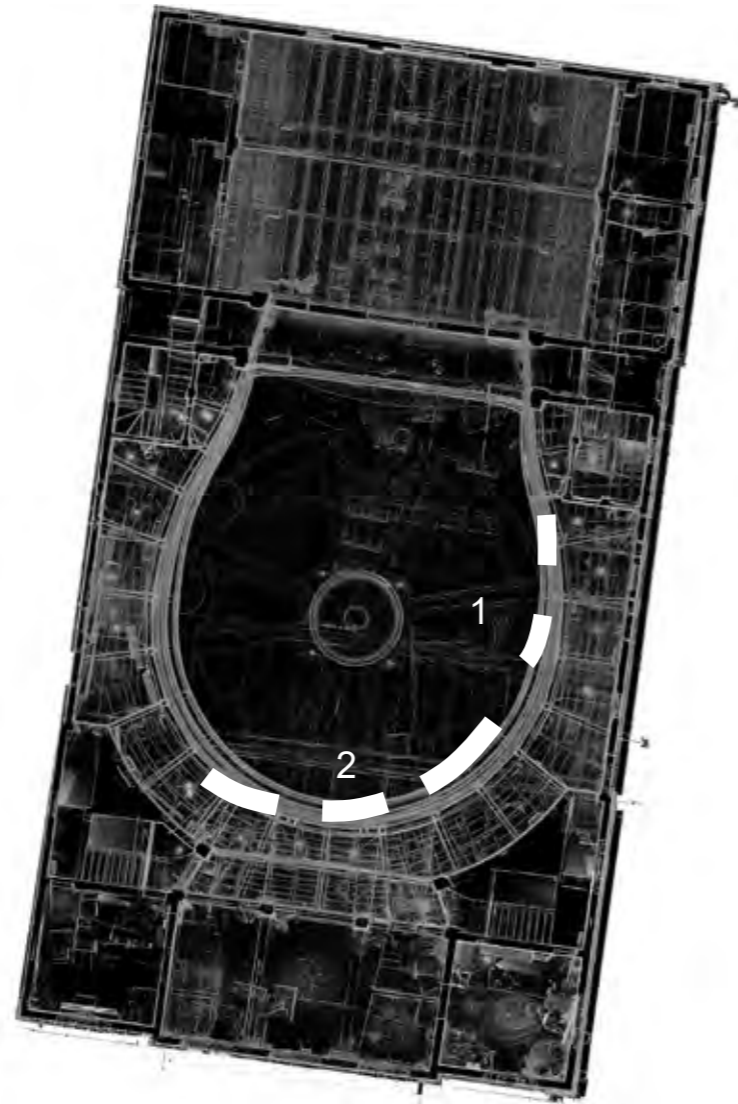
M18-M22
US 0.2
03_0.2_001

Detailed views of the damage found across the gallery border

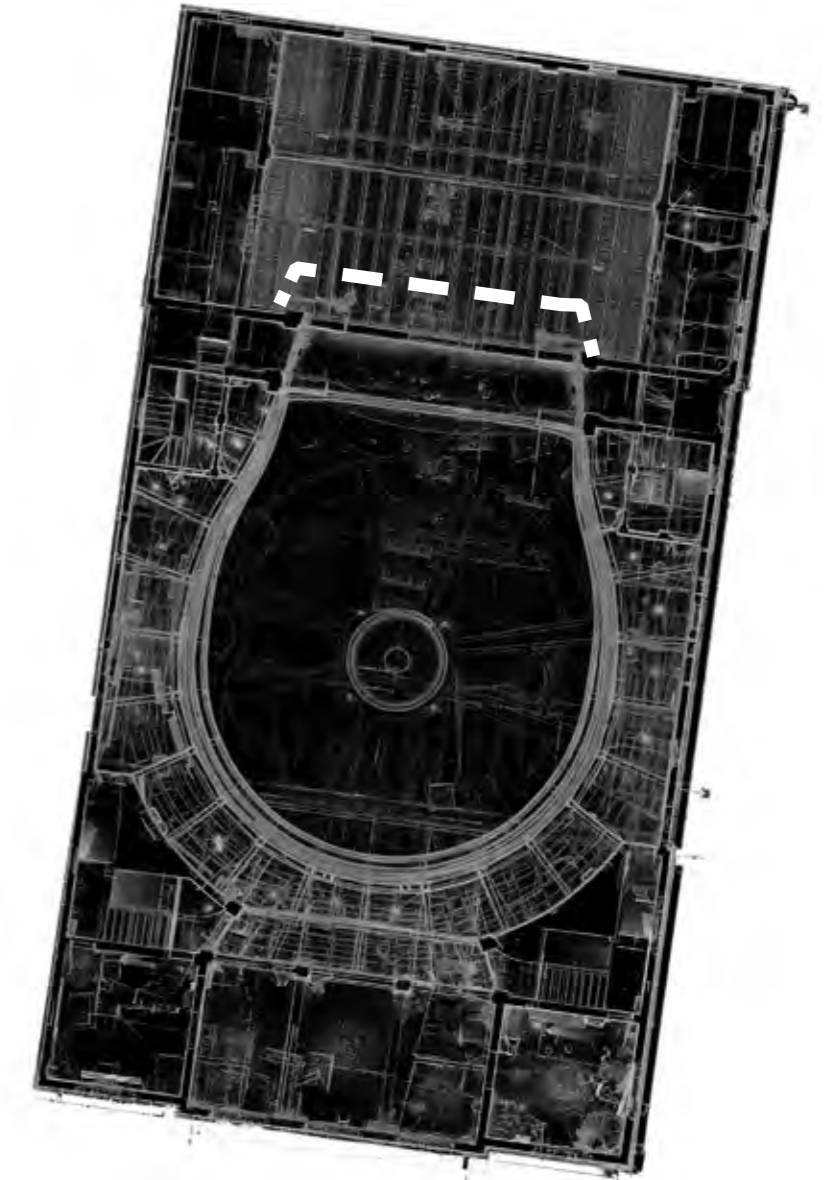
M18-M22
US 0.2
03_0.2_001

Detail views showing beam and scenic arch injuries

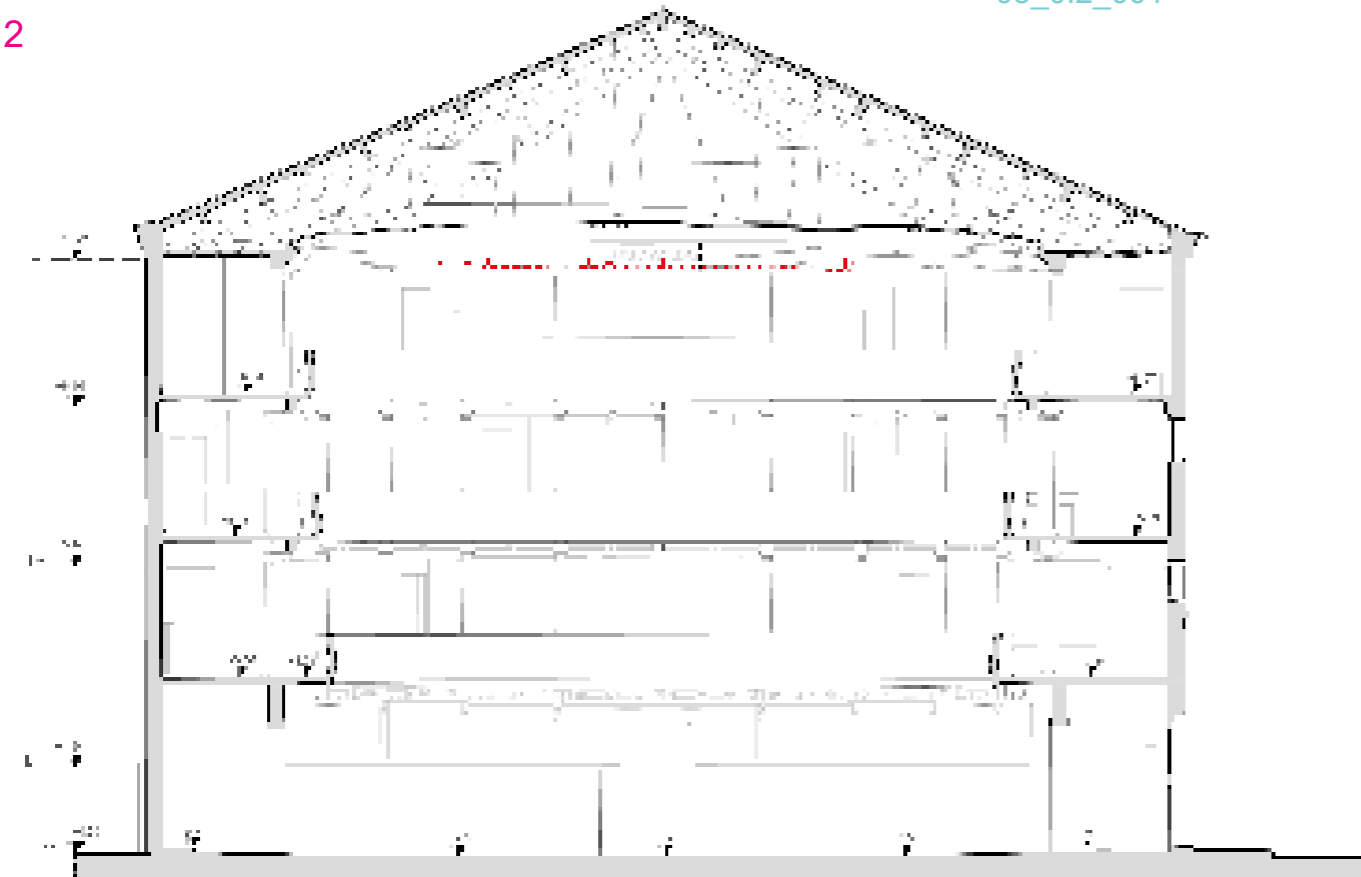
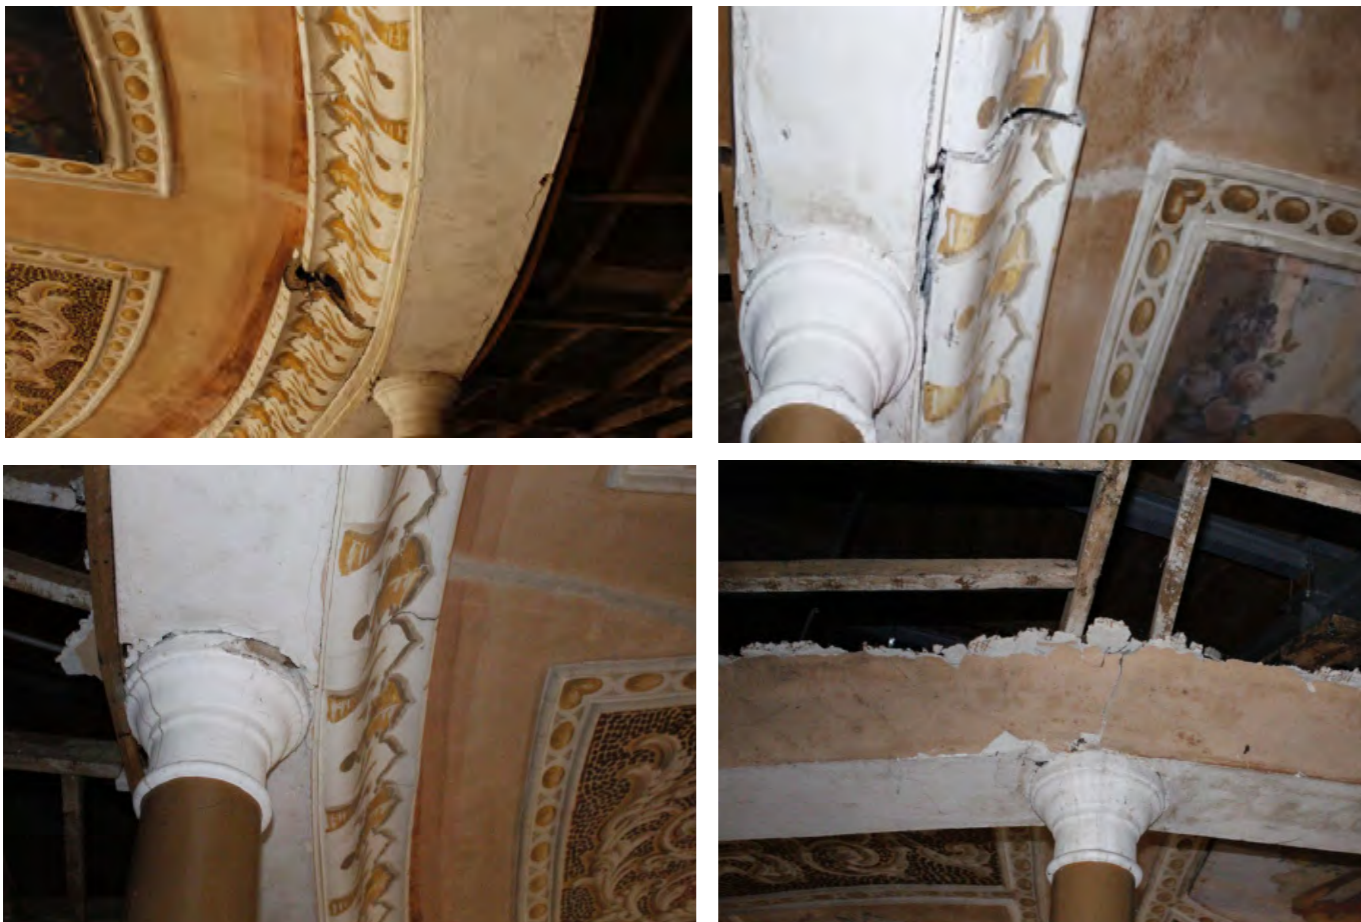
M18-M22
US 0.2
03_0.2_001

Detailed views of the damage found across the gallery border

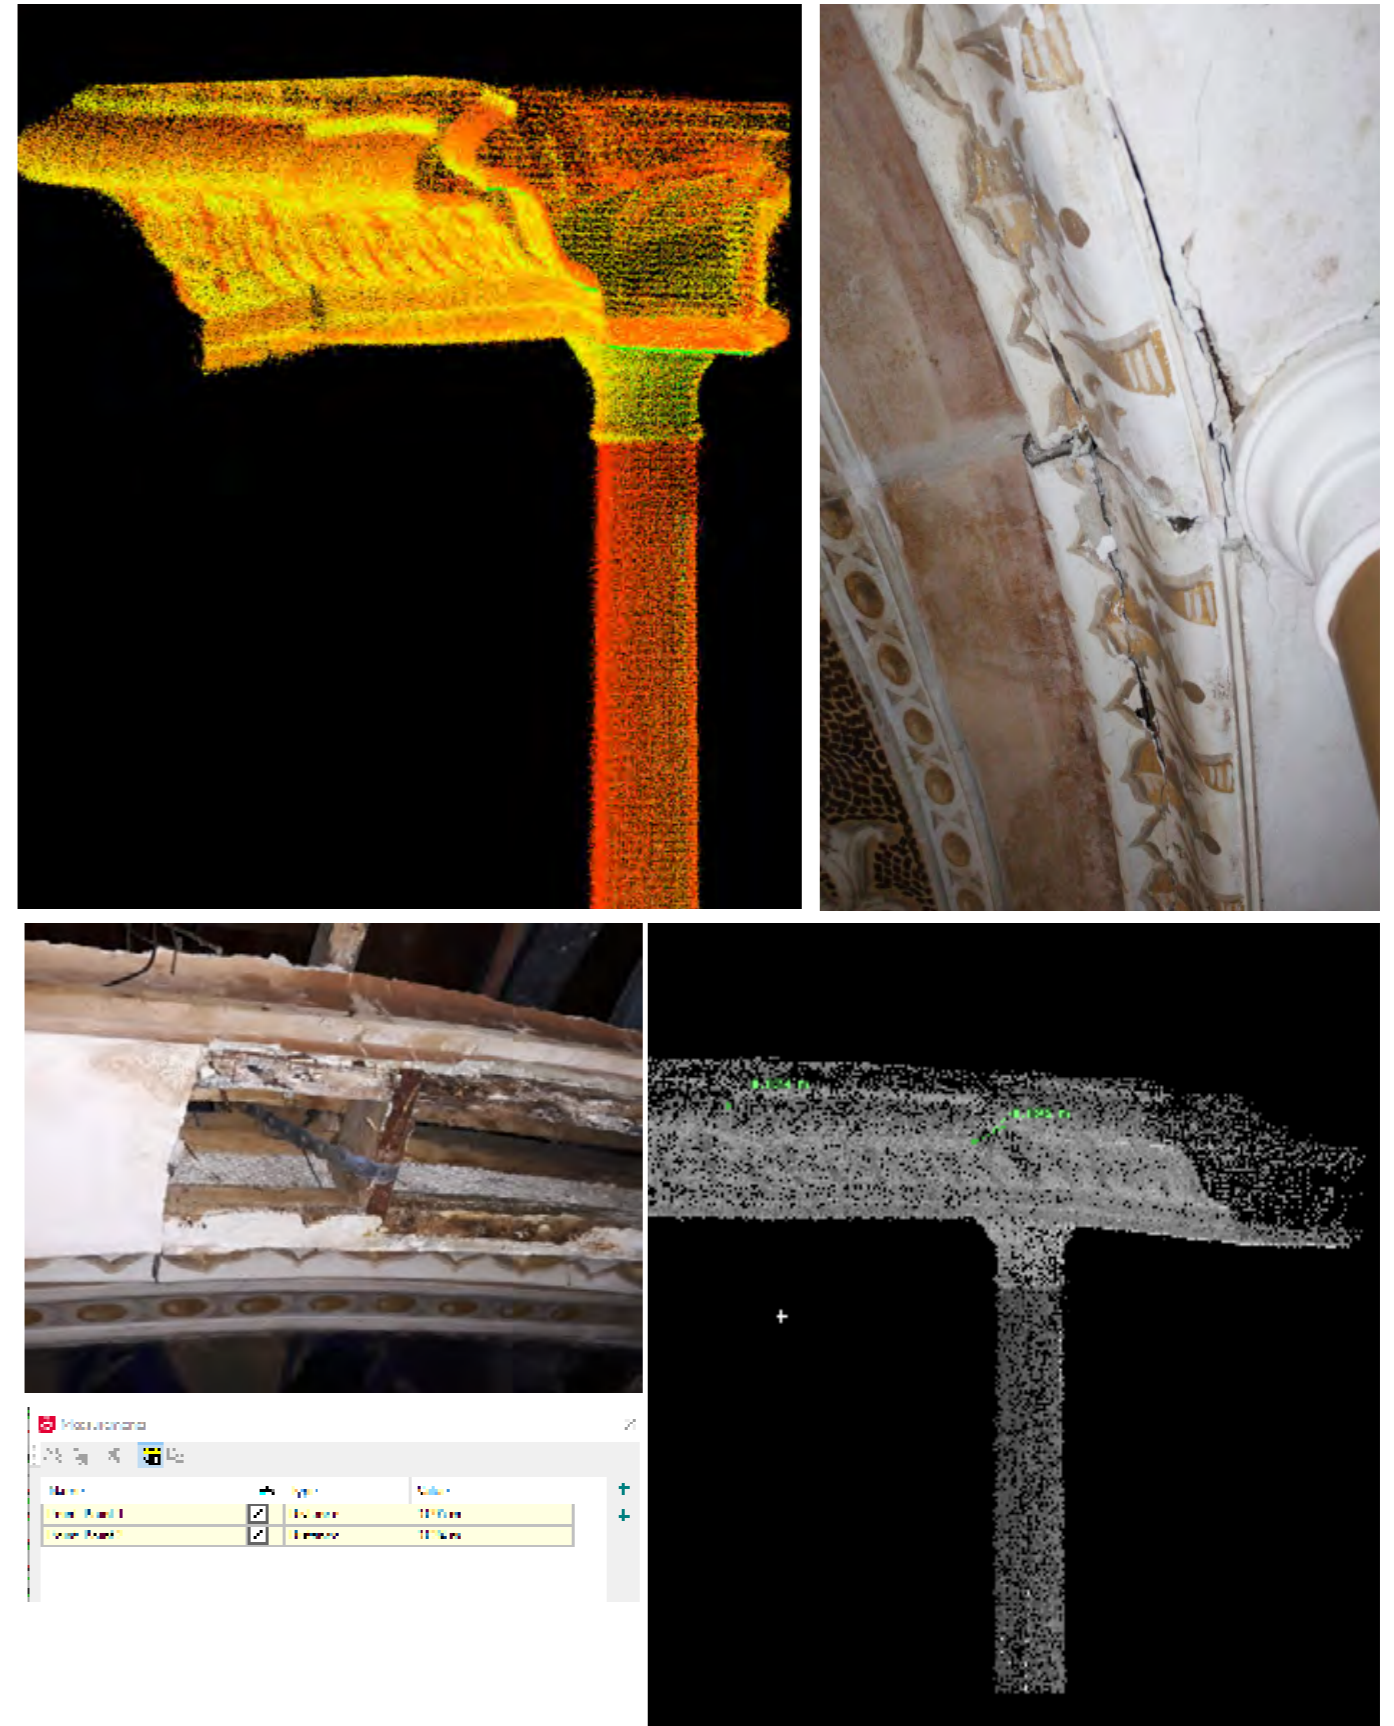
M18-M22
US 0.2
03_0.2_001

Detailed views of the damage found across the gallery border

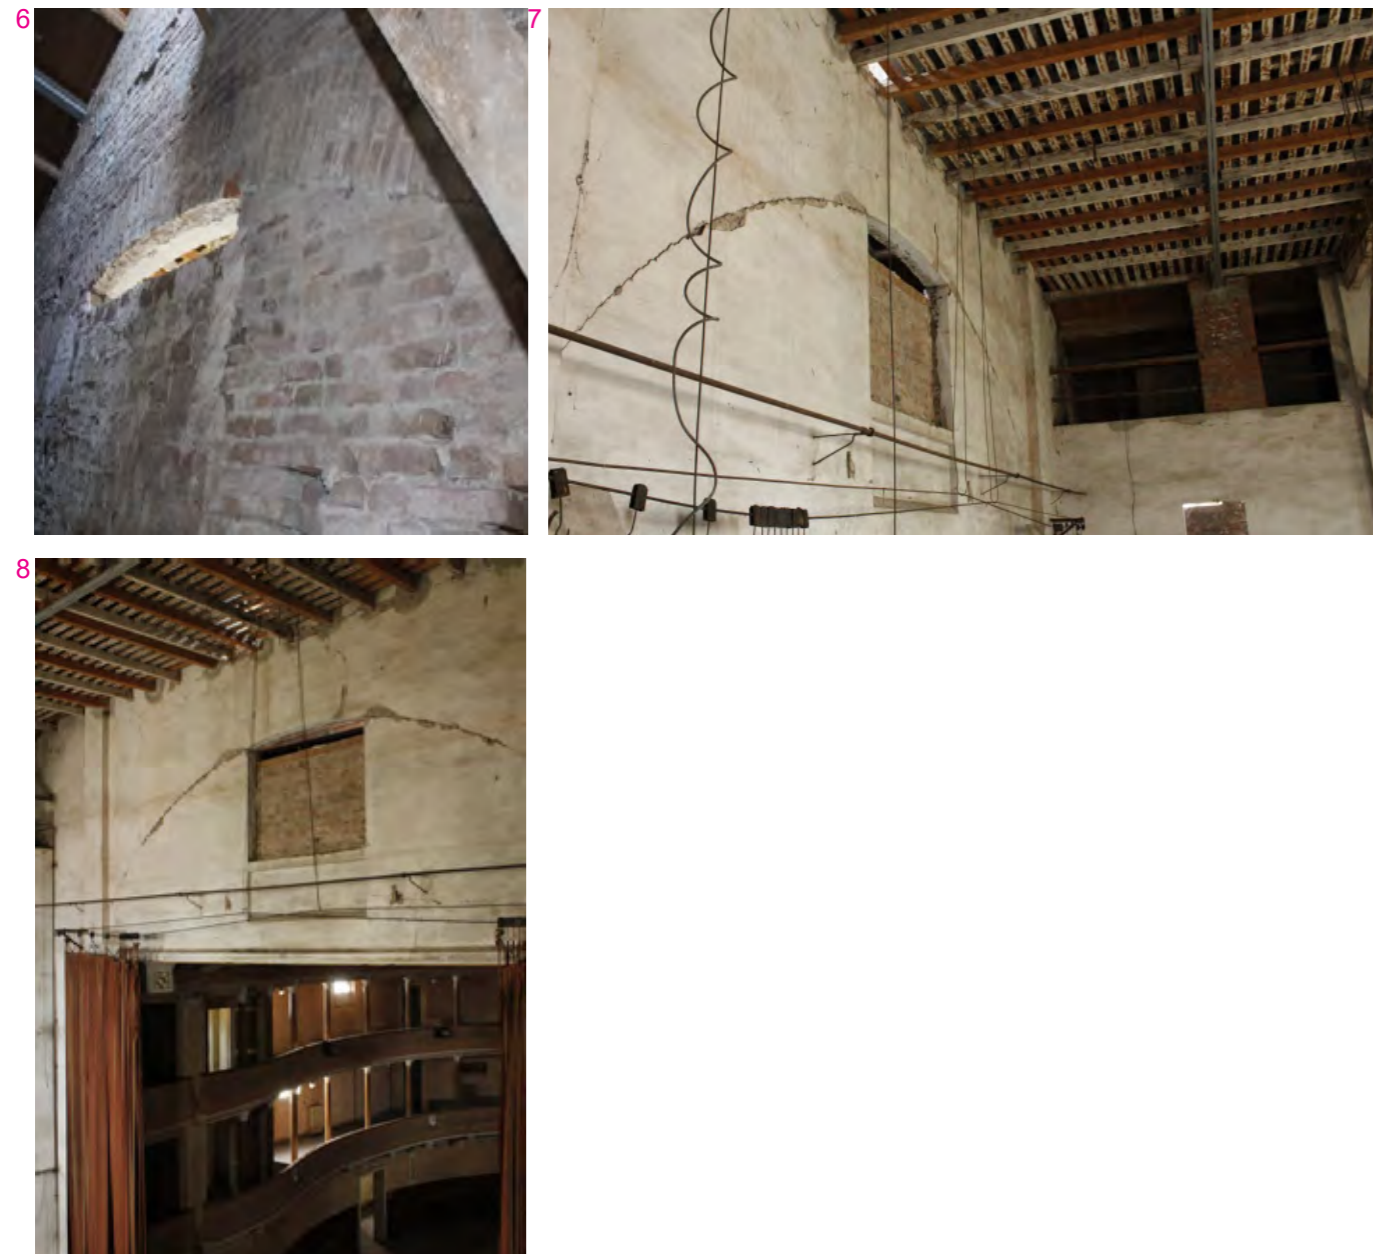
M14
stair 2
UST 01. 03

The staircase (2), a hinge between body A (reduced) and body B (cavea), is particularly damaged in the third-order (northeast quadrant), with significant cracking along the attachment of the perimeter walls to the ceiling and local collapse of the ceiling itself. The cracking of the roof of the opposite staircase (8) is significant (see appendices pp. 19-20).

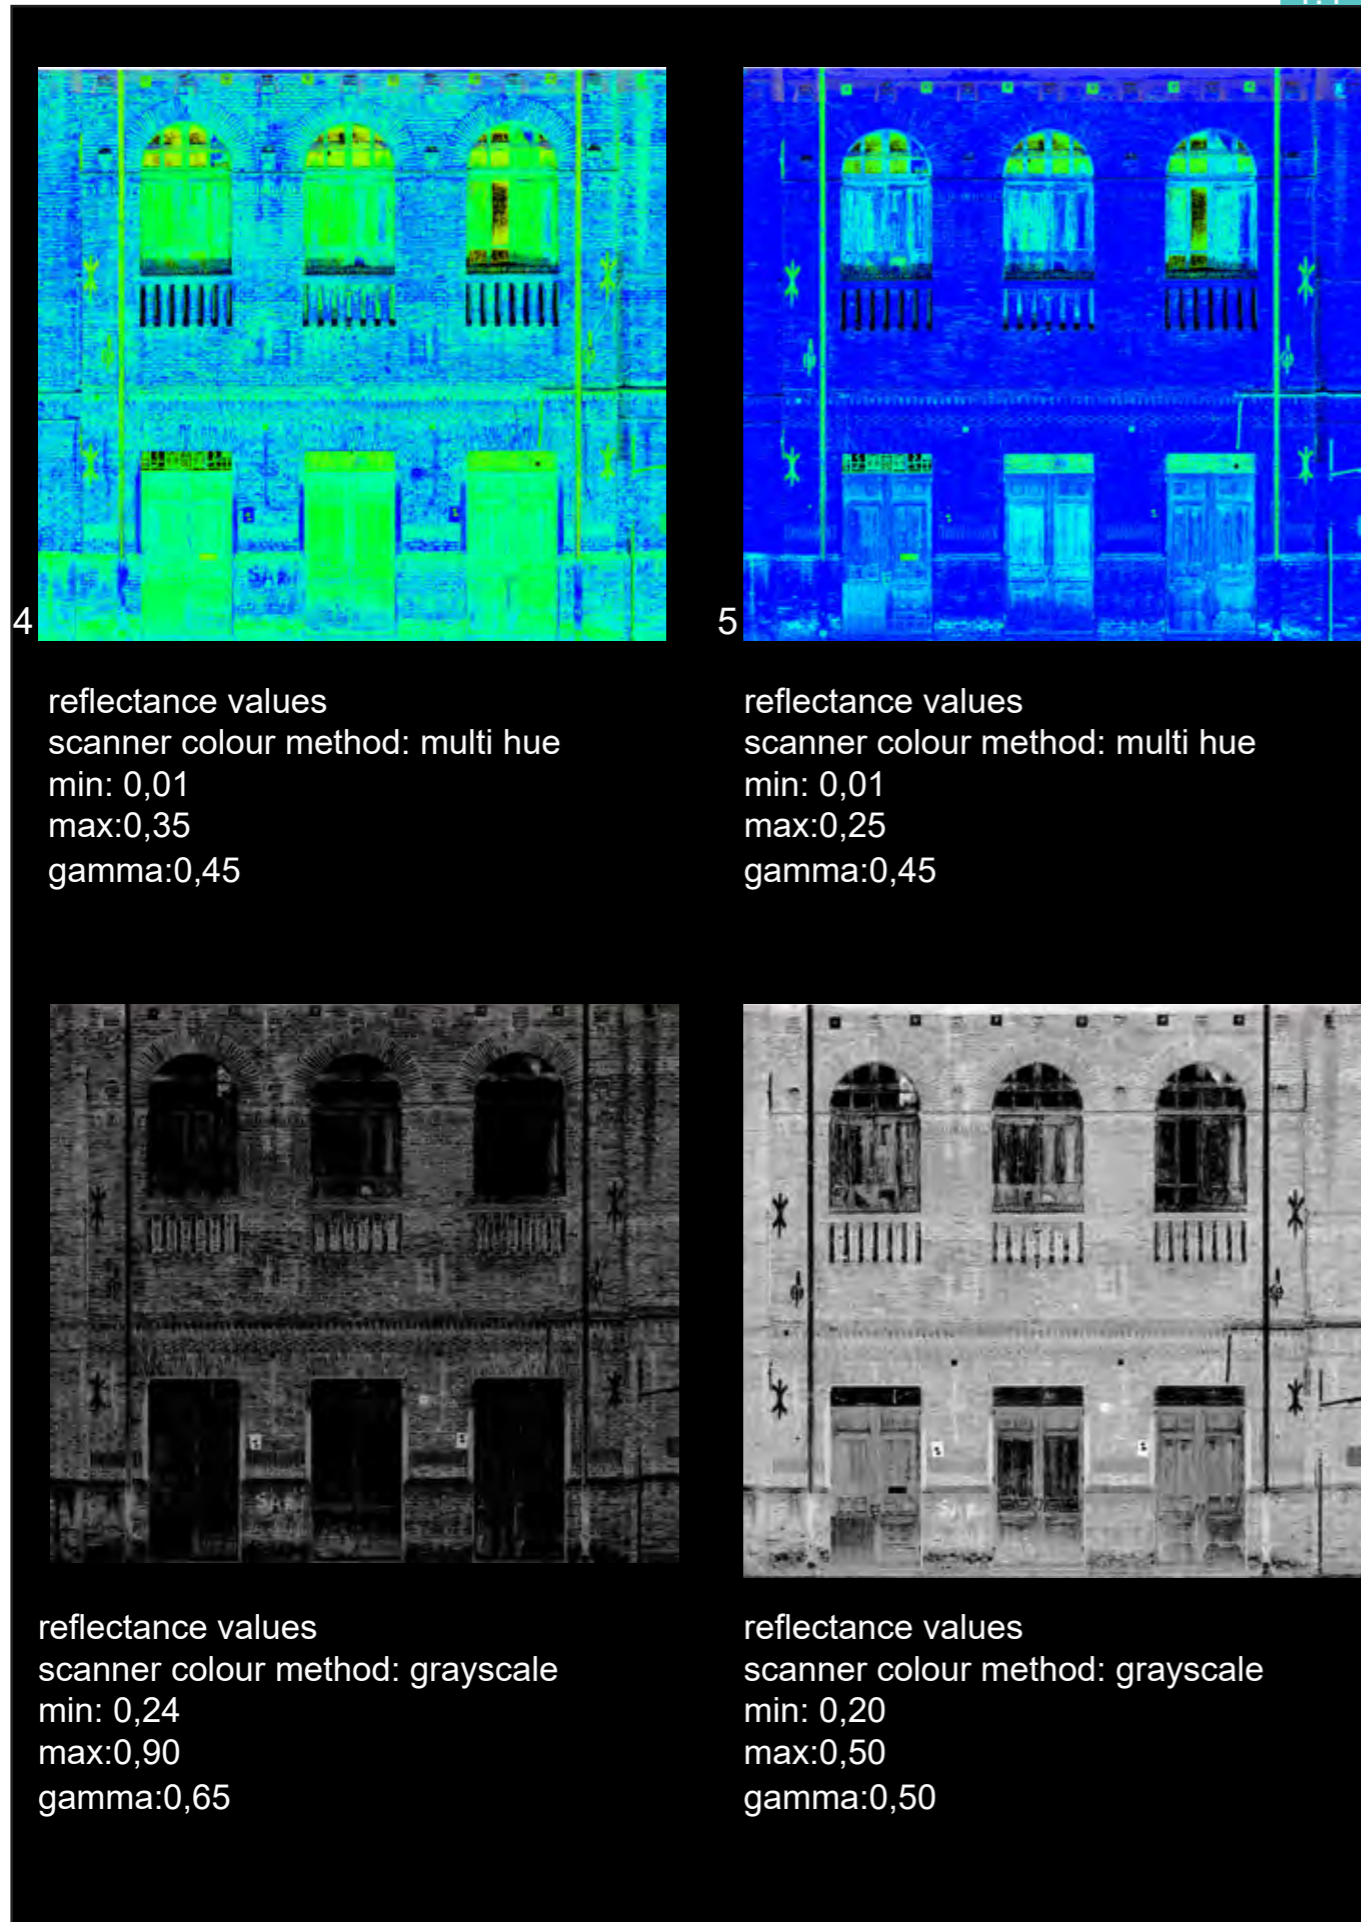
- 1) green: brick surface
 yellow: biological patina
 orange: biological colonisation
- 2) yellow: efflorescence
 dense orange: efflorescence
 red: biological patina
 dense red: rising front
- 3) dense green: efflorescence
 orange: run-off; biological patina
 red: biological colonisation
 dense red: rising front
- 4) dense blue: efflorescence
 cyan: efflorescence, biological patina
 green: biological colonisation
- 5) blue: brick surface
 cyan: biological patina, dripping
 green: biological colonisation

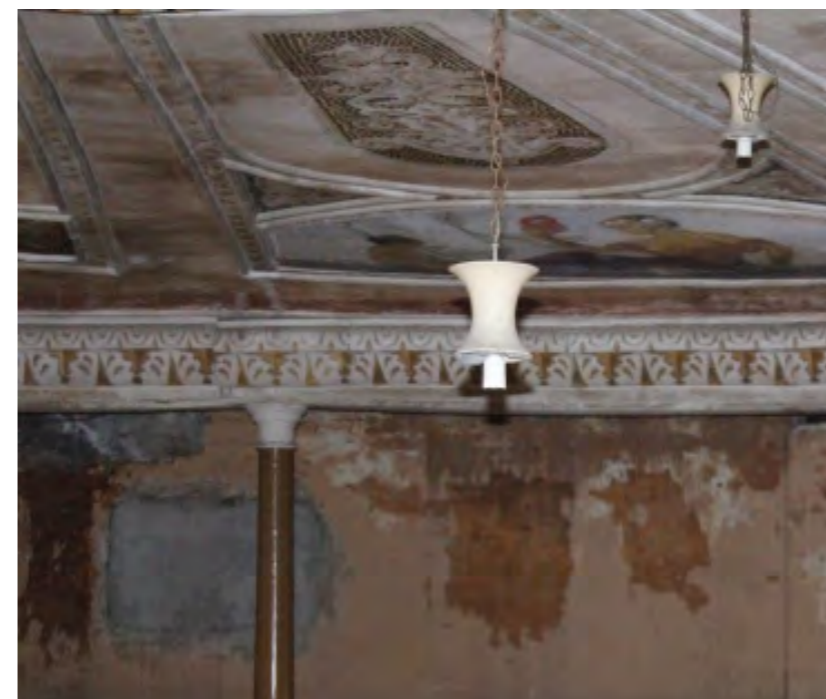
Analysis of decay morphologies of the ceiling vault.

Causes of decay: the presence of water.

Phenomenon: "darkening" of the vault due to thermo-hygrometric conditions of the vault.

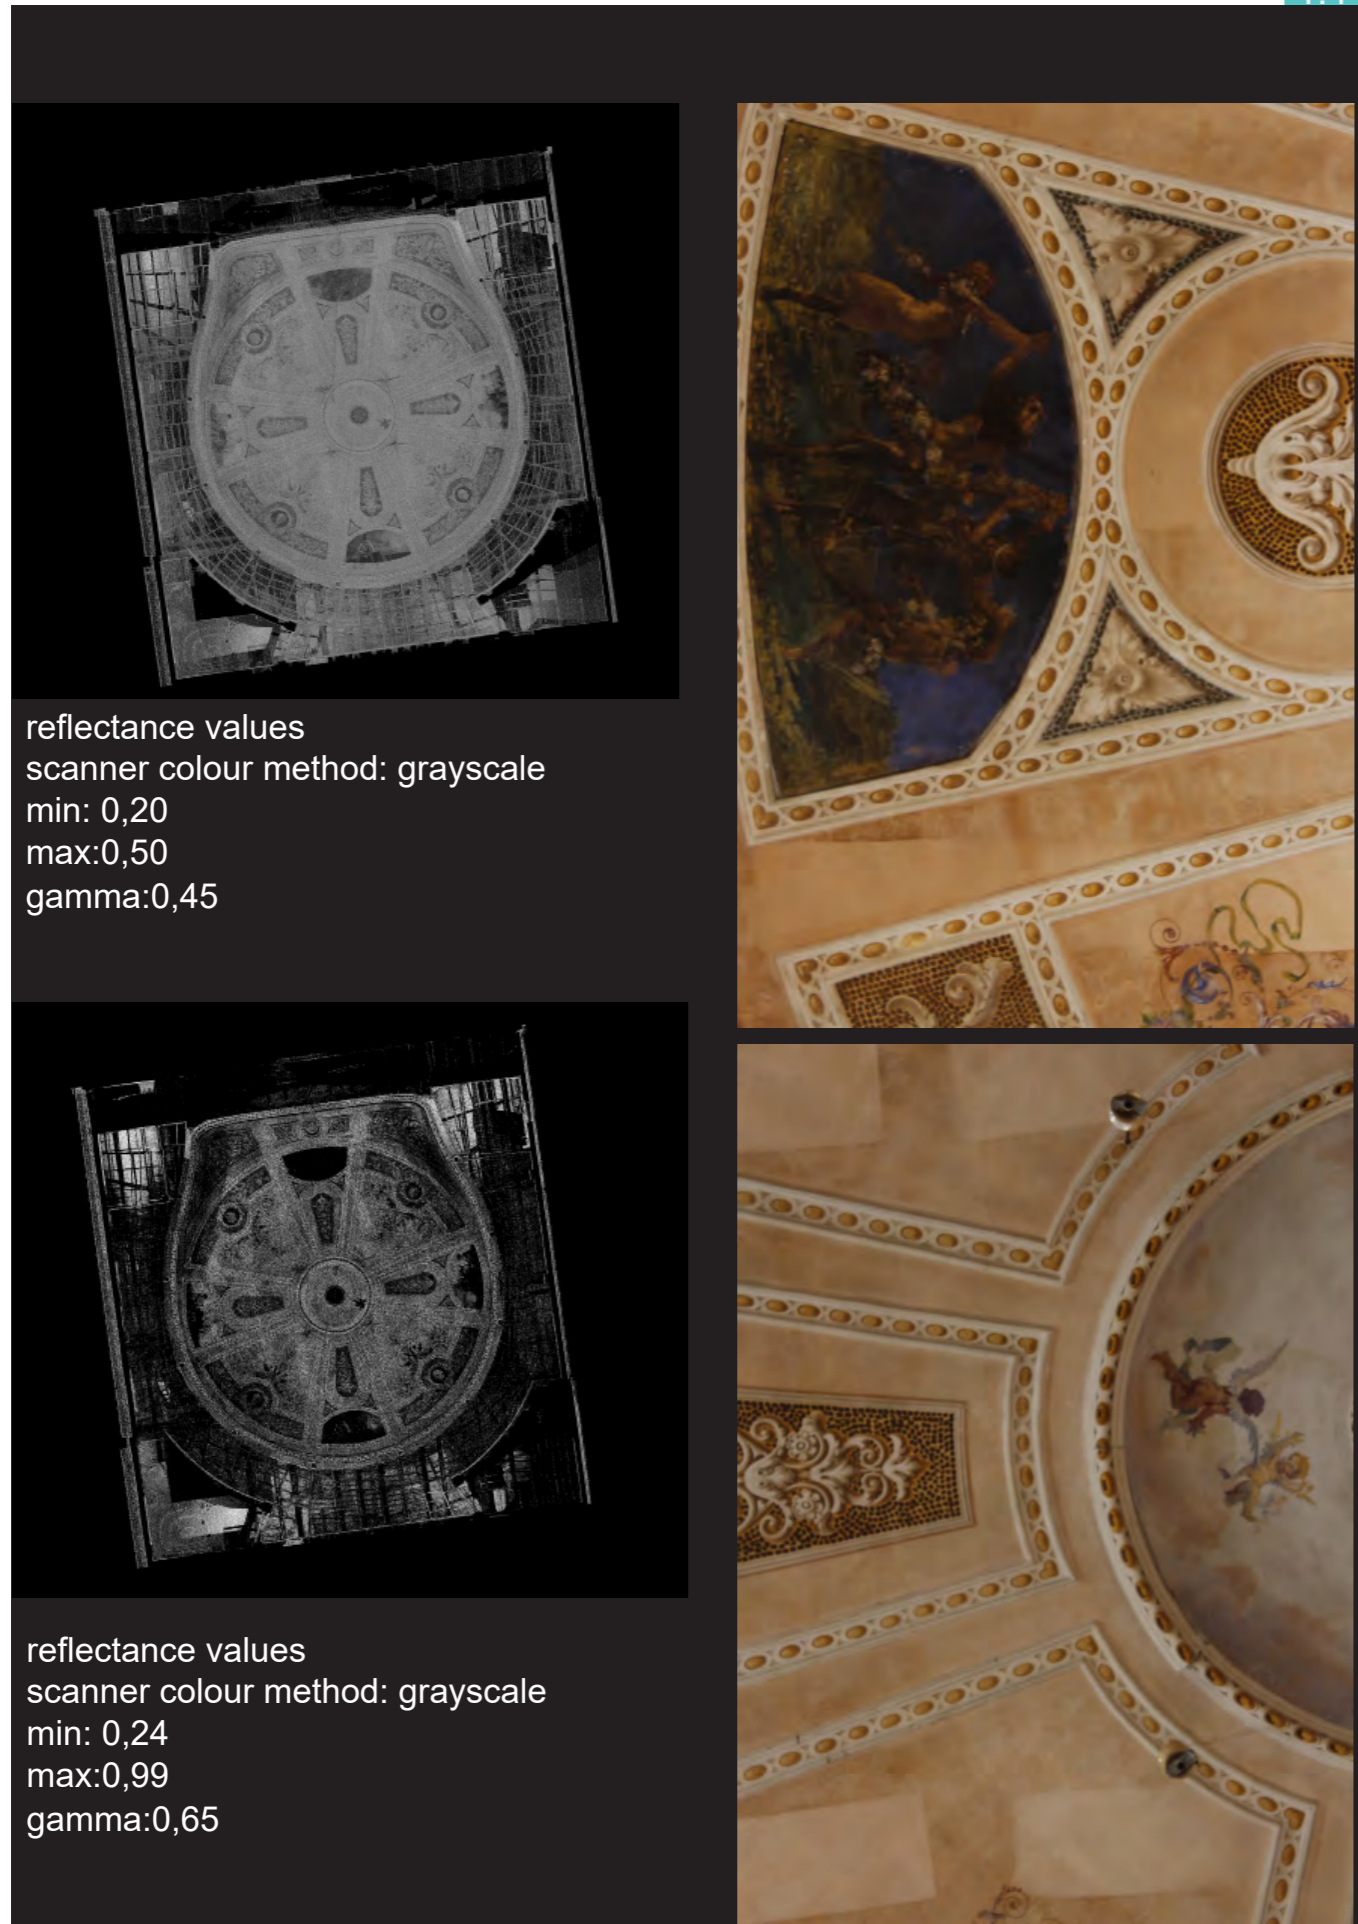
- 1) red: patina, casting
dense orange: stain
- 2) red: stain, biological patina on brickwork
dense red: casting on plastered surface
orange: casting
green: detachment
- 3) red: brick surface
blue: surface deposit on the plastered surface (not analysed in degradation because not related to damage)
dense orange: stain
- 4) dense blue: efflorescence
cyan: dripping, biological patina
green biological colonisation
- 5) cyano: diaccacco
yellow-orange: stain
green: dripping and biological patina

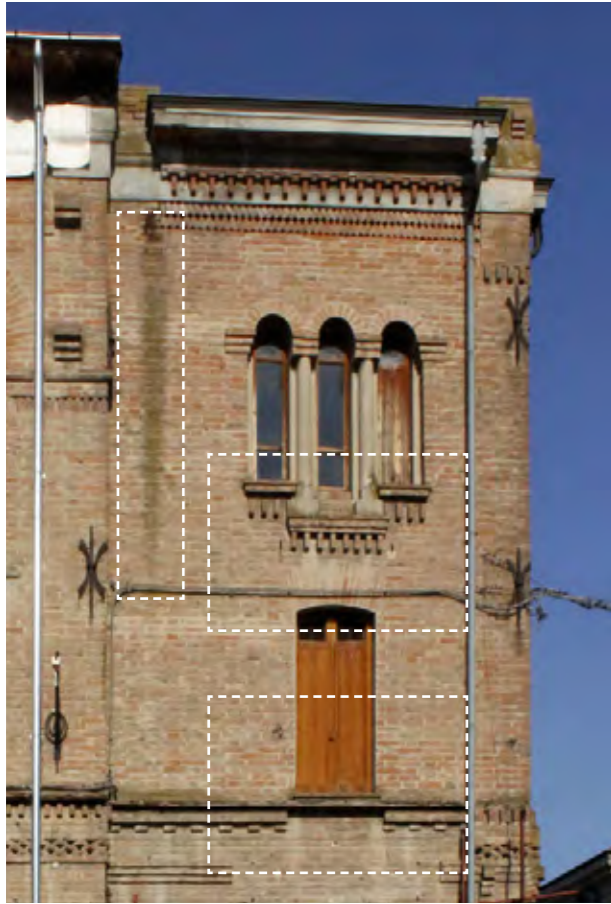
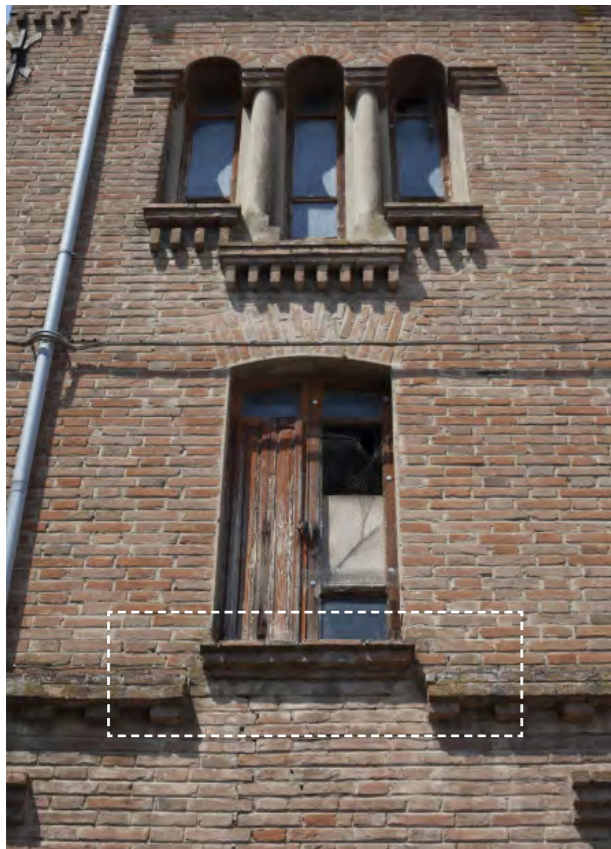
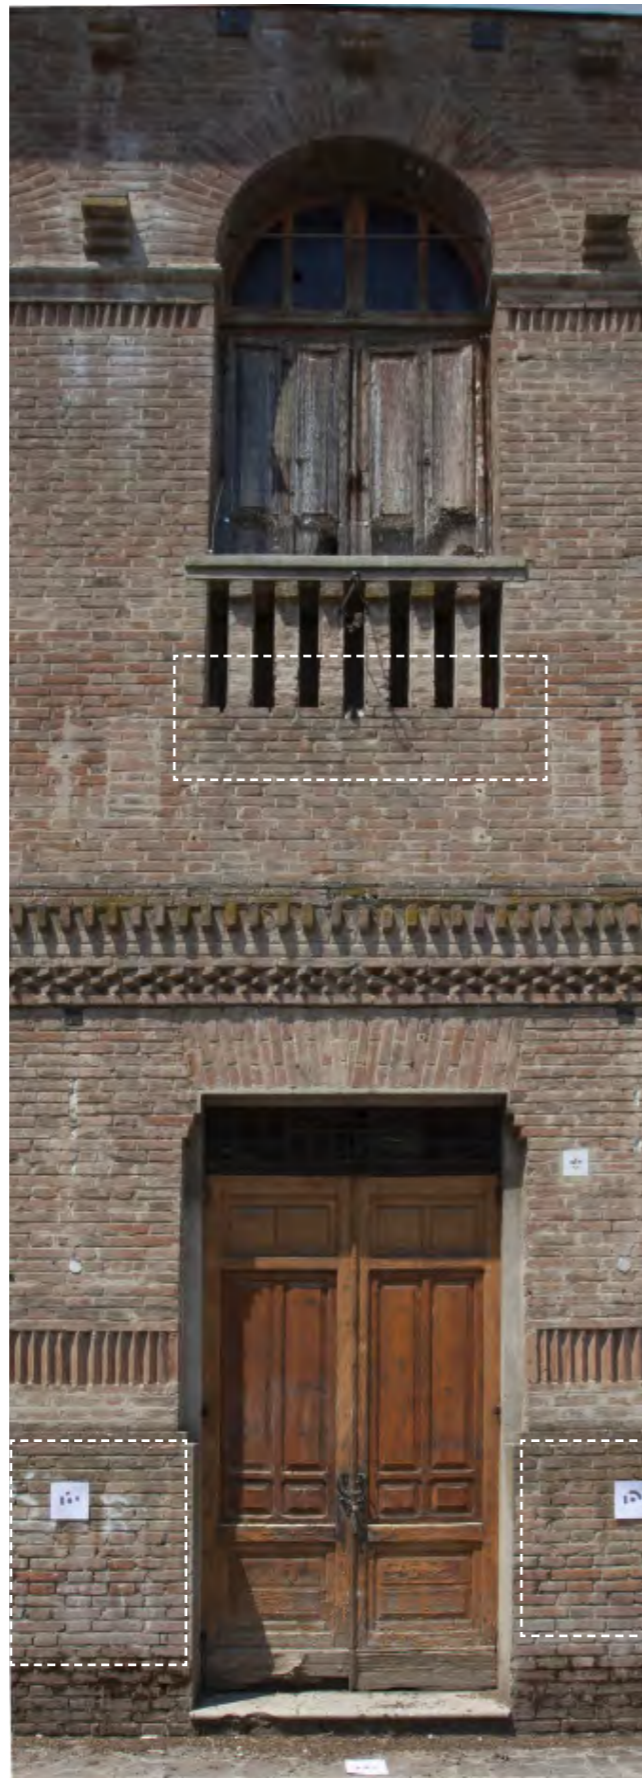
photographic survey_ north elevation

dripping; biological patina: the phenomenon is linked to inadequate water drainage, often caused by the absence of pavement markings.

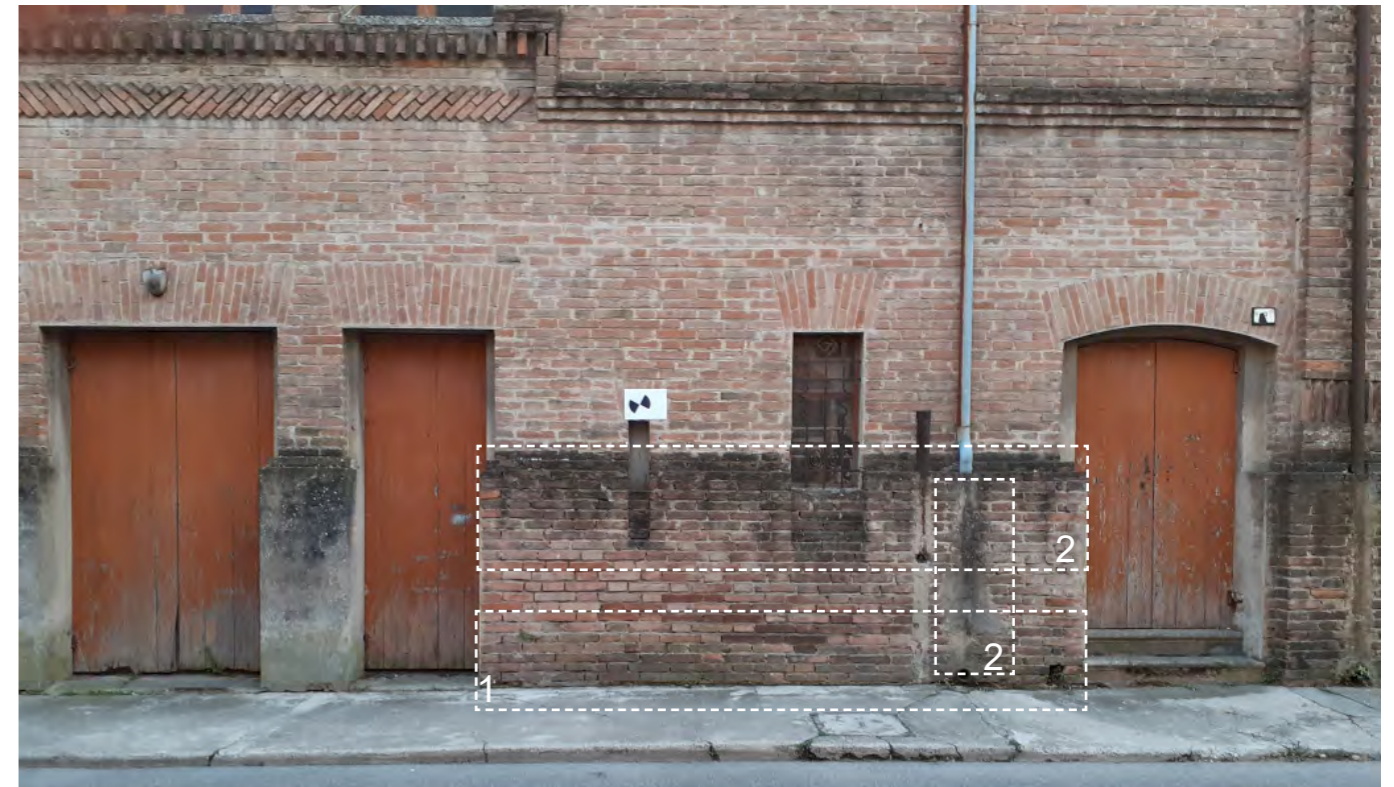
photographic survey basement strip

1-rise; biological colonisation
 2-dripping; biological patina: the phenomenon is linked to inadequate water disposal..

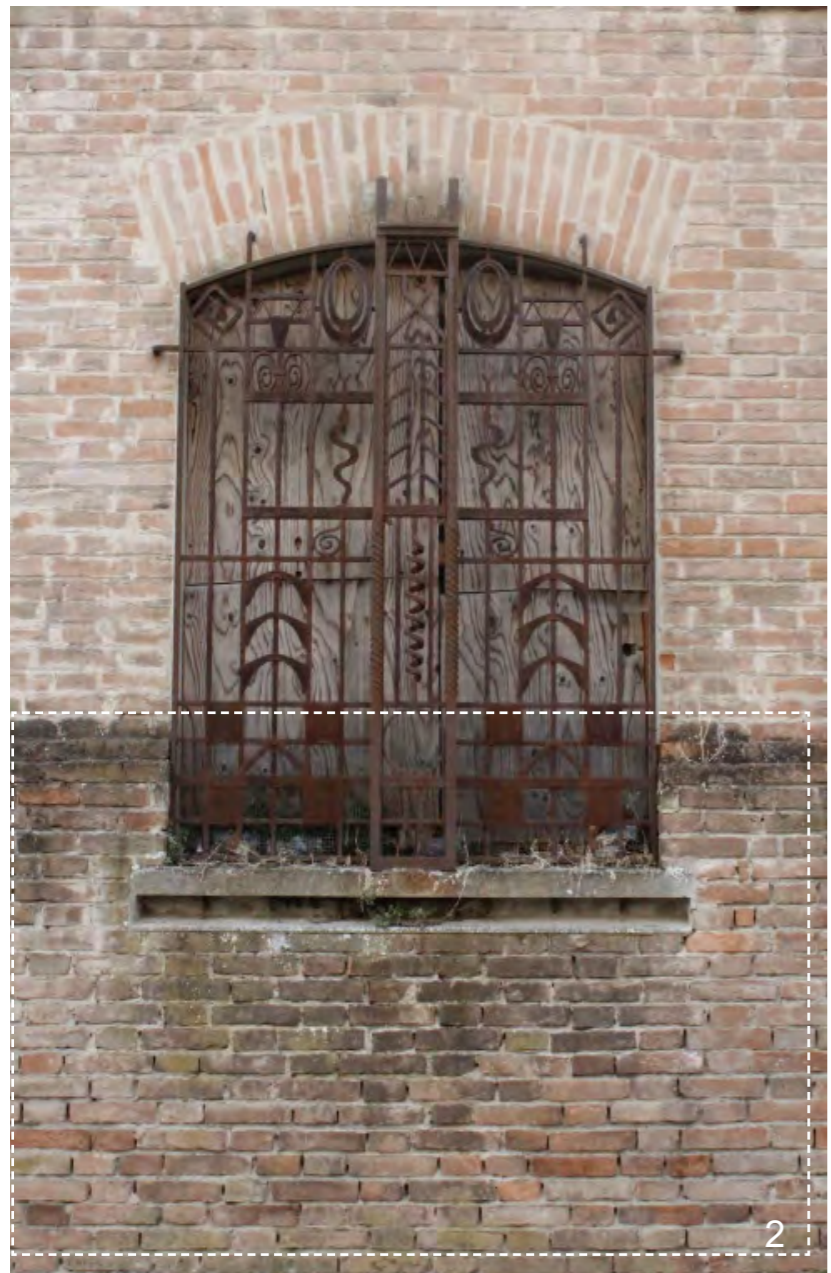
photographic survey_ north elevation

1-rise; biological colonisation

2-dripping; biological patina: the phenomenon is linked to inadequate water disposal..
