Optimisation of survey procedures and application of integrated digital tools for seismic risk mitigation of cultural heritage: The Emilia-Romagna damaged theatres.

APPEDIX B: DAMAGE SURVEY

B PD form - Social Theatre of Novi (Modena)

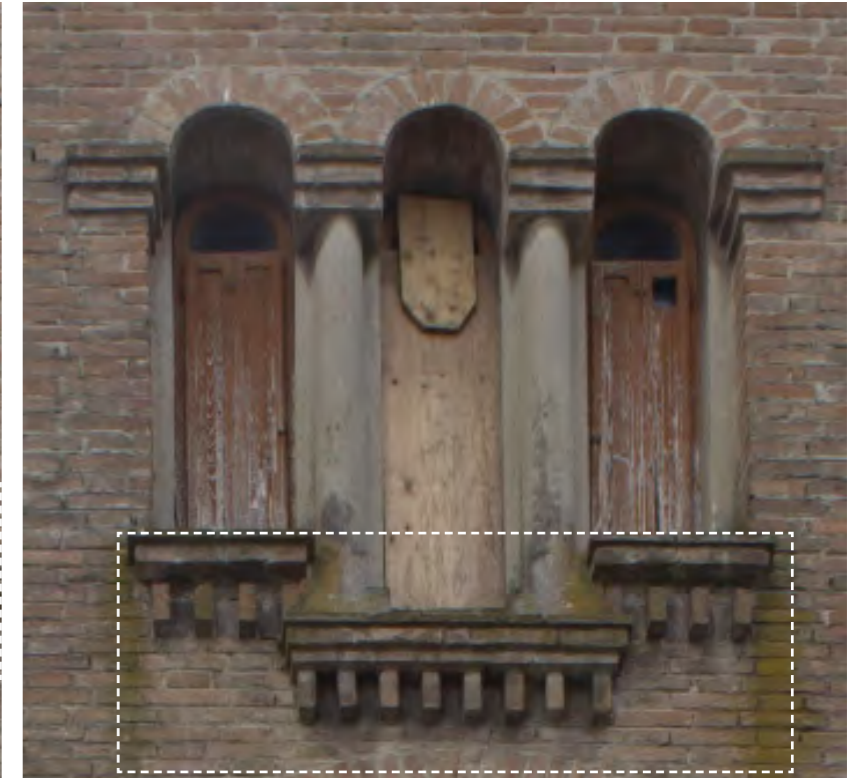
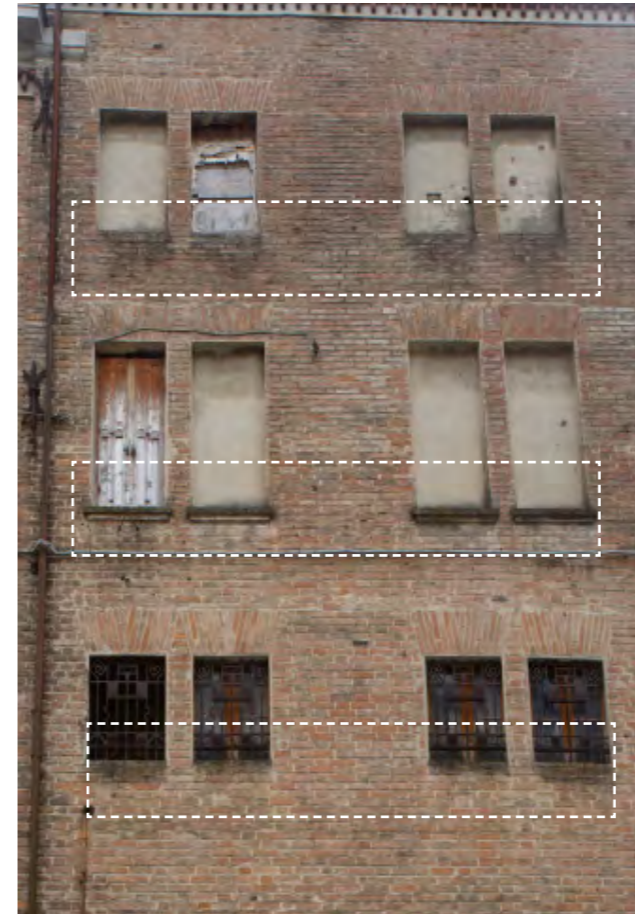
photographic survey_ north elevation

2-Colouring; biological patina: the phenomenon is linked to inadequate water drainage, often caused by the absence of pavement markers.

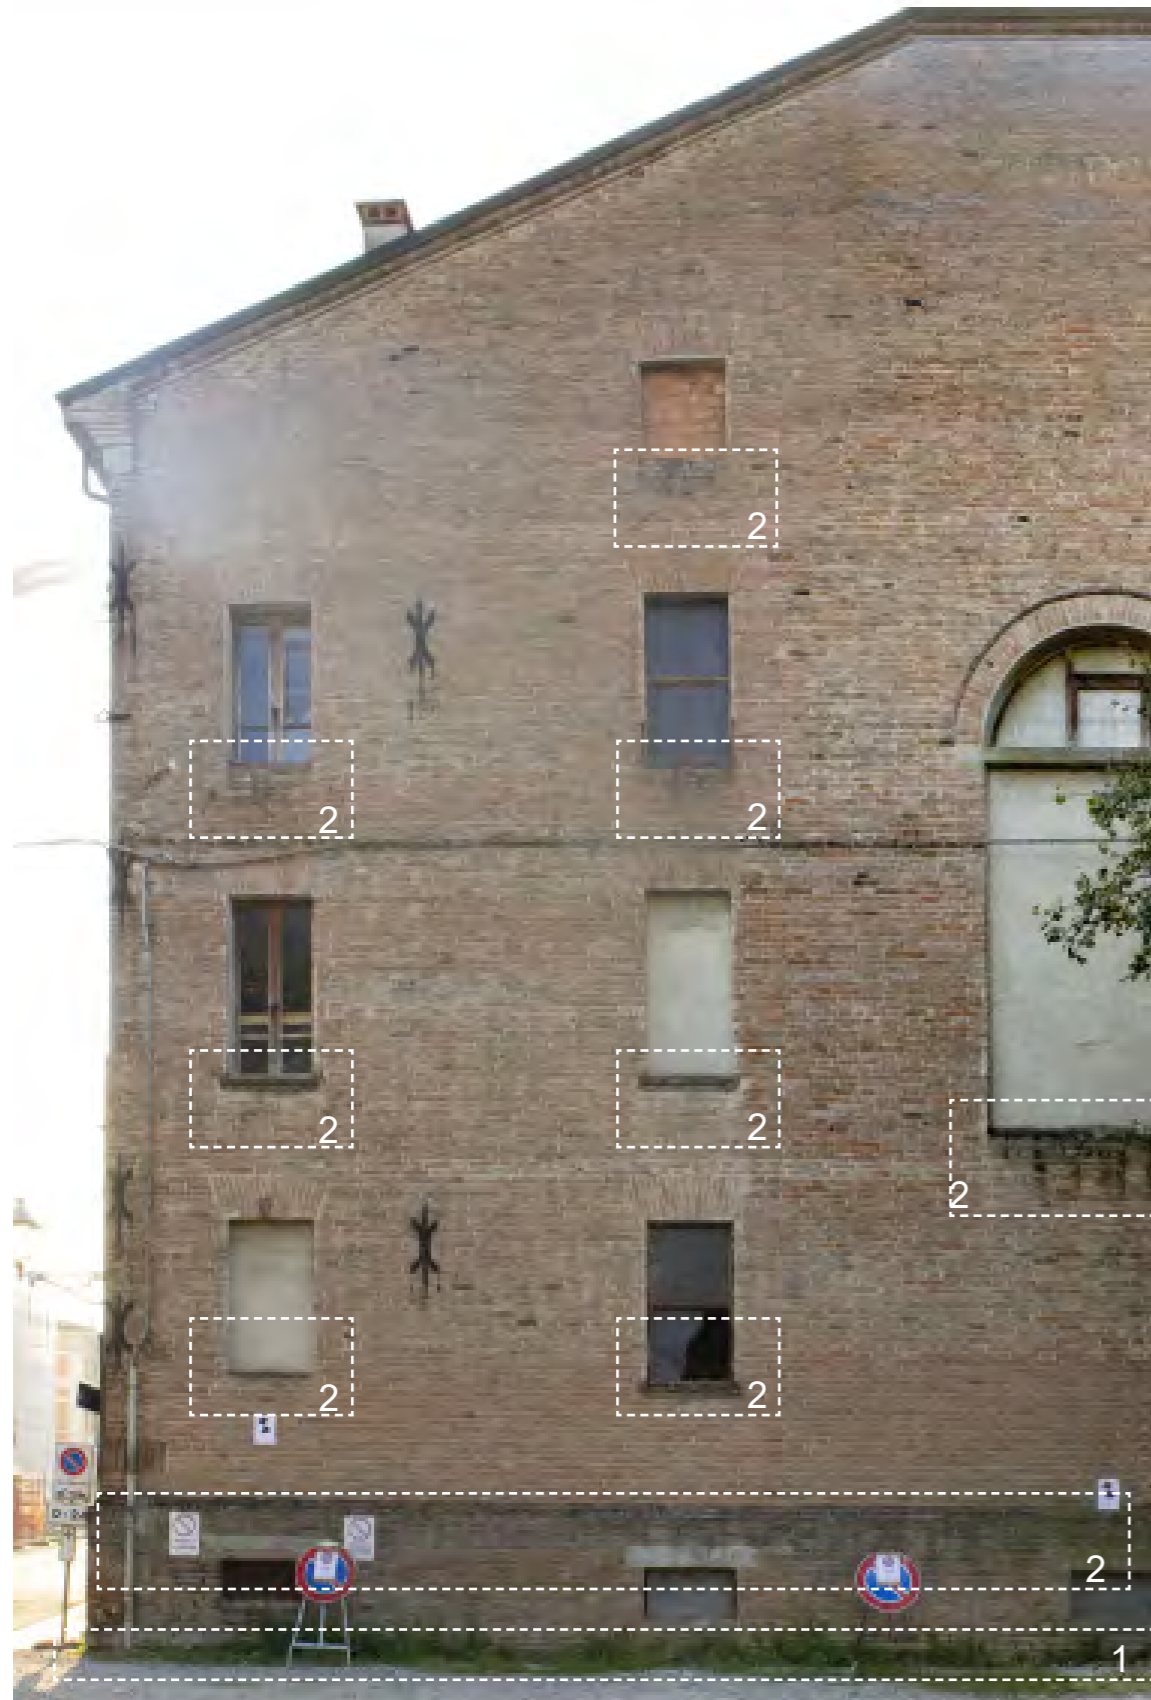
photographic survey_ north elevation

1-rising front; biological colonisation; the presence of vegetation

2-Colouring; biological patina: the phenomenon is linked to inadequate water drainage, often caused by the absence of pavement markers.

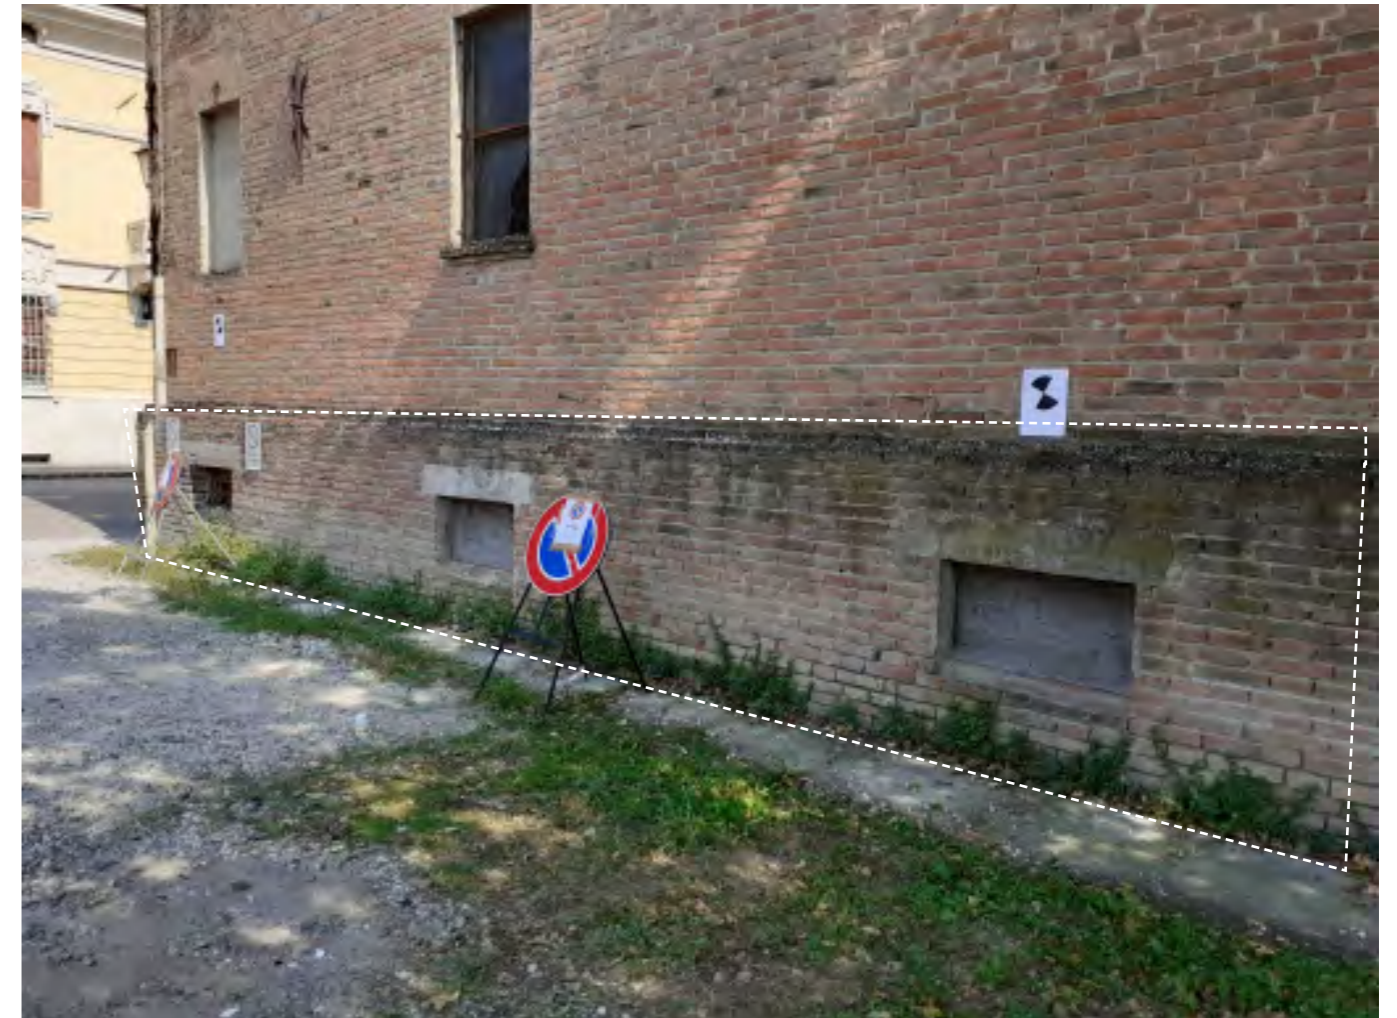
photographic survey_ west elevation

1-rise; biological colonisation; the presence of vegetation

2-colouration; biological patina: the phenomenon is linked to inadequate water disposal.

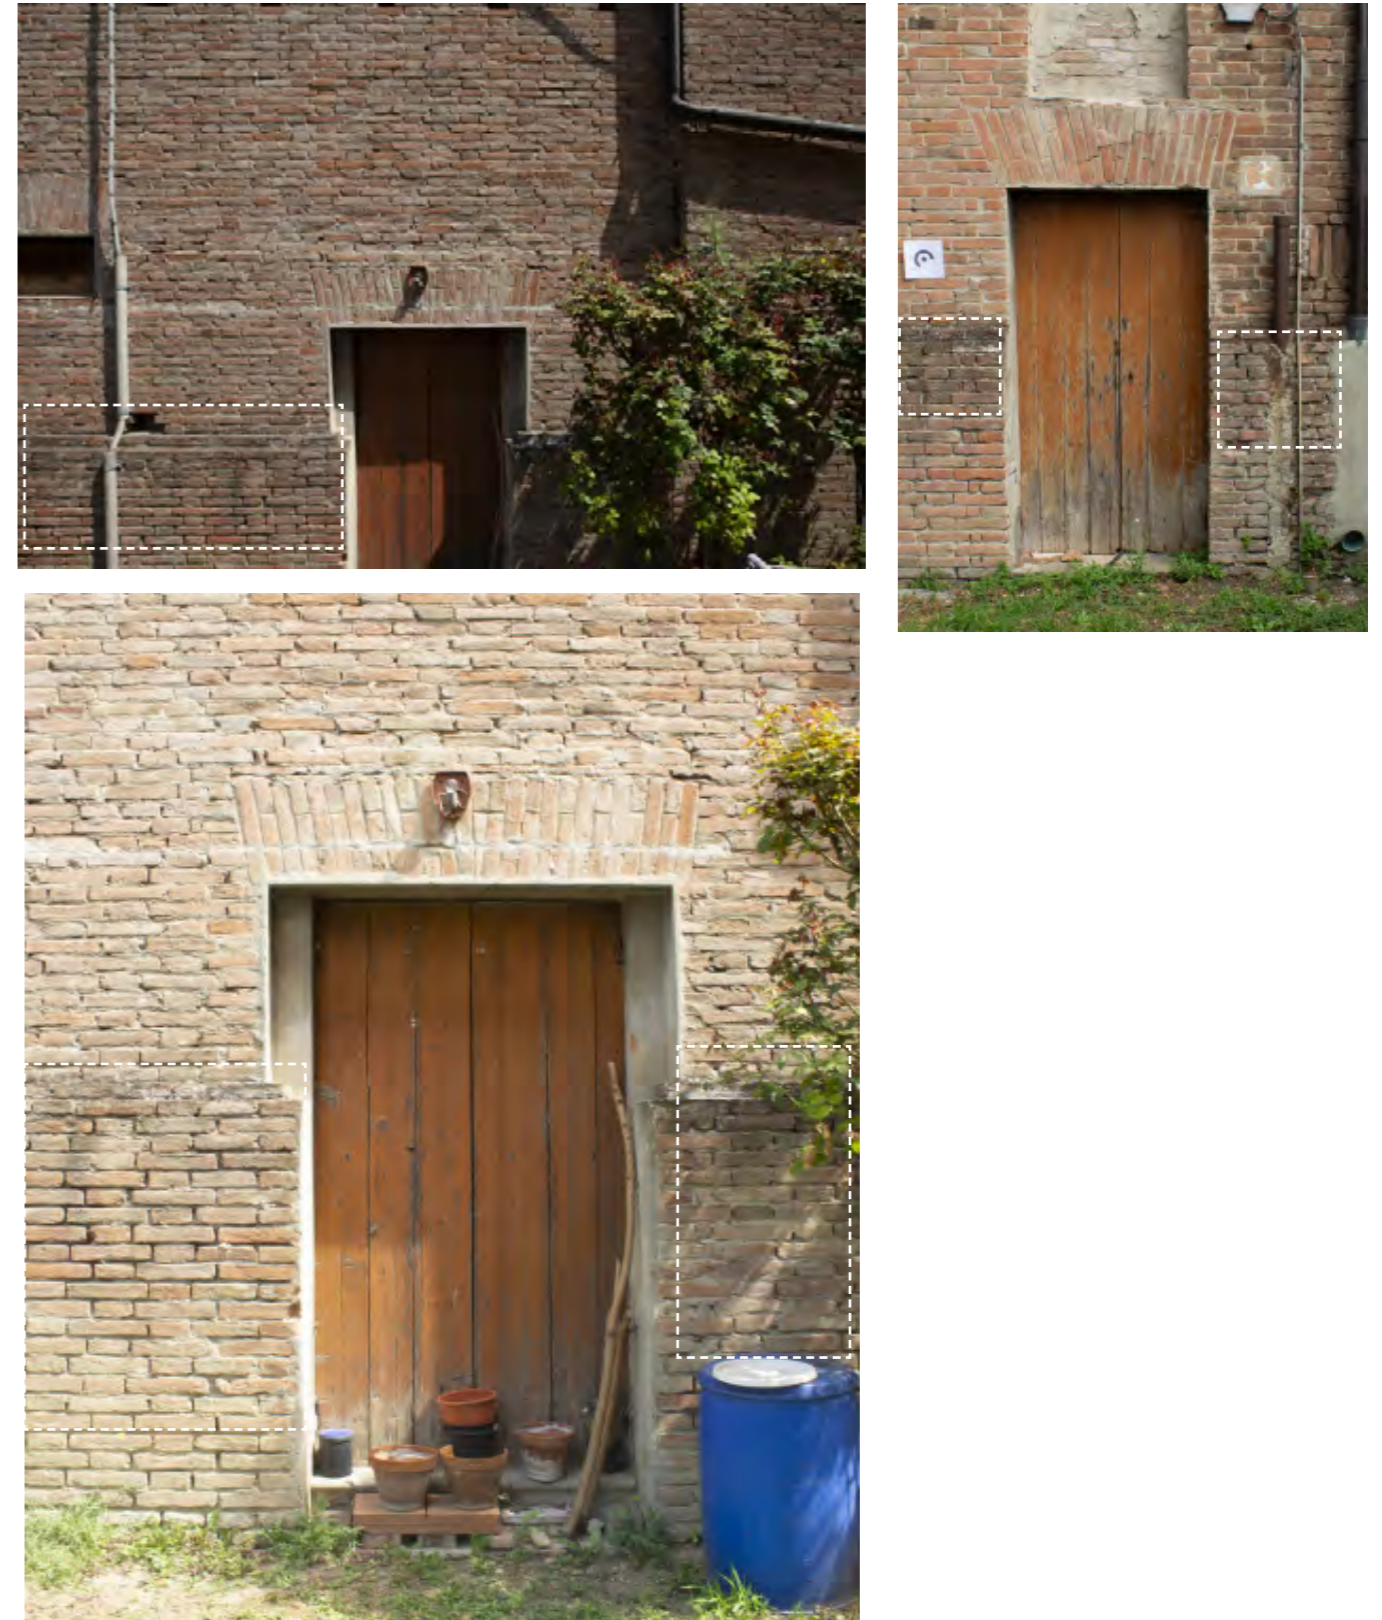
photographic survey_ south elevation

1 biological colonisation

2 dripping; biological patina: the phenomenon is linked to inadequate water disposal.

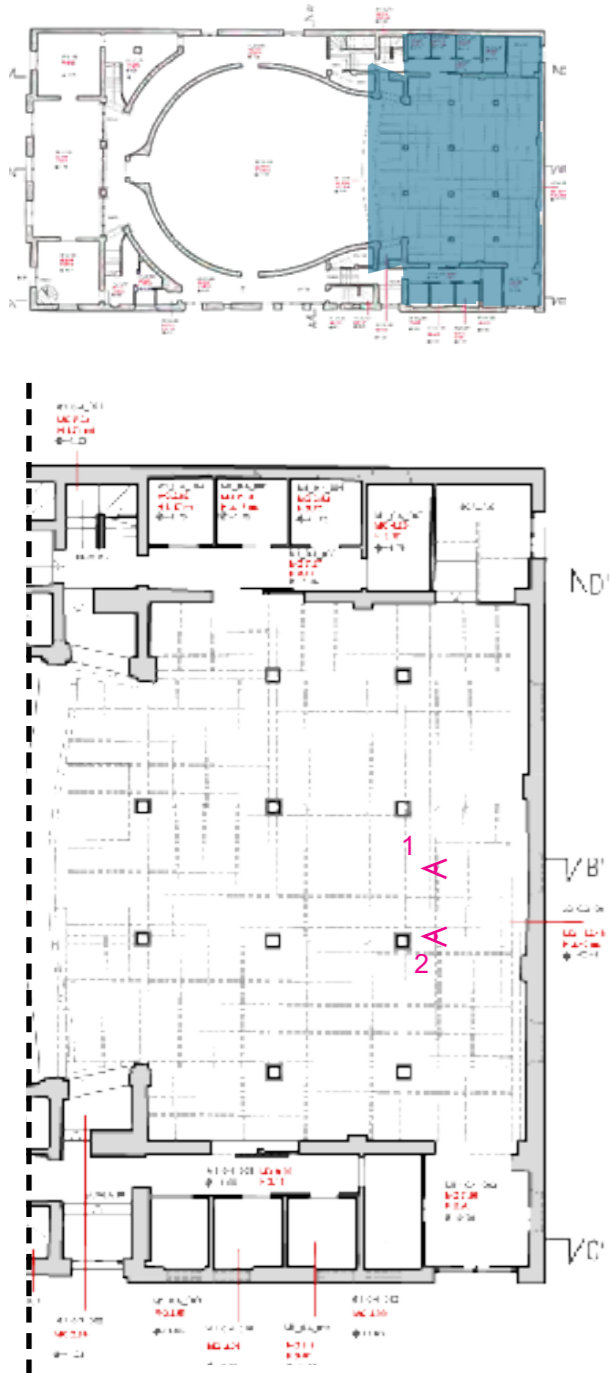
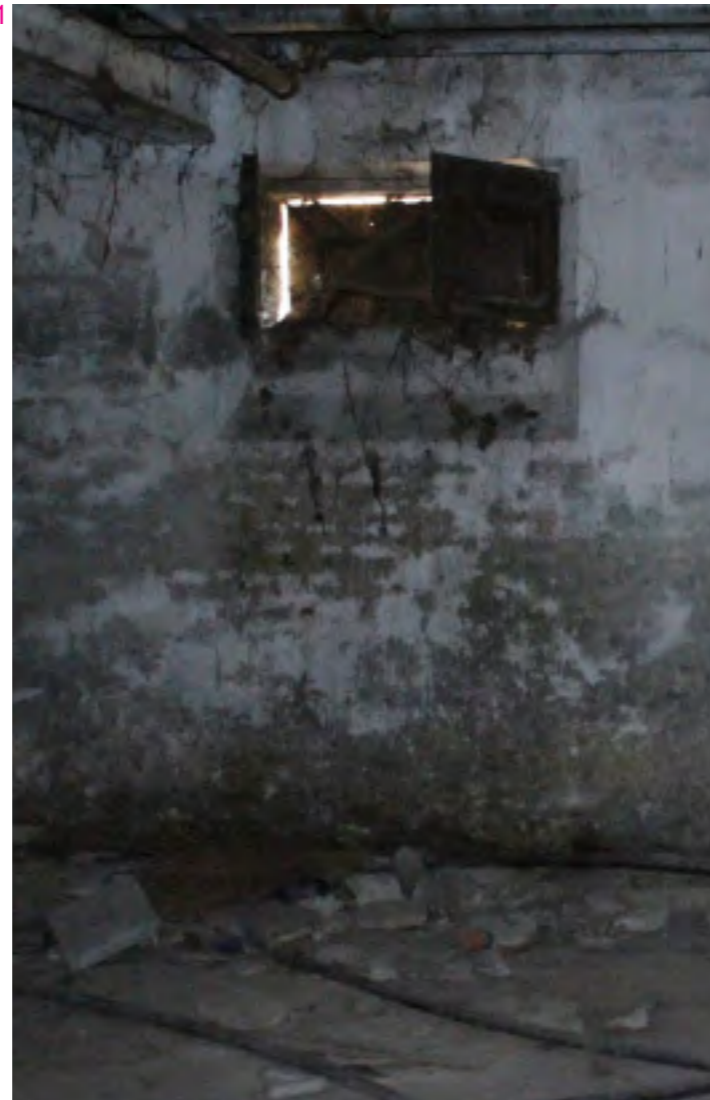
US 0.4
LG_0.4.001

1-2 rising edge

1-2 stain: localised colour change of the surface, related to the presence of water

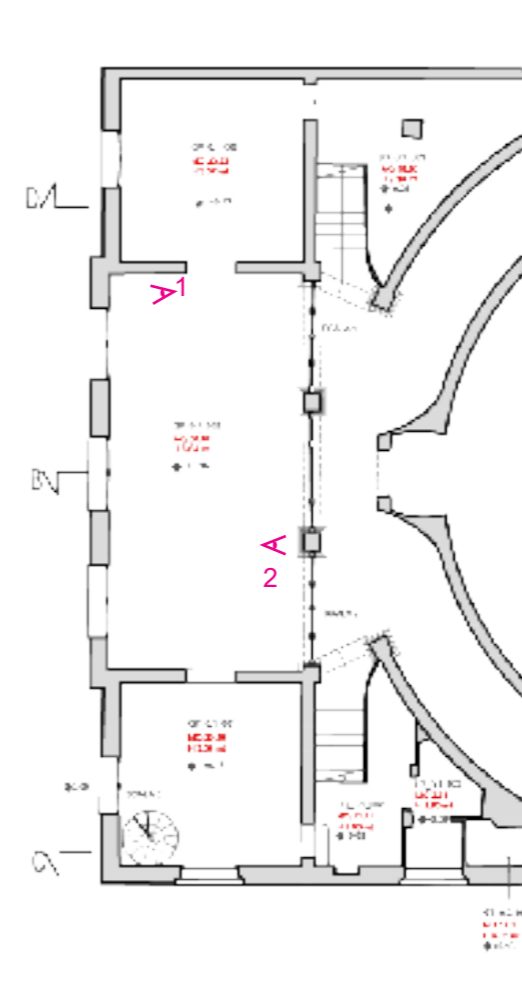
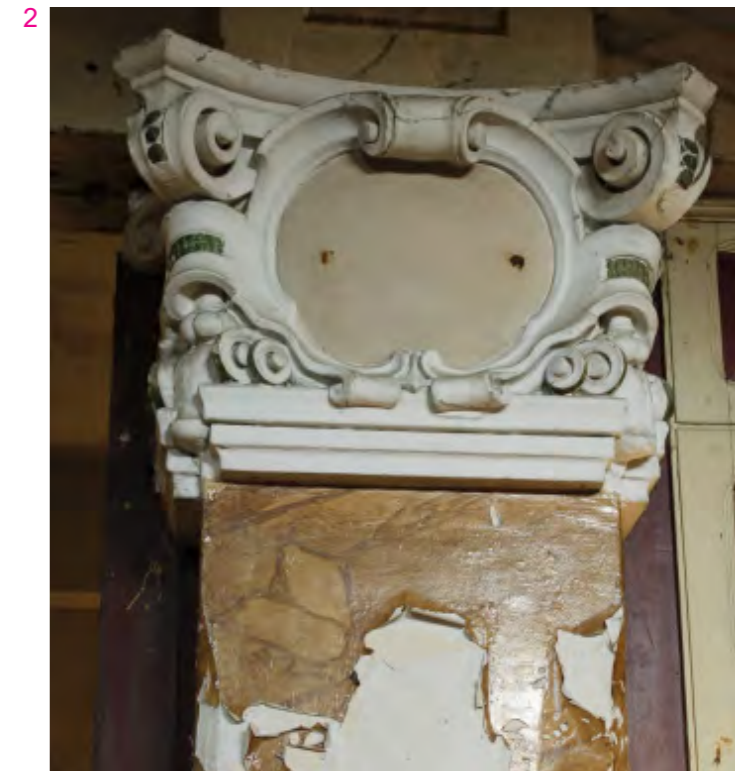
US 0.1
GF_0.1.002

1 -detachment is a phenomenon present on plasterwork, with the layers falling off.

2 -detachment of the decorative film

2 - 3 superficial deposit

3 - biological colonisation

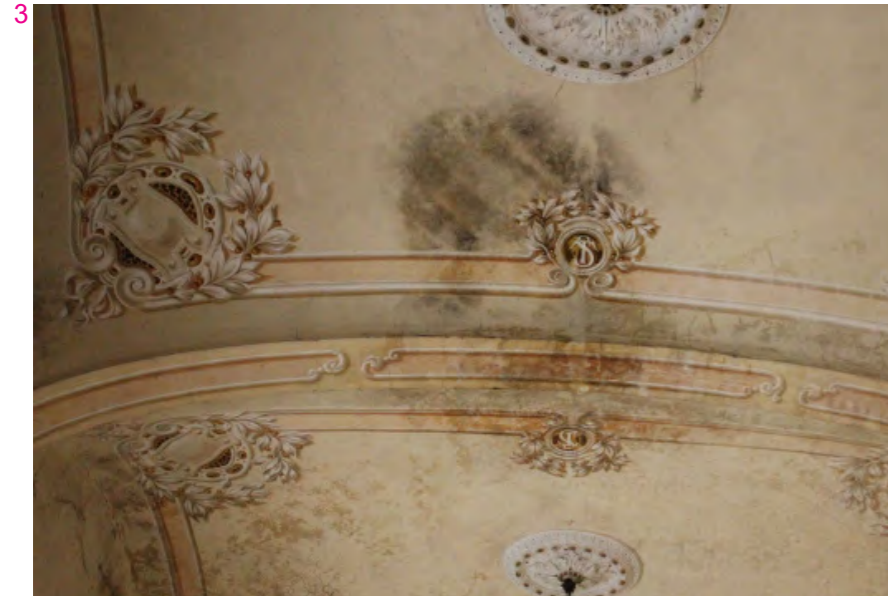
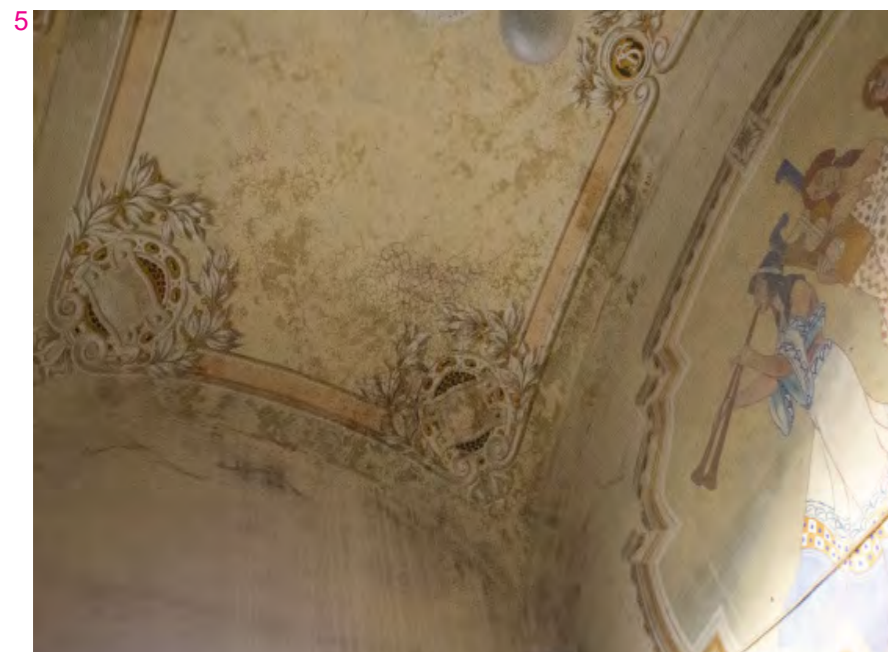
detail of the vaulted ceiling GF_0.1.002

3-4-5 staining: localised colour variation of the plaster surface

3-5 differential plaster degradation

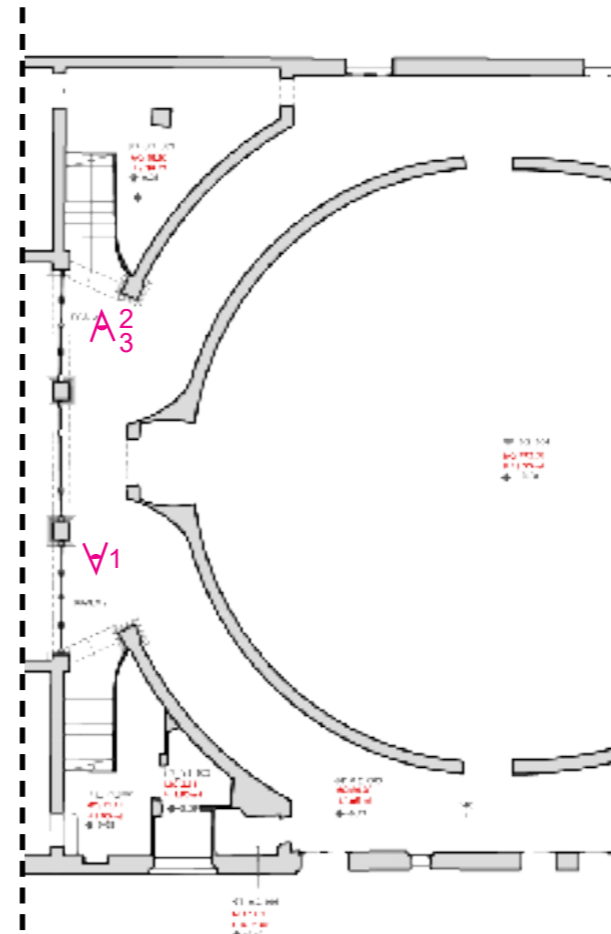
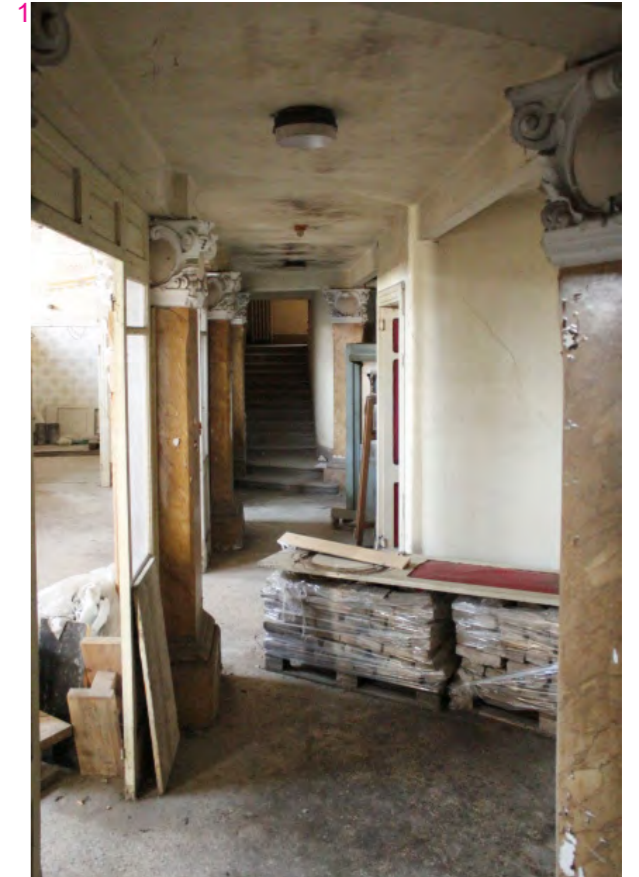
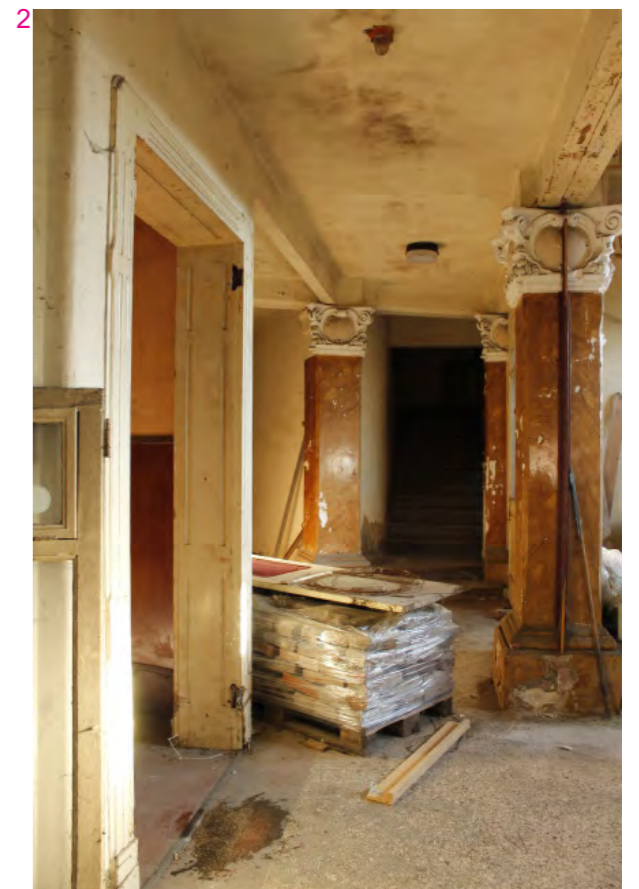
US 0.2
GF_0.2.005

1-2-3 stain: localised colour change on the plaster surface

1-2-3 differential plaster degradation

4- detachment: a phenomenon present on plaster, with falling layers.

macro detail of the plaster detachment partially visible in photo 4

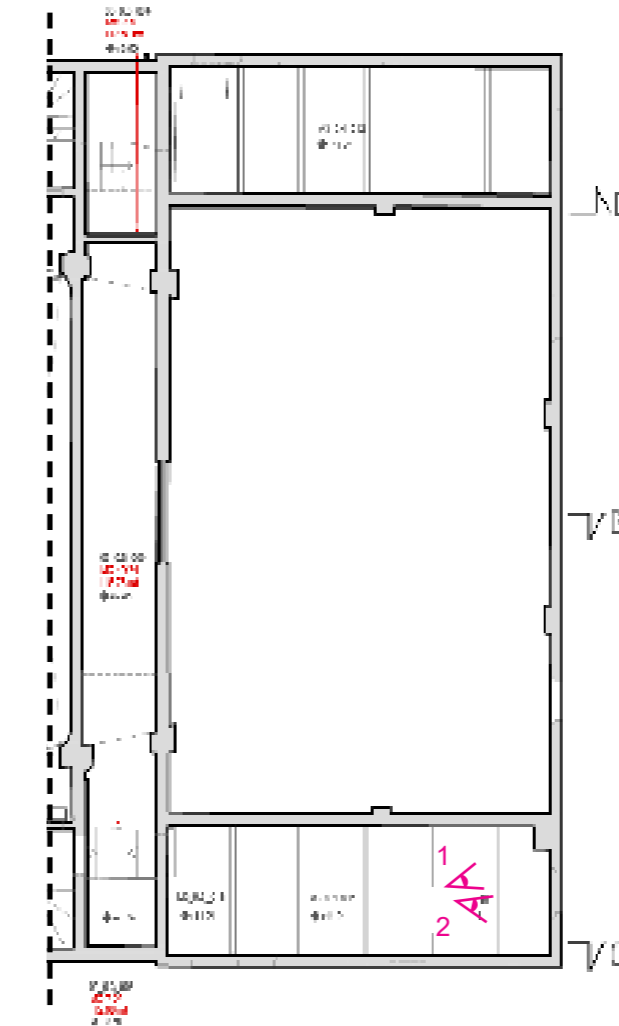
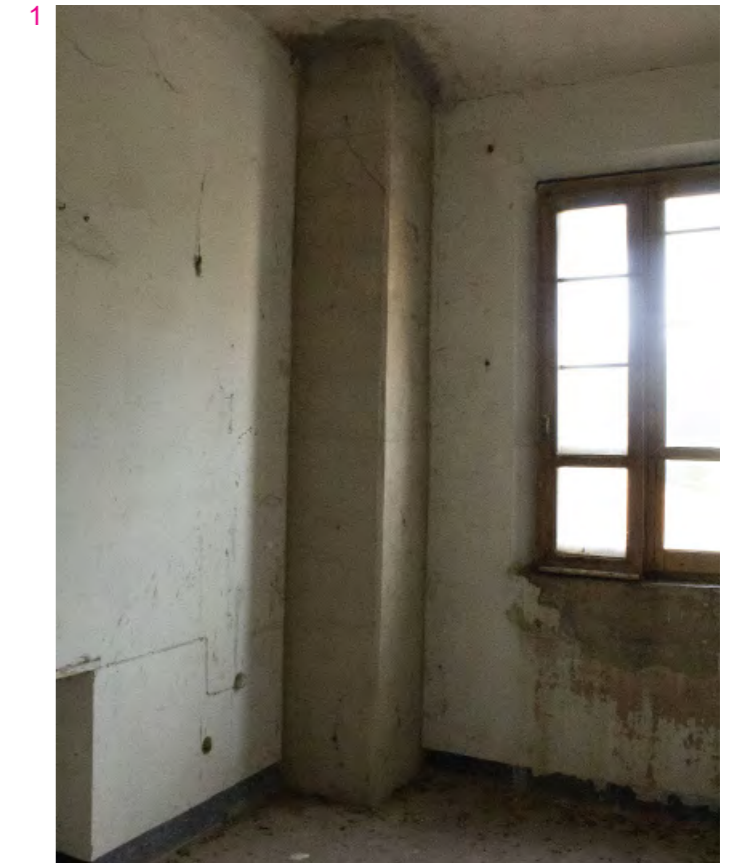
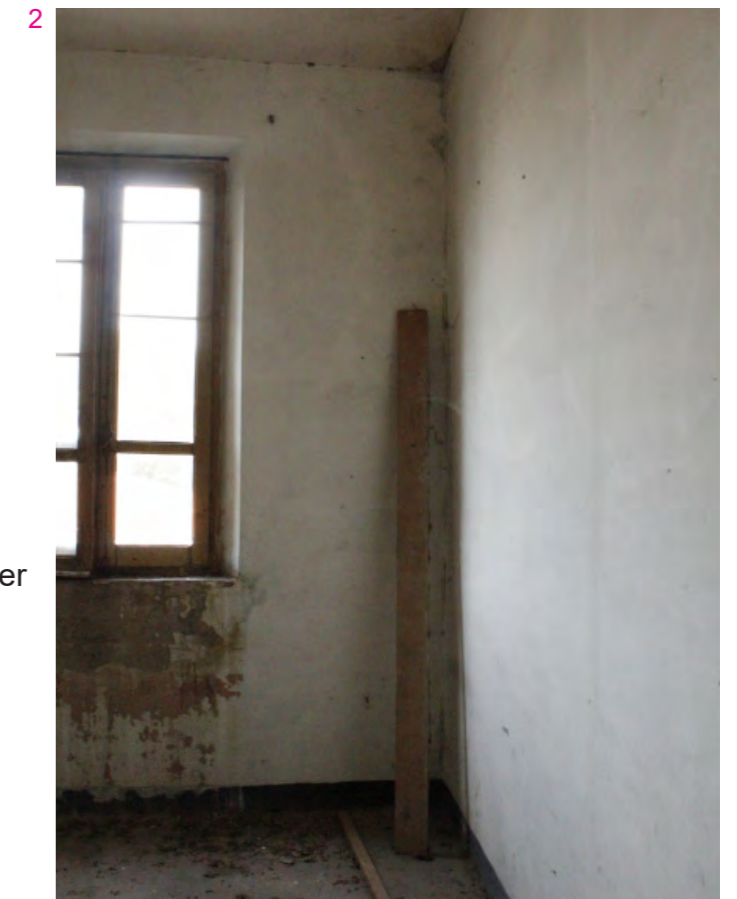
03_0.3.013-14-15

1-2 staining: localised colour change on plaster surface

1-2 dripping

1-2 differential plaster degradation

1-2 detachment: a phenomenon present on plaster, with falling layers.

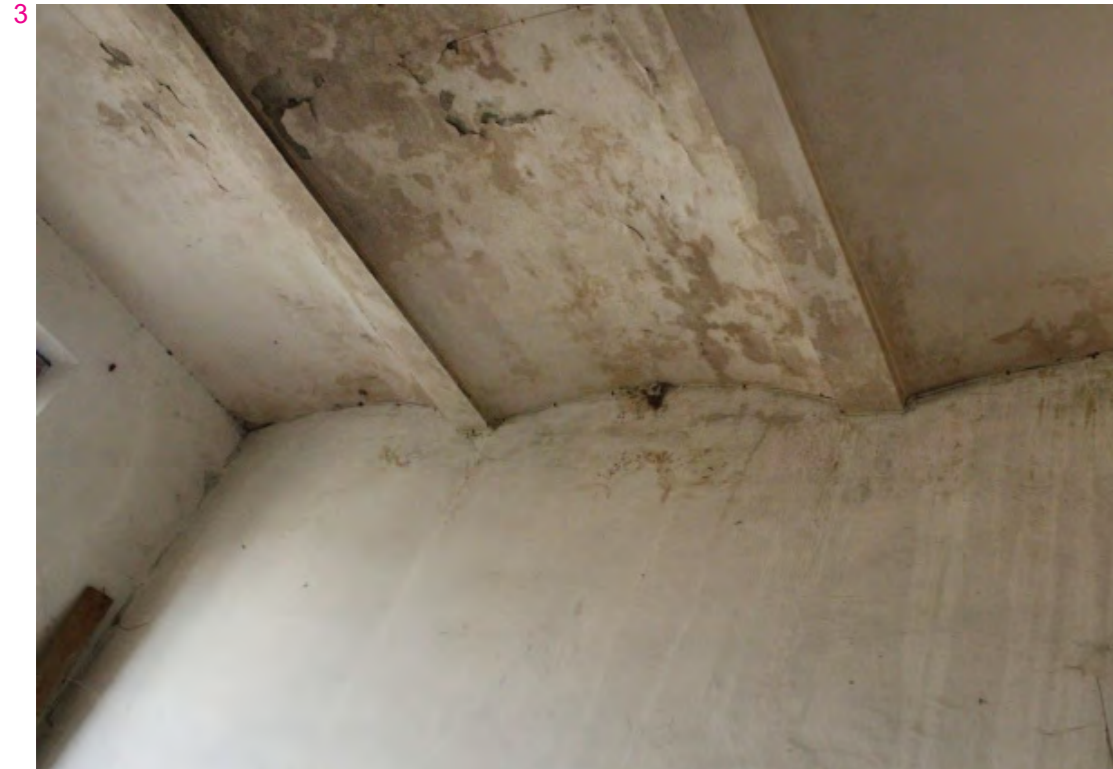
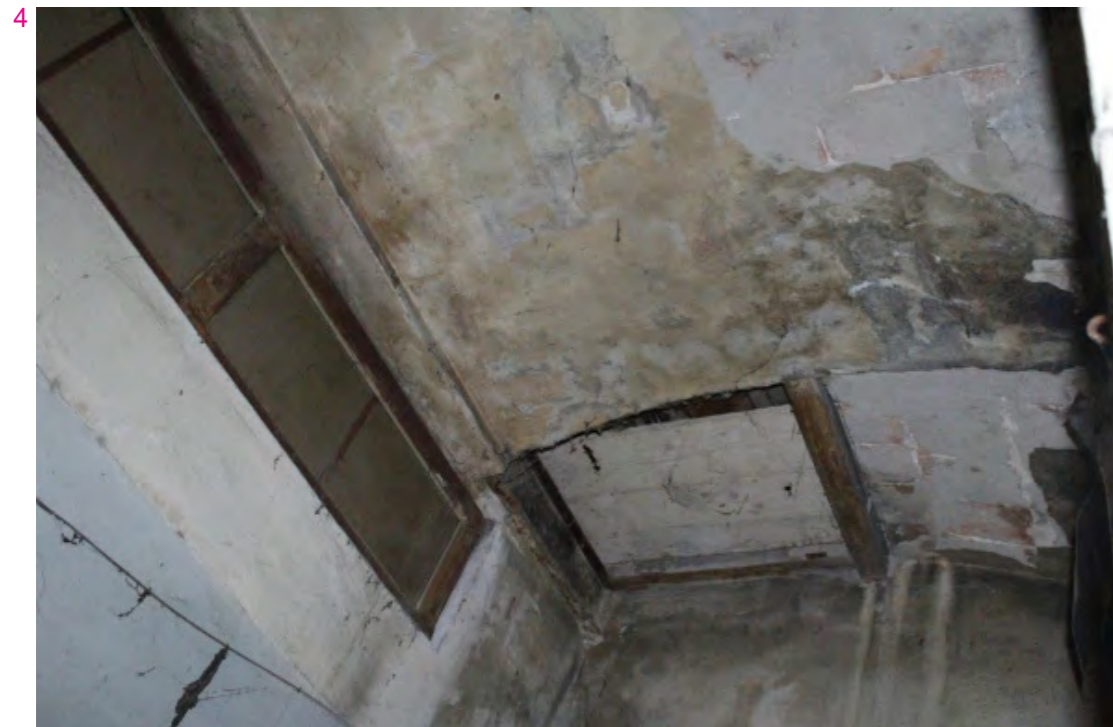
detail of the ceiling 03_0.3.013-14-15

- 3-4 staining: localised colour variation of the plaster surface
- 3-4 dripping
- 3-4 differential plaster degradation
- 3-4 detachment: a phenomenon present on plaster, with falling layers.

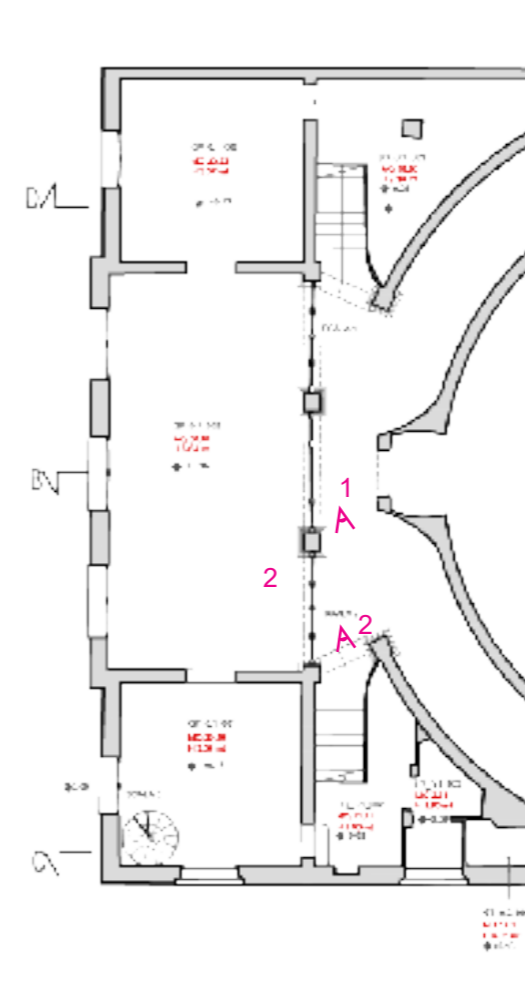
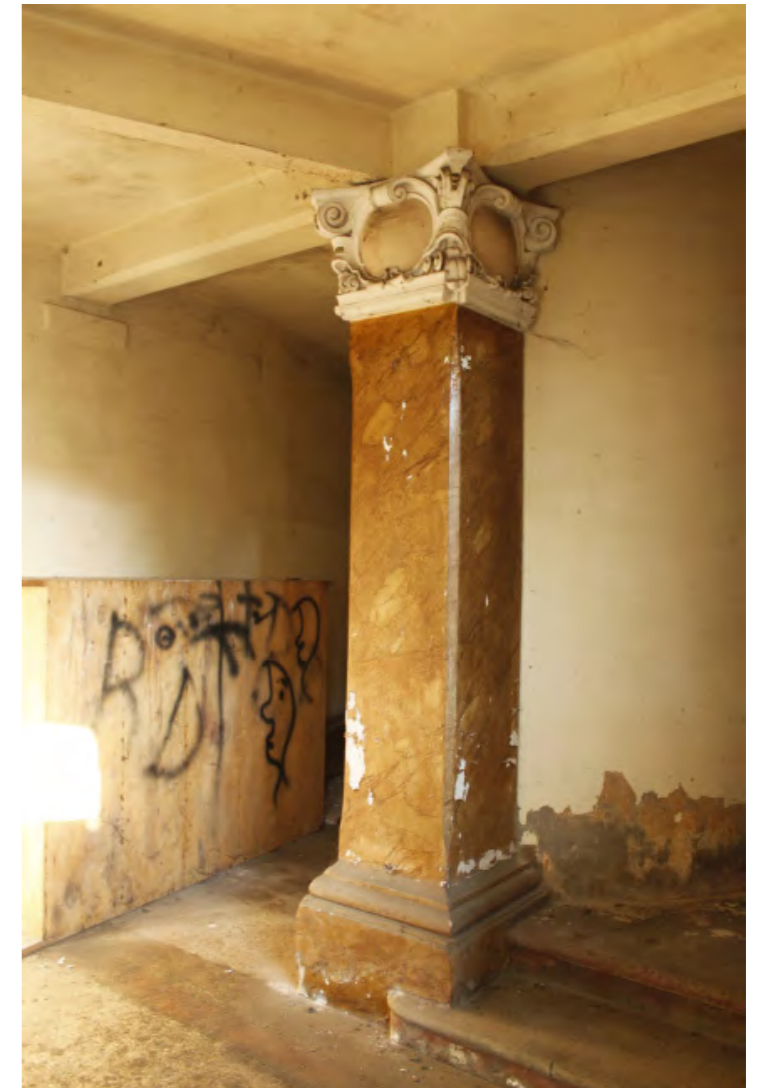
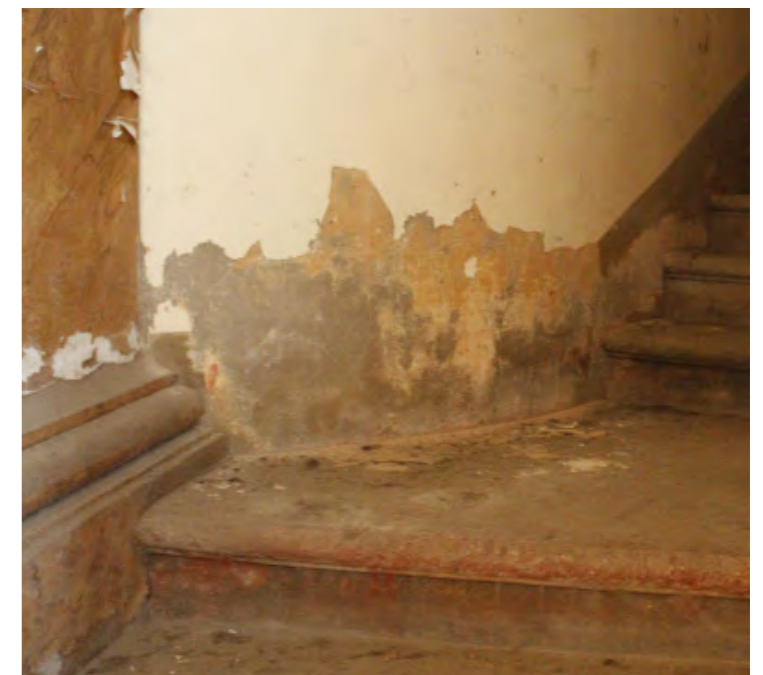
staircase 2

- 1-2 detachment: phenomenon present on plaster, with falling layers.
- 1-2 surface deposit
- 1- vandalistic murals(corridor wall)

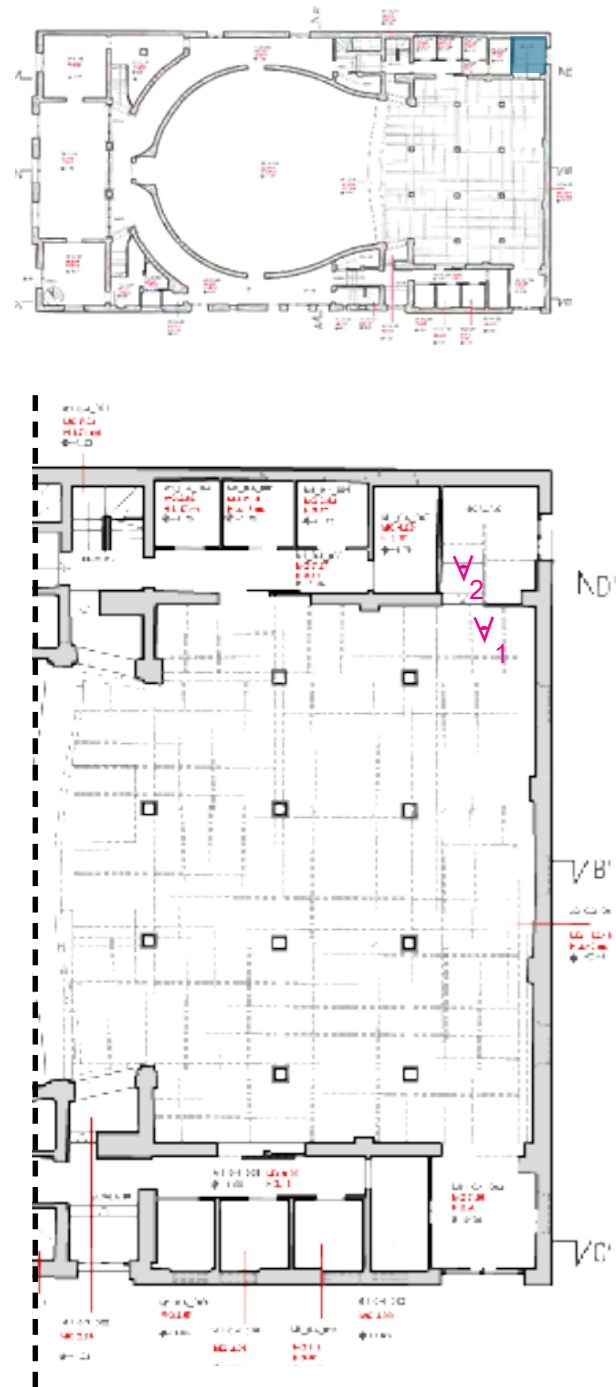
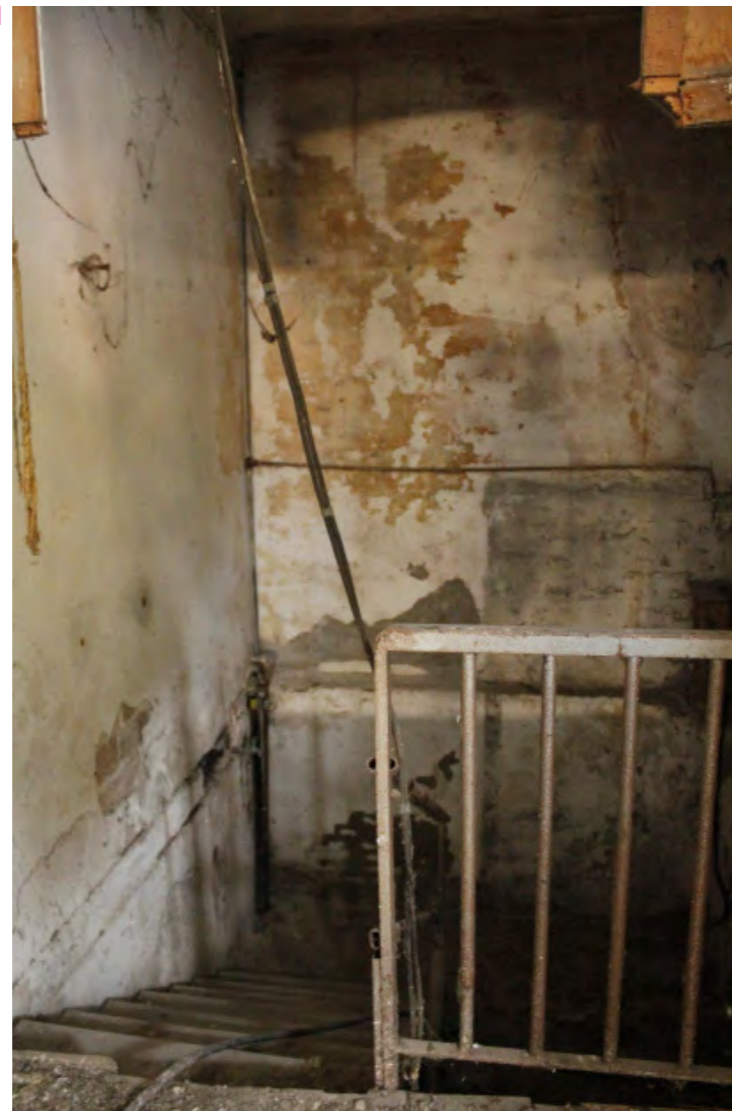
staircase 9

1-2 staining: a localised colour variation on the surface, related to the presence of water

1-2 detachment: a phenomenon present on plaster, with the layers falling off

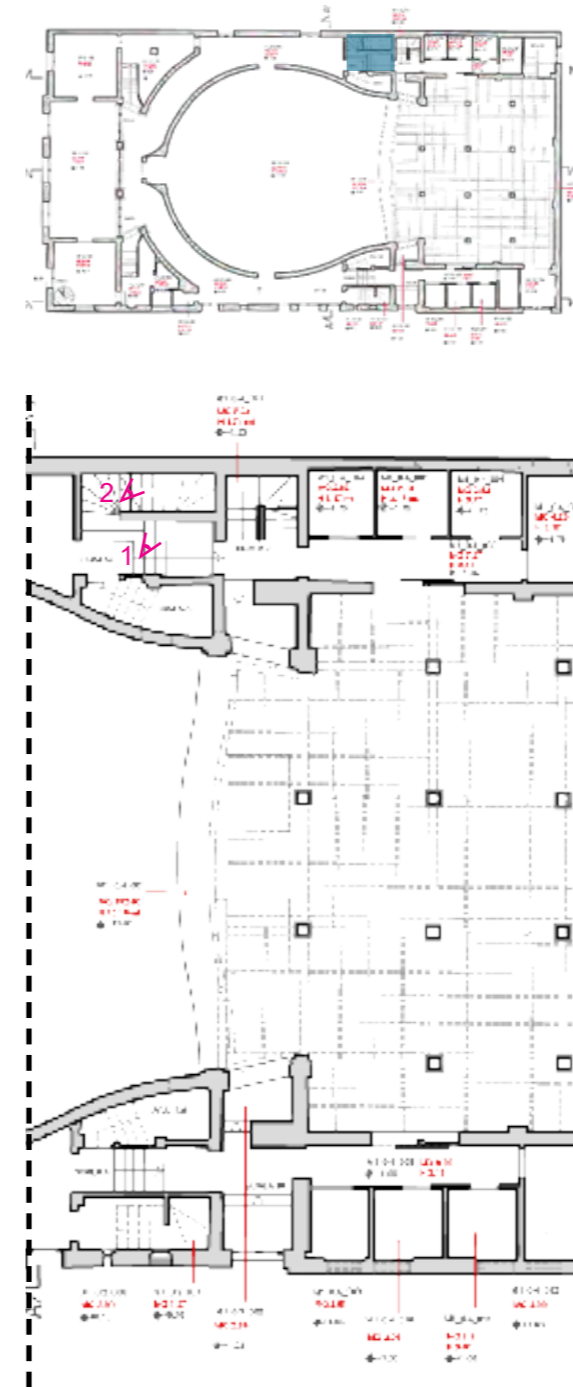
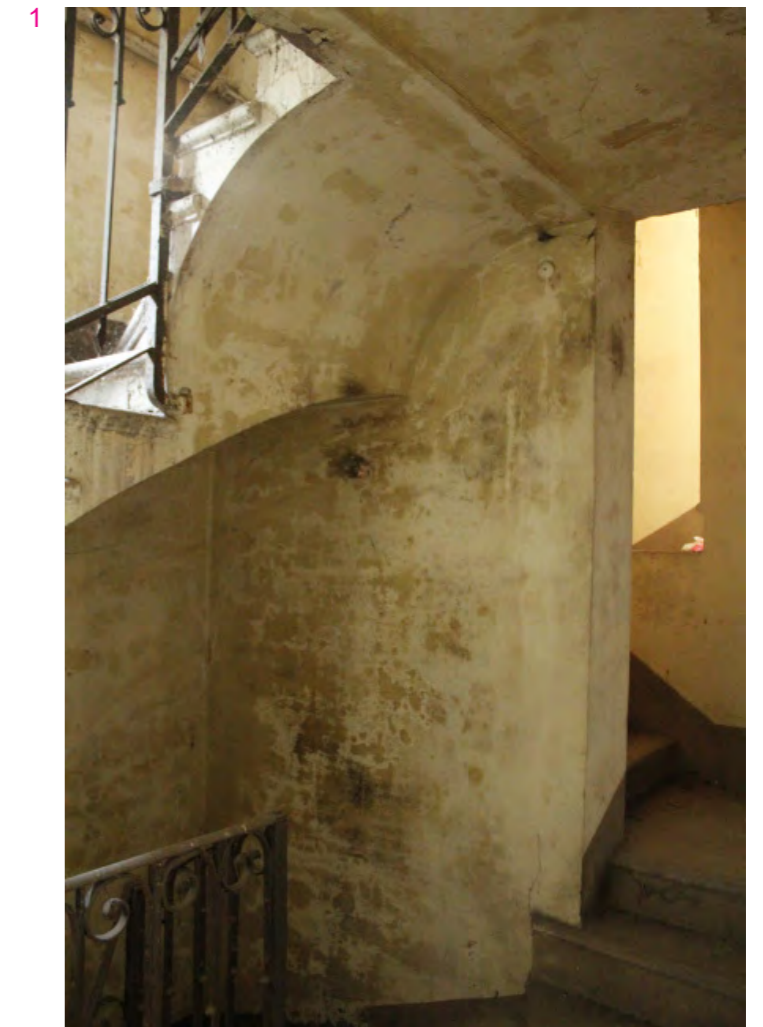
staircase 7

1-2 staining: localised colour variation on the surface, related to the presence of water

1-2 detachment: a phenomenon present on plaster, with the layers themselves falling off

1-2 differential plaster degradation

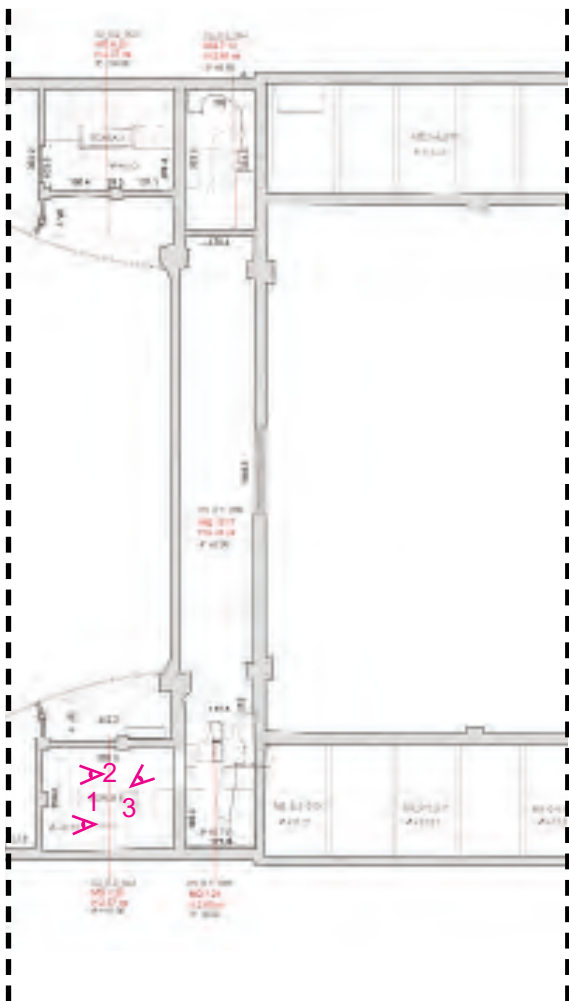
staircase 8

1-2-3 staining: localised colour change on the plaster surface

1-2-3 dripping

1-2-3 differential plaster degradation

1-2-3 detachment: phenomenon present on plaster, with falling layers
