Manuscript number	EFA_2018_415_R1
Title	FAILURE ANALYSIS OF WORN VALVE TRAIN COMPONENTS OF A FOUR-CYLINDER DIESEL ENGINE
Article type	Research Paper

This work investigates the causes of excessive wear occurring at the rocker arm/pushrod and rocker arm/valve interfaces of a diesel engine for industrial cleaning machines, after only 1000 hours of engine operation. In this engine, the recent replacement of tappets by hydraulic valve lifters not only reduced the running time but also required supplementary maintenance. The chemical composition of the worn components was verified by optical emission spectroscopy. The microstructures, mechanical properties and surface textures were determined by optical microscopy, Vickers hardness and non-contact 3D profilometry. To evaluate the wear mechanisms, the worn surfaces were analyzed by scanning electron microscopy with energy dispersive spectroscopy. The results indicated non-uniform wear damage at the rocker arm/valve interface, probably due to a misalignment of valves with respect to valve seat inserts. For rocker arms and pushrods, improper austenitization parameters and/or unsuitable design of the inductor left some free ferrite, respons

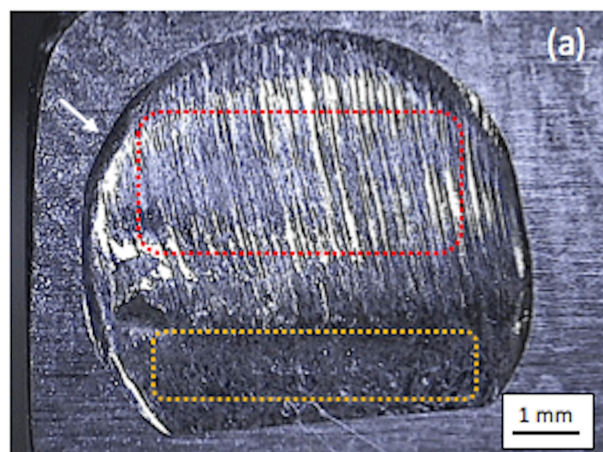
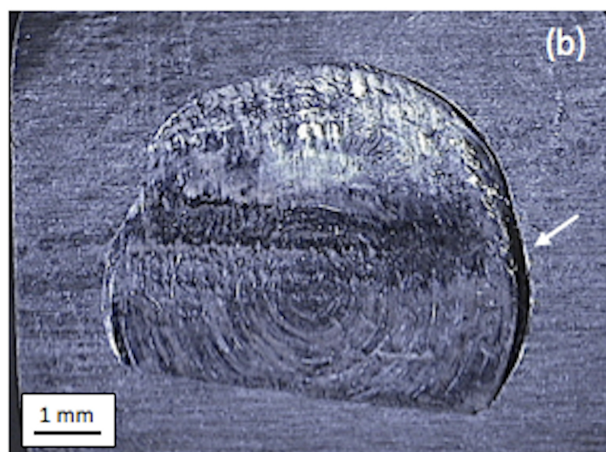
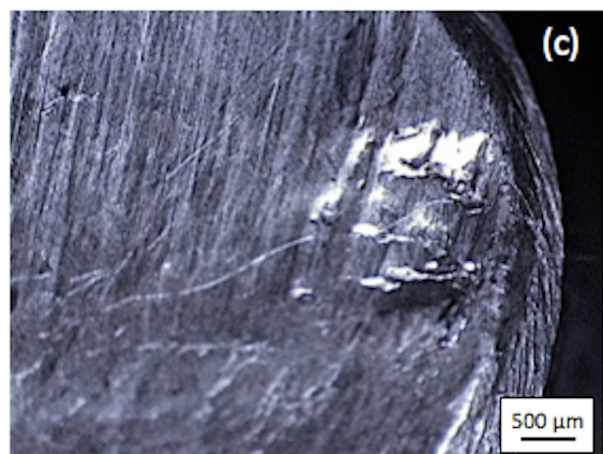
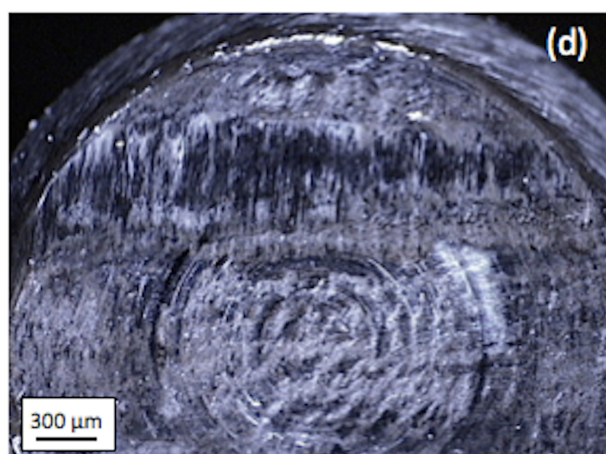
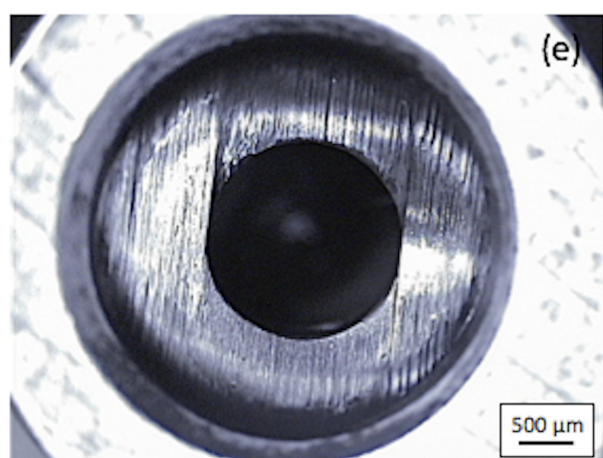
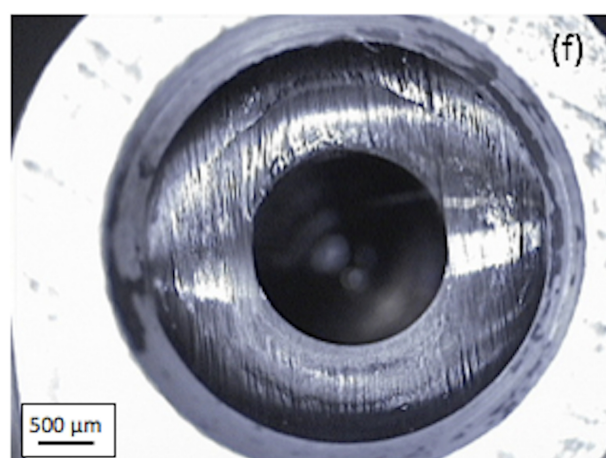
118 The stereomicroscopy images representing the excessive wear at the induction hardened regions are
119 shown in Fig. 2a-f. The extent of wear on the surface of the outlet rocker arm pad (Fig. 2(a)) was
120 greater than that on the surface of the inlet rocker arm pad (Fig. 2(b)). At the exhaust side, the wear
121 damage was slightly offset from the center of the outlet rocker arm pad; conversely, at the intake
122 side, the wear damage was located at the center of the inlet rocker arm pad. At exhaust and intake
123 sides, the depth of wear was higher at the surface regions respectively located at the opposite
124 directions of the intake and of the exhaust side (white arrows in Fig. 2(a) and (b)). From a
125 morphological point of view, the worn surface of the outlet/inlet rocker arm pad could be divided
126 into two zones: the first one (Fig. 2(a), red outline) was shiny with scuffing appearance, whereas the

127 second one (Fig. 2(a), orange outline) was matted with numerous pits uniformly distributed over the
128 worn surface. Moreover, on the worn surface of the inlet rocker arm pad (Fig. 2(b)) several
129 concentric circles were visible. The morphology of the worn surfaces of exhaust and intake valve
130 stem tips was characterized by the same features observed on the worn surface of the outlet/inlet
131 rocker arm pad (Fig. 2(c) and (d)). Once again, at the center of the intake valve stem tip many

132 concentric circles could be observed (Fig. 2(d)). Concerning the outlet and inlet rocker arm pivot
133 sockets, excessive wear involved material removal with grooves and scratch marks, mostly parallel
134 and distributed over the worn surfaces (Fig. 2(e) and (f)).

194 The SEM/EDS analysis of the shiny area observed on the worn surface of outlet rocker arm pad
195 (Fig. 2(a)) indicated material removal by scuffing, as in pushrod ball ends. Concerning the matted
196 area observed on the worn surface of the same component, the SEI-SEM micrographs showed the
197 presence of numerous pits, ranging in size from a few tens of micrometers to several hundred
198 micrometers (Fig. 8(a)). At higher magnification, subsurface interconnected microcracks and
199 fatigue striations were visible inside the pits (Fig. 8(b)), together with wear particles in the form of
200 spherical agglomerates (Fig. 9 (left)). The semi-quantitative EDS analysis of spherical agglomerates
201 indicated the presence of high percentages of oxygen and iron, and traces of manganese, silicon and
202 calcium (Fig. 9 (right)). For all pairs of outlet/inlet rocker arm pads the morphology of the worn

222 cylinder head [12]. Slight misalignments caused by small differences in roundness or valve seating
223 face angles may lead to uneven wear and non-uniform heat transfer from the valve head to the seat
224 insert. Eventually, misalignments occurring during assemblage may cause the valve recession into
225 the seat insert [13,14]. The absence of concentric circles on the wear surfaces of the outlet rocker
226 arm pad and exhaust valve stem tip, associated to non-rotating valve during engine operation,
227 support the hypothesis of misalignment, although the concentric circles could have been removed
228 by scuffing at the rocker arm/valve interface. On the other hand, the concentric circles are visible on
229 the worn surfaces of the inlet rocker arm pad and intake valve stem tip, thus the valve rotates more
230 or less correctly, reducing wear and friction [15].

373 **Fig. 2.** Stereomicroscopic images representing the excessive wear at the induction hardened
374 regions: (a) outlet rocker arm pad; (b) inlet rocker arm pad; (c) exhaust valve stem tip; (d) intake
375 valve stem tip; (e) outlet rocker arm pivot socket; (f) inlet rocker arm pivot socket. In (a) and (b)
376 white arrows indicate the surface regions respectively located at the opposite directions of the
377 intake and of the exhaust side, and in (a) the red and orange dashed lines enclose regions with
378 different morphological features.

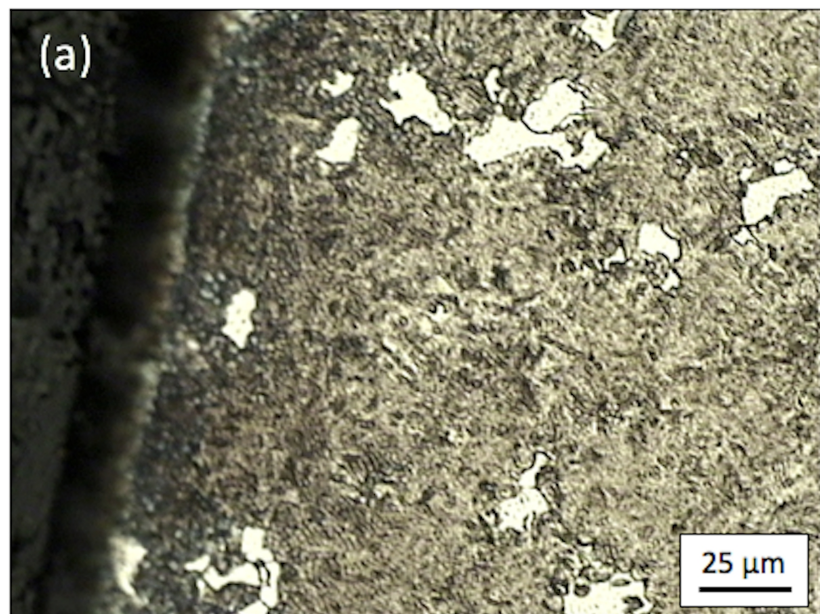
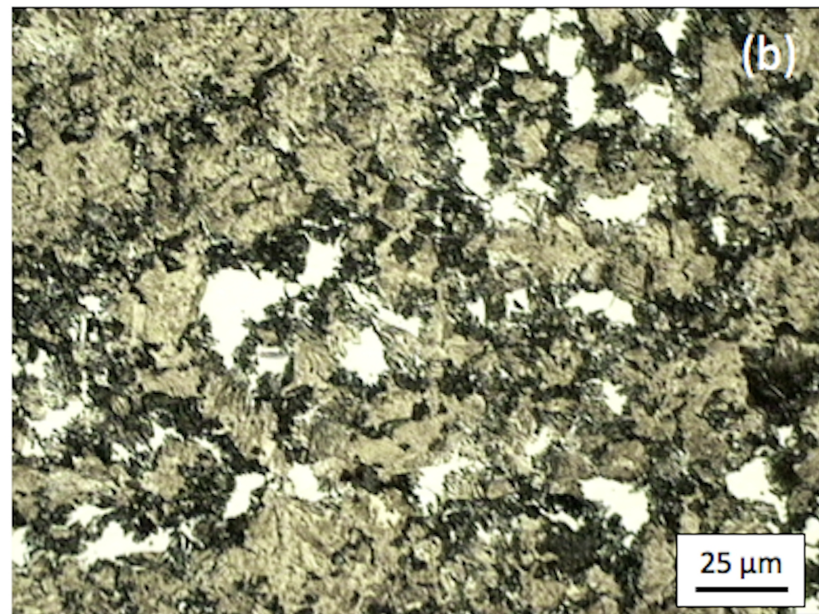
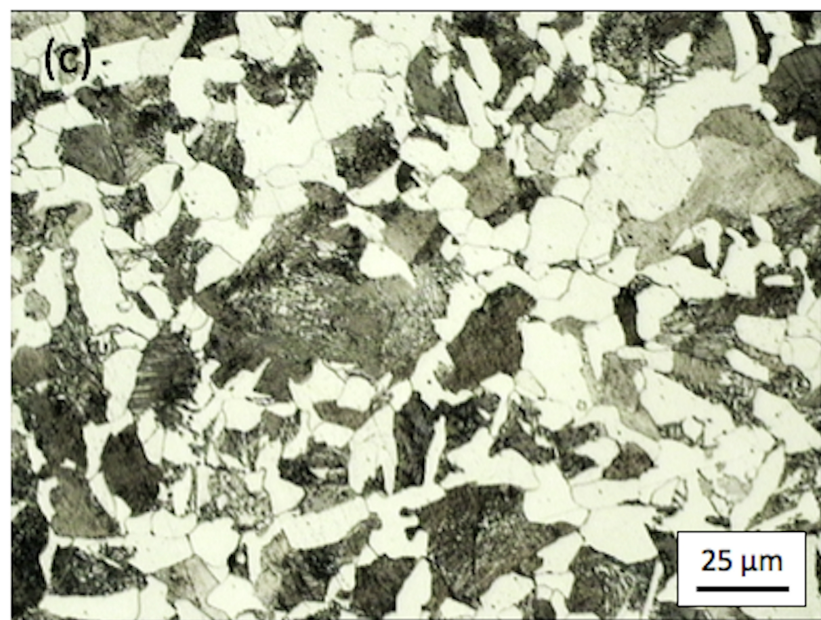
135 An example of the microstructure observed on the cross-section of the inlet rocker arm pivot socket
136 is shown in Fig. 3a-c. Beginning from the worn surface inwards, the microstructure of the induction
137 hardened region was bainitic-martensitic with some free ferrite (Fig. 3(a)), and that of the transition
138 region between the induction hardened layer and the unaffected core was upper bainitic with
139 troostite, again with some free ferrite (Fig. 3(b)). The coarse microstructure of the unaffected core
140 was ferritic-pearlitic (Fig. 3(c)). The microstructures of the cross-sections of the outlet rocker arm
141 pivot socket and of the outlet/inlet rocker arm pad were similar. The pushrod ball ends were totally
142 induction hardened, thus the microstructure was uniformly bainitic-martensitic with some free
143 ferrite. The mean area fractions in percentage of bainite-martensite and free ferrite occurring in the

240 chemical composition of steel [17]. For the outlet/inlet rocker arm and pushrods composed of
241 hypoeutectoid carbon steels, the starting microstructures consisted of pearlite and proeutectoid
242 ferrite. When A_{c1} is reached, these phases initiate the transformation into austenite, which occurs
243 more rapidly in pearlite. The rates of austenitization depend on size and shape of the workpieces, so
244 the final microstructure and grain size distribution will be non-uniform from the surface to the core
245 of material [17]. Previous research showed that A_{c1} and A_{c3} temperatures were significantly higher
246 for an initial microstructure of ferritic-pearlitic type than for a tempered martensitic one [18]. In the
247 present study, for all pairs of rocker arms unsuitable austenitization temperatures and times left
248 some of the proeutectoid ferrite untransformed, in the form of free ferrite. The presence of free

249 ferrite was also probably favored by a design of the inductor shape unsuitable for the induction
250 hardened regions, especially for those of the rocker arm pivot sockets. Improper austenitization
251 parameters and/or unsuitable design of the inductor shape could therefore be responsible for the
252 non-compliance with the required specifications for the induction hardening treatment.

380 **Fig. 3.** Optical micrographs of the microstructure observed in cross-sections of the inlet rocker arm
381 pivot socket. From the worn surface inwards: (a) induction hardened region with free ferrite (white
382 areas); (b) transition region between the induction hardened layer and the unaffected core, with
383 troostite (dark grey clusters) and free ferrite (white areas); (c) unaffected core.

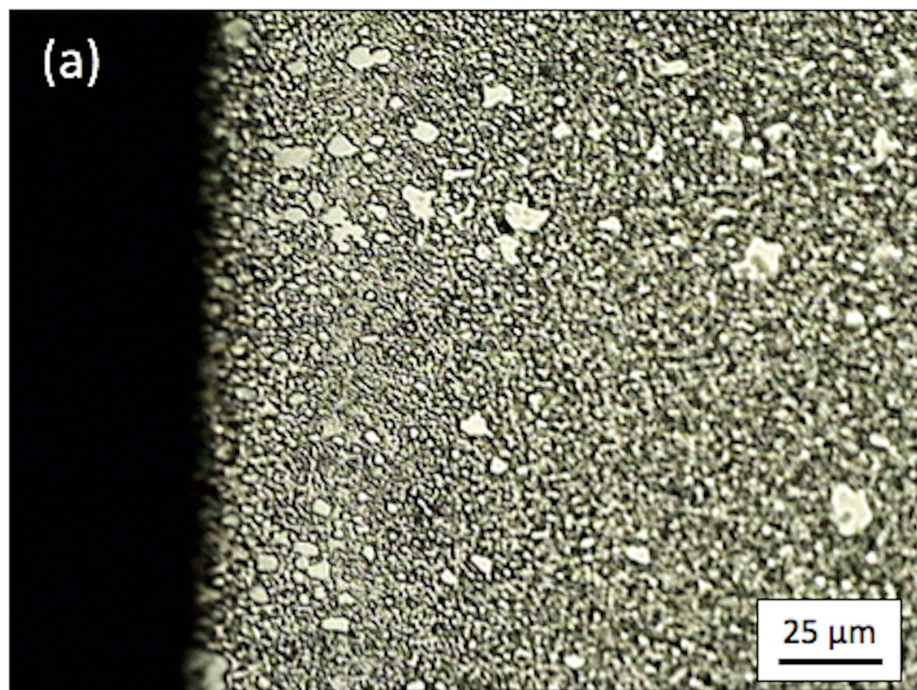
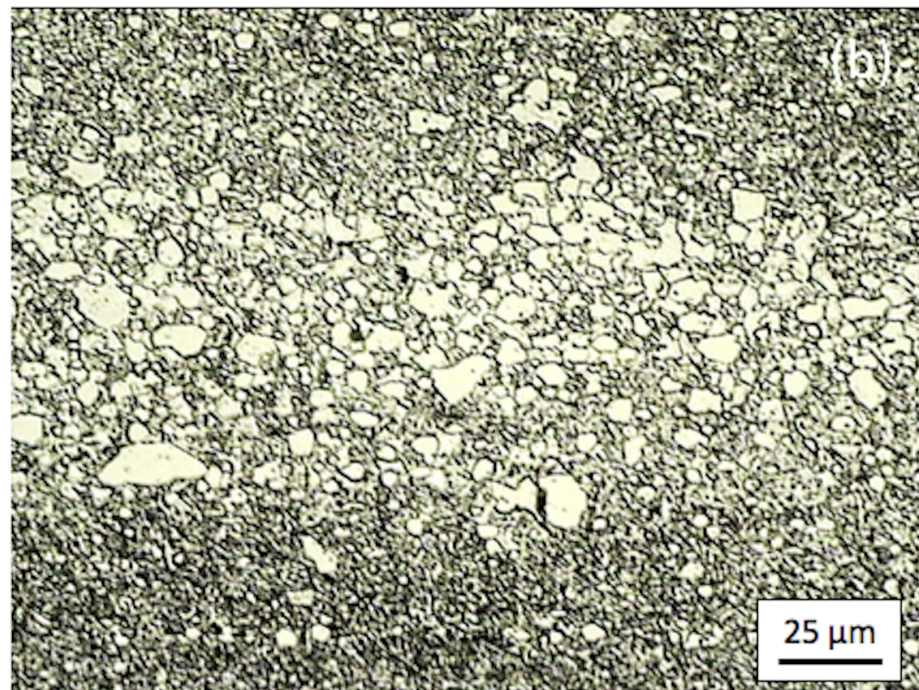
148 An example of the banded microstructure observed on a cross-section of the intake valve stem tip is
149 shown in Fig. 4a-b. The microstructure of the induction hardened region was martensitic with large
150 primary carbides oriented along the working direction and small secondary carbides located along
151 the grain boundaries (Fig. 4(a)). The microstructure of the unaffected core was composed of fine
152 pearlite and globular cementite particles, with a greater amount of oriented large primary carbides
153 and segregated secondary carbides (Fig. 4(b)). The microstructures of the cross-sections of the
154 exhaust valve stem tip were similar.

385 **Fig. 4.** Optical micrographs of the microstructure observed in cross-sections of the intake valve
386 stem tip. From the worn surface inwards: induction hardened region (a) and unaffected core (b)
387 with primary and secondary carbides (white areas).

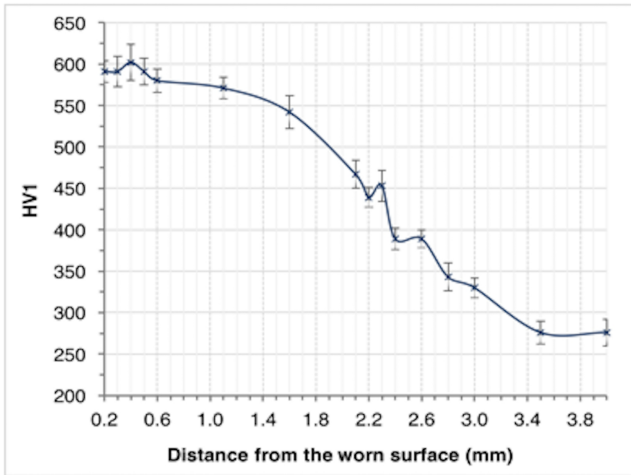
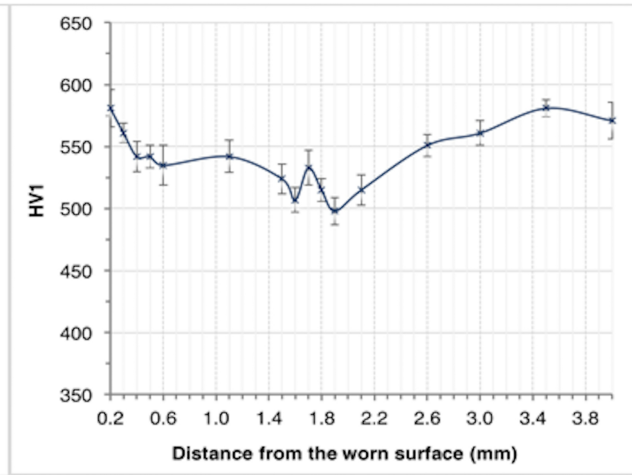
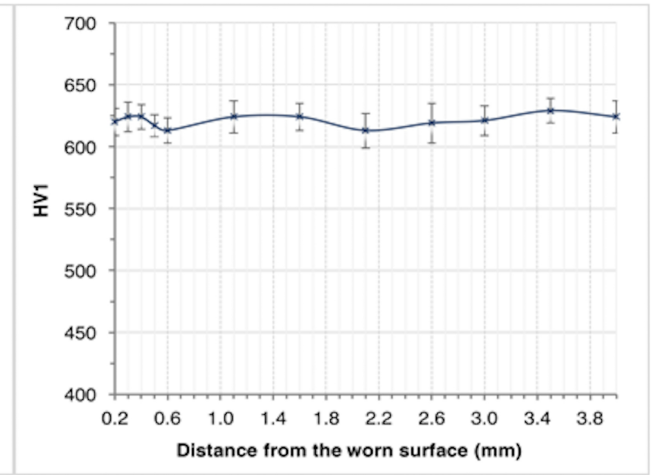
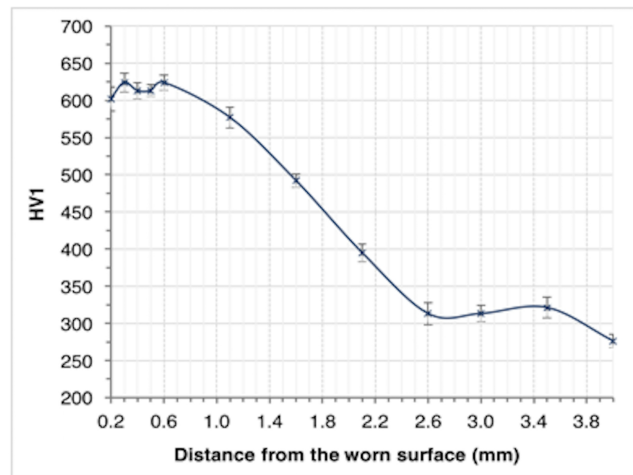
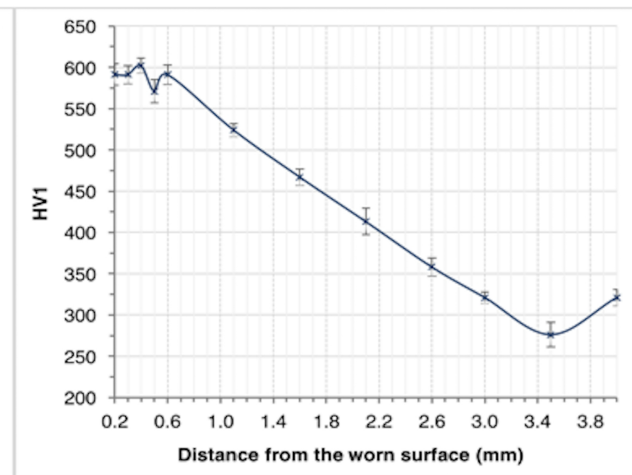
155 The Vickers hardness profiles of the cross-sections of inlet rocker arm pad, inlet rocker arm pivot
156 socket, pushrod ball ends, exhaust valve stem tip and intake valve stem tip at different distances
157 from the worn surfaces are displayed in Fig. 5a-e. For the inlet rocker arm pad and inlet rocker arm
158 pivot socket, the hardness profiles did not comply with the specifications concerning HRC values
159 and effective depth required at the induction hardened regions: for the inlet rocker arm pad, the
160 required HRC values (55-59 HRC, corresponding to 595-674 HV1) were maintained only up to
161 about 0.5 mm in depth (Fig. 5(a)); for the inlet rocker arm pivot socket (Fig. 5(b)), the HRC values
162 were not the required ones and no decrease in hardness was registered from the worn surface to the
163 core of material. Moreover, the hardness profile of the inlet rocker arm pivot socket (Fig. 5(b))

389 **Fig. 5.** Vickers hardness profiles of the cross-sections of inlet rocker arm pad (a), inlet rocker arm
390 pivot socket (b), pushrod ball ends (c), exhaust valve stem tip (d) and intake valve stem tip (e), at a
391 distance (mm) from the worn surfaces. Error bars represent standard deviation.

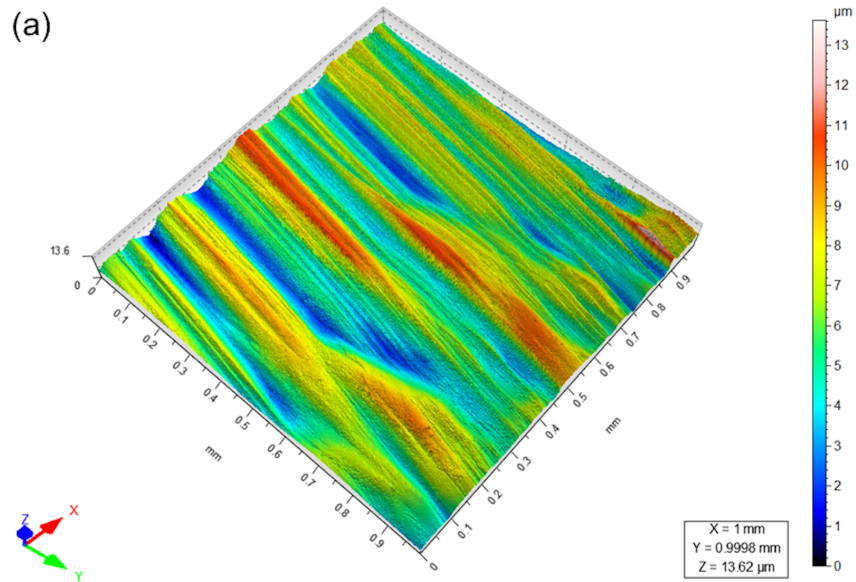
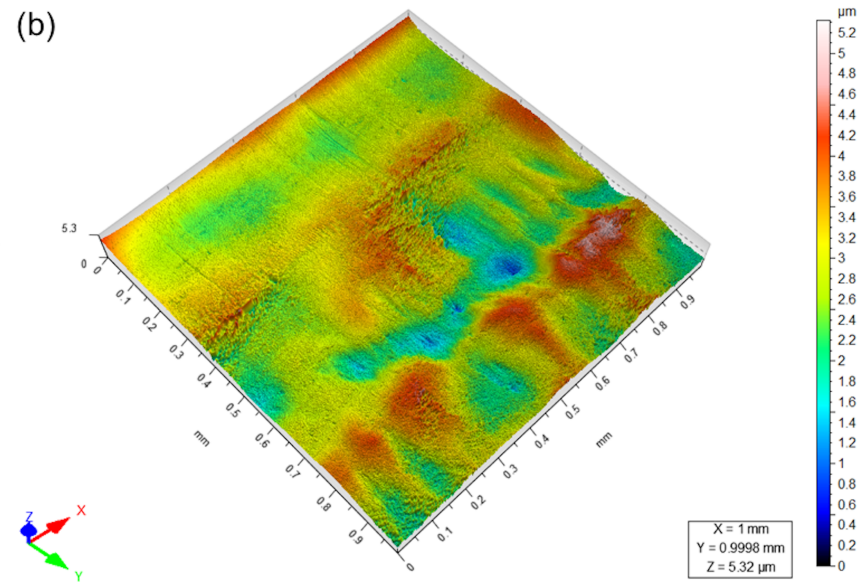
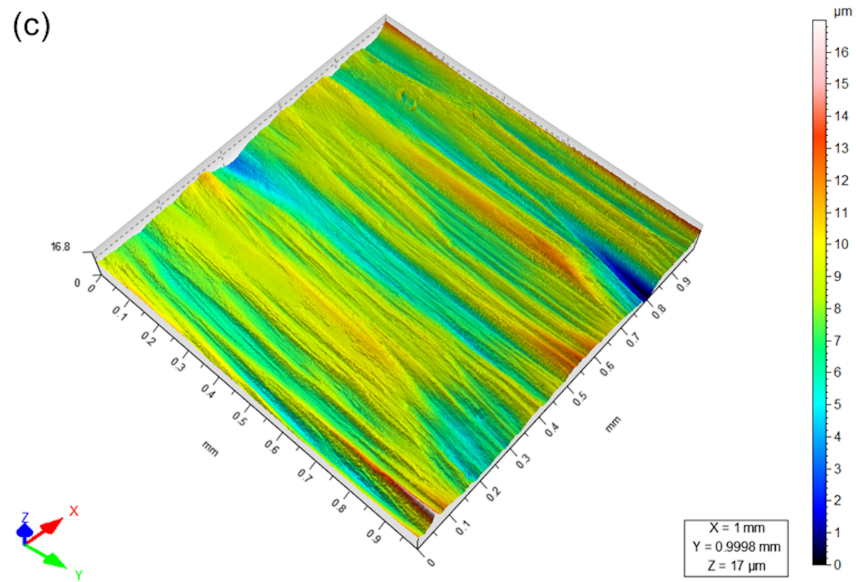
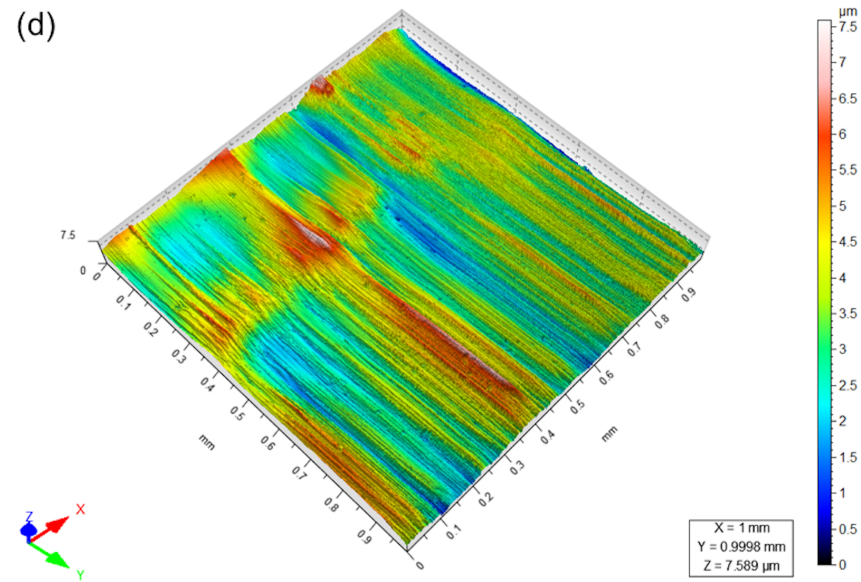
172 Examples of 3D surface textures of the worn surfaces of the outlet/inlet rocker arm pad and
173 exhaust/intake valve stem tip are shown as 3D isometric views in Fig. 6a-d. The 3D isometric view
174 of the surface of the inlet rocker arm pad was apparently less worn in comparison to that of the
175 other three components. The mean values of the 3D height parameters S_a , S_q , S_{sk} and S_{ku} of the
176 fresh and worn surfaces of the outlet/inlet rocker arm pad and exhaust/intake valve stem tip are

177 shown in Table 4. For the outlet rocker arm pad and the exhaust/intake valve stem tip, the Sa and Sq
178 values of the worn surfaces were higher than those of the fresh ones; on the contrary, as previously
179 mentioned, those of the inlet rocker arm pad were lower than those of the fresh ones. The skewness
180 (Ssk) of the fresh surfaces was negative, but that of the worn surfaces became positive for all
181 components except the exhaust valve stem tip. Concerning the kurtosis (Sku), this parameter
182 exhibited a different behavior: for the outlet/inlet rocker arm pad, Sku values of the fresh surfaces
183 were higher than those of the worn surfaces ($Sku < 3.00$), but those of the exhaust/intake valve stem
184 tip were lower than those of the worn surfaces ($Sku > 3.00$).

393 **Fig. 6.** The 3D isometric views of the worn surfaces of the outlet rocker arm pad (a), inlet rocker arm
394 pad (b), exhaust valve stem tip (c) and intake valve stem tip (d).

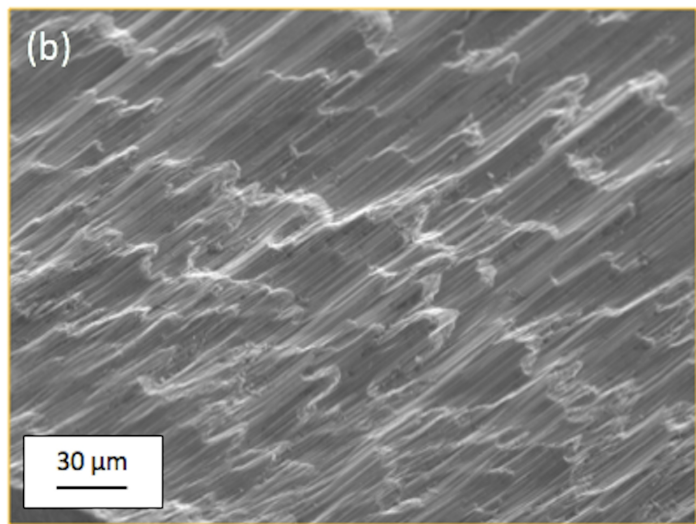
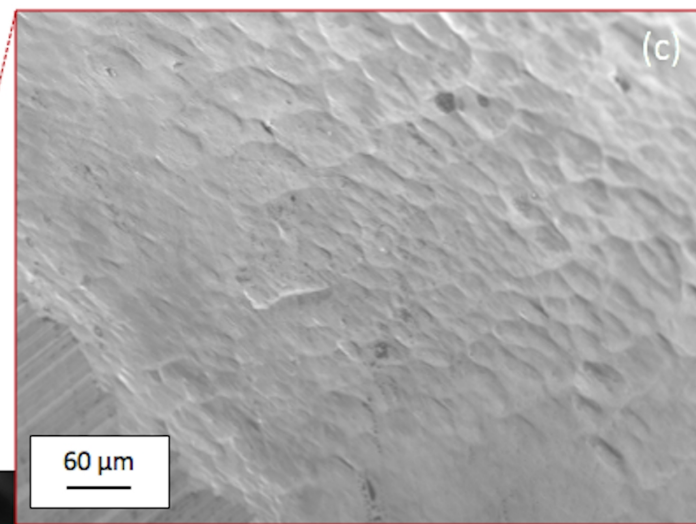
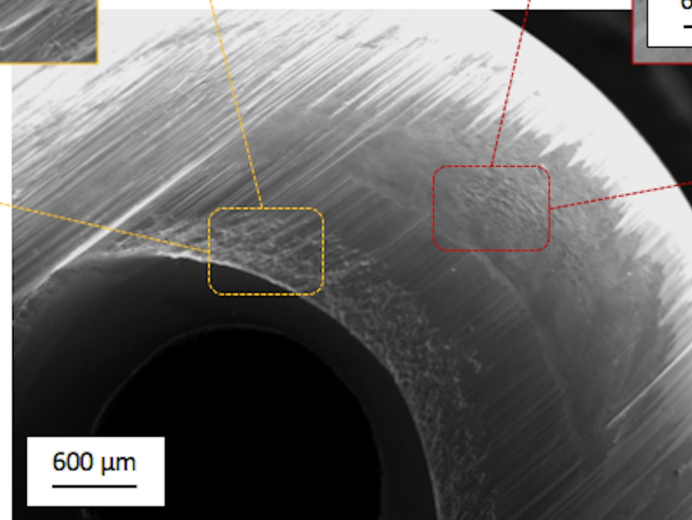
185 The SEI-SEM micrographs of the worn surfaces of pushrod ball ends are shown in Fig. 7a-c. The
186 morphology of the worn surface of pushrod ball ends (Fig. 7(a)) was characterized by two features:
187 material removal by scuffing (Fig. 7(b)) and probably by erosive cutting (Fig. 7(c)). The material
188 removal by scuffing was associated with linear grooves and scratch marks, mostly parallel and
189 uniformly distributed over a wide area of the worn surface. All plastically deformed material was
190 mostly removed by the surface during motion and to a minor extent it accumulated to the sides of
191 the grooves. The erosive cutting generated a series of ripples oriented along the direction of grooves
192 and limited to a narrow region of the worn surface. For all pairs of pushrod ball ends and rocker
193 arm pivot sockets the morphology of the worn surfaces was similar.

253 For all components, the scanning electron microscope analyses revealed linear grooves and scratch
254 marks which were mostly parallel and uniformly distributed over wide areas of the worn surfaces.
255 These data suggest scuffing as the main failure mode. Scuffing is known to be promoted by the
256 presence of free ferrite in the microstructure, while pearlite tends to retard it [19]. In boundary
257 lubrication conditions, it is associated with the progressive desorption of the lubricant at the contact
258 interface, depending on the interaction among polar constituents of lubricants and surfaces, and on
259 the rate of destruction and reforming of protective oxides [19]. When scuffing occurs, a severe
260 surface destruction process is established [20,21], as confirmed by the increase in Sa, Sq and Ssk
261 parameters from fresh to worn surfaces in the present study. Concerning the worn surfaces of

396 **Fig. 7.** SEI-EM micrographs of the worn surface of pushrod ball ends: (a) overview of worn
397 surface; (b) detail of the surface showing material removal by scuffing with parallel grooves and
398 scratch marks; (c) detail of the surface showing erosive cutting with ripples oriented along the
399 direction of grooves.

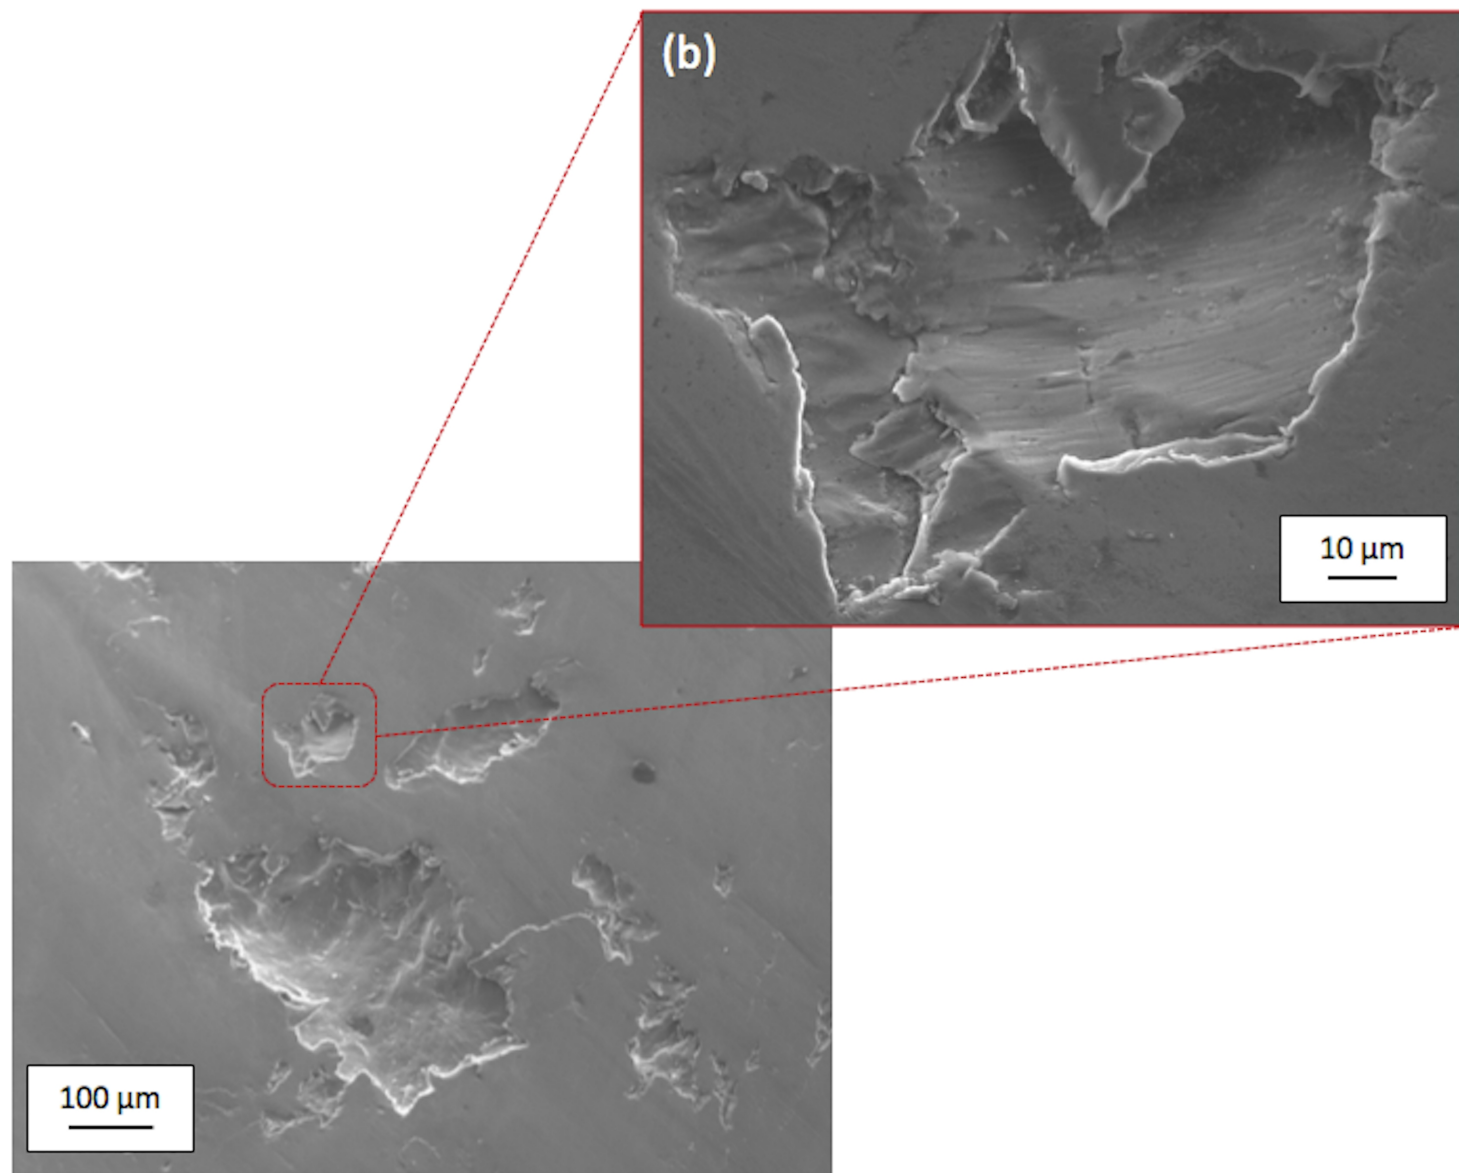
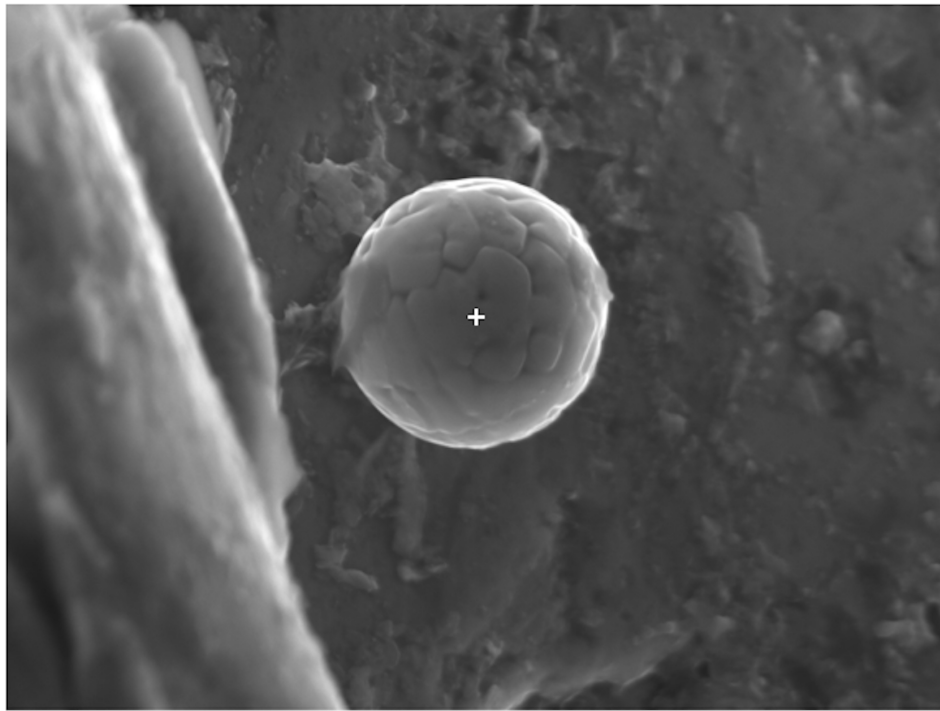
266 The SEM/EDS analyses of the worn surfaces at the rocker arm/valve interface also revealed the
267 presence of numerous pits with subsurface interconnected microcracks and fatigue striations. The
268 pits contained wear particles in the form of spherical agglomerates identified as iron oxides by EDS
269 analyses. Pitting is the consequence of fatigue affecting surfaces characterized by non-conformal
270 contacts [22]. In these conditions, fatigue cracks may nucleate either at the surface or at stress
271 concentration points at small depths below the surface, such as non-metallic inclusions, precipitates
272 or pre-existing flaws, and/or soft spots in the microstructure, for example in regions where free
273 ferrite is present. Cracks then propagate towards the interior of the material and eventually curve
274 up, producing wear particles and pits [16,22]. **Fatigue cracking has been identified by the presence

275 of fatigue striations inside pits that indicate the periodic advance of the crack front during cyclic
276 loading.** In all surfaces, residues of lubricant additive containing sulfur, phosphorous, calcium and
277 zinc were detected, attributable to Zinc Dialkyl Dithio Phosphate (ZDDP) anti-wear additives.
278 Previous research showed that ZDDP additives may promote fatigue crack initiation by preventing
279 surface roughness reduction during running-in, or by creating corrosion pits on the contact surfaces
280 [23,24]. Due to the high pressure at these surfaces, the lubricant flows into cracks, exerting a
281 pumping effect which increases the driving force for crack propagation [25].
282 Finally, in some narrow regions of the worn surfaces of pushrod ball ends and rocker arm pivot
283 sockets, a series of ripples oriented along the direction of grooves were observed, generated by
284 erosive cutting. For ductile materials, these ripples may be the product of free moving particles

401 **Fig. 8.** SEI-SEM micrographs of the matted area with pits observed on the worn surface of outlet
402 rocker arm pad: (a) overview of pits; (b) details of the subsurface of a pit showing interconnected
403 microcracks and fatigue striations.

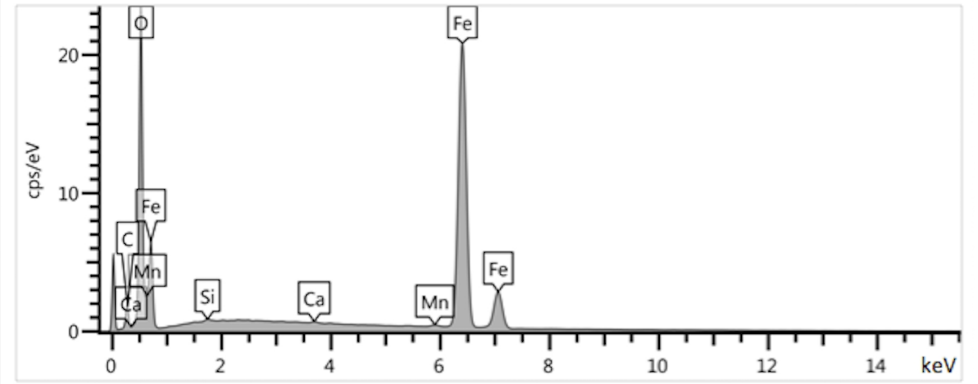
405 **Fig. 9.** SEI-SEM micrograph of a wear particle in form of a spherical agglomerate detected inside a
406 pit of the matted area on the worn surface of outlet rocker arm pad (left) and semi-quantitative EDS
407 analysis of the spherical agglomerate (right).

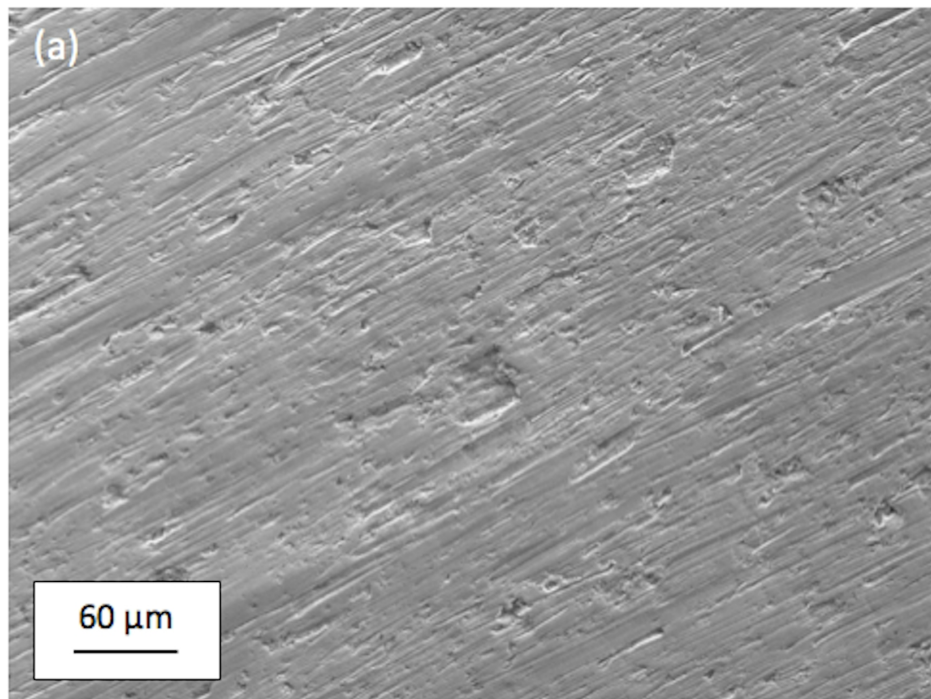
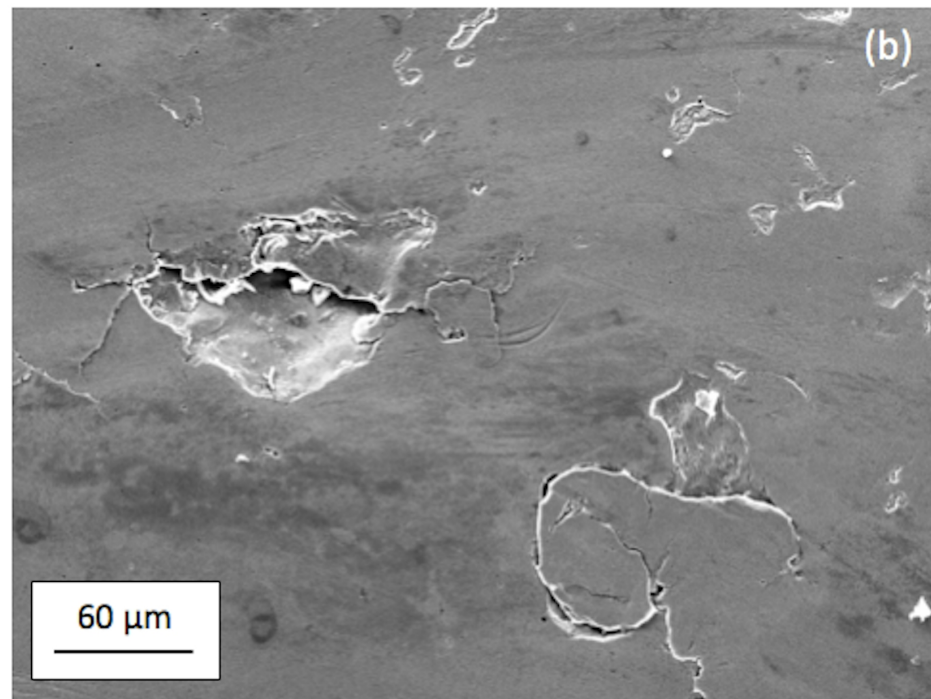
204 The morphology of the worn surfaces of all pairs of exhaust/intake valve stem tips was
205 characterized by the same features identified on the worn surfaces of the outlet/inlet rocker arm
206 pads, but the grooves, scratch marks and pits were less marked (Figs. 10(a) and (b)).

409 **Fig. 10.** SEI-SEM micrographs of the worn surface of an exhaust valve stem tip: (a) detail of
410 grooves and scratch marks; (b) detail of pits.

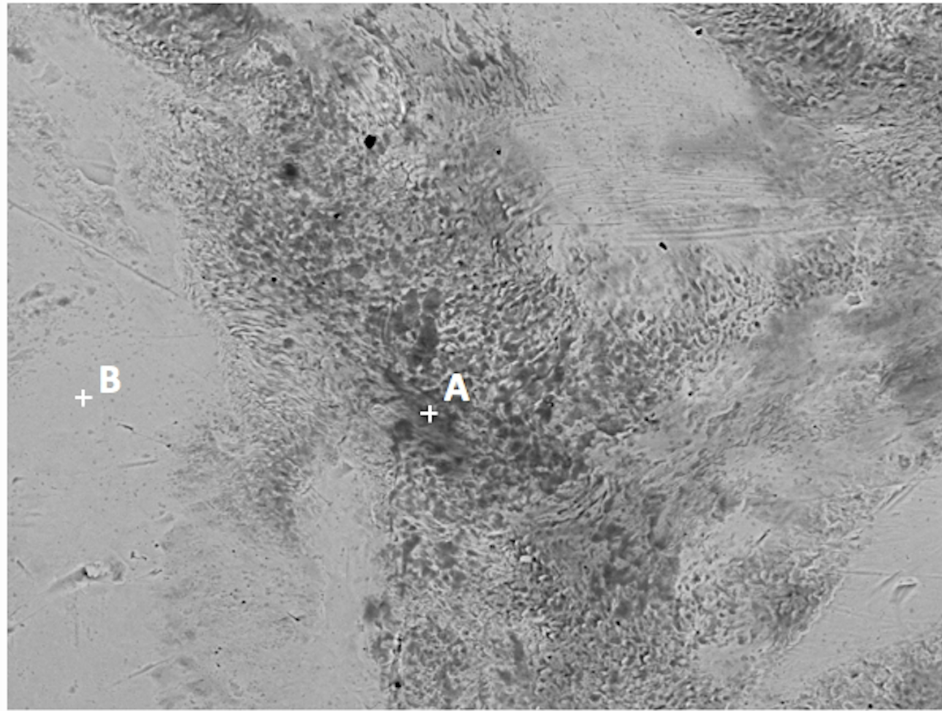
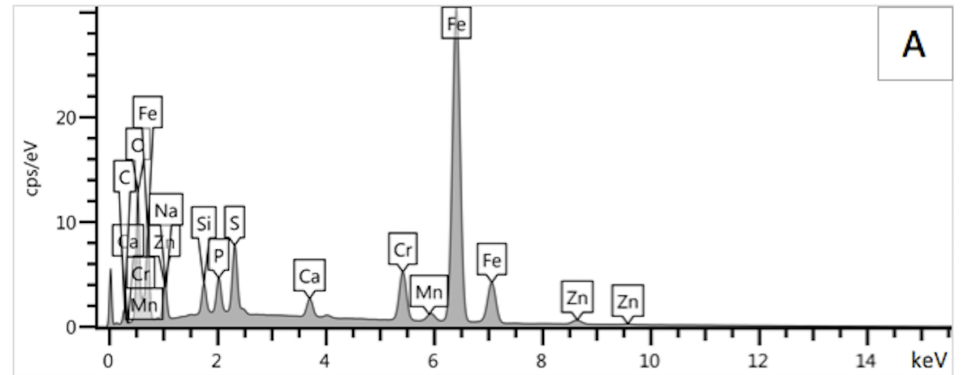
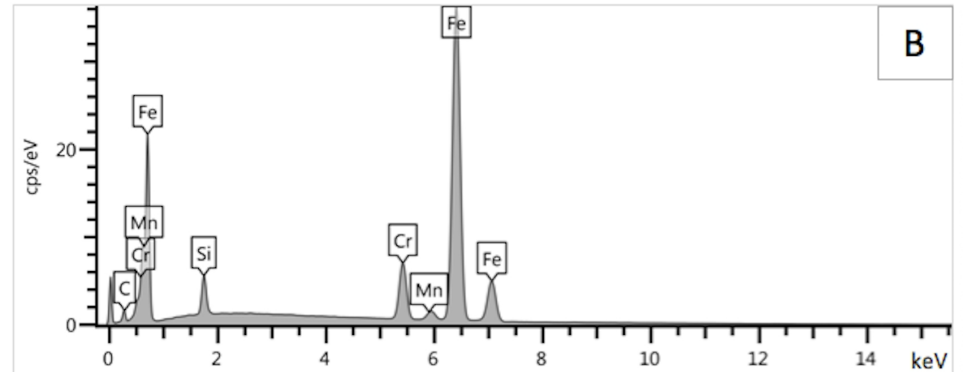
207 These worn surfaces were also analyzed by SEM/EDS in back-scattered electron mode (BSE-
208 SEM), followed by semi-quantitative EDS analysis. In all surfaces, dark and light contrast areas
209 could be identified (Fig. 11 (left)): the EDS analysis revealed the presence of sulfur, phosphorous,
210 calcium and zinc in the dark contrast areas, which was related to the residues of lubricant additives
211 (Fig. 11 (right)).

412 **Fig. 11.** BSE-SEM micrograph of the worn surface of an intake valve stem tip (left) and semi-
413 quantitative EDS analyses of dark (A) and light (B) contrast areas in the same surface (right).
