LVAD driveline infection: Pump cable relocation in two stage surgical strategy and preventive partial driveline replacement

Jacob Zeitani^{1*}, Simir Kuci², Alfred Ibrahim², Antonio Pellegrino³ and Ermal Likaj³

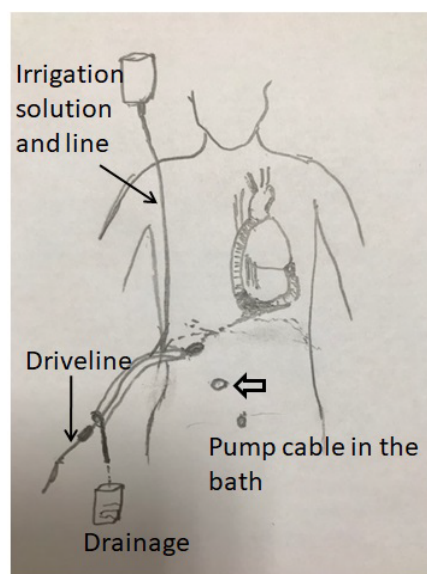
Figure 2. The design illustrates the irrigation drainage system, where the subcutaneous exposed pump cable segment, is immersed in PVC tube, "the bath". * indicate the previous driveline exit site

In this report we proposed to immerse completely, for a period of time, the pump cable in a "bath", created from a PVC tube sealed in both ends. Continuous washout with aggressive antiseptic solutions might help to eradicate the bacteria deep-rooted in the woven material

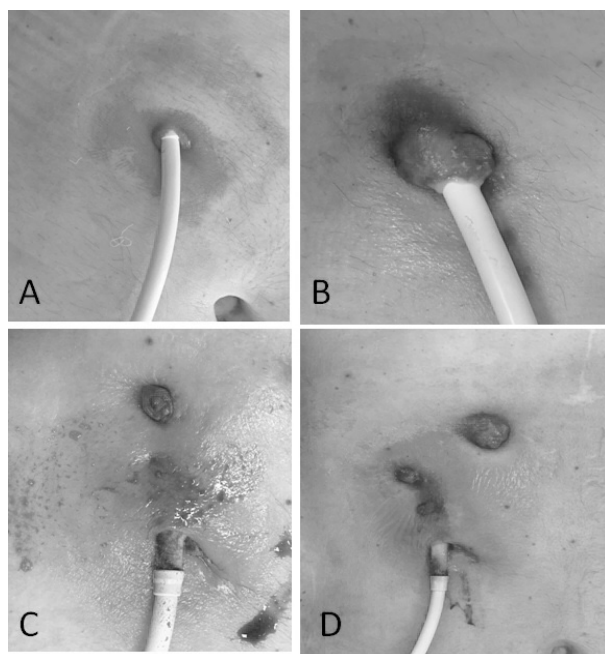
Figure 1. Images A-D showing infection spread along the driveline and fistula formation during 18, 23, 30 and 36 months, respectively, after device implantation. In images C and D the polyester cover can be seen because skin retraction

A 56-year-old man, with non-ischemic dilated cardiomyopathy in advanced heart failure, underwent LVAD implantation (HeartMate 3, Thoratec Corp, Pleasanton, CA), as destination therapy in March 2017. The postoperative course was uneventful, so he was discharged and periodically followed-up at the outpatient clinic. An infection at the exit site of the driveline, presenting with skin inflammation and pus secretion, was detected for the first time 18 months after implantation (Figure 1A). Based on culture-derived antibiograms, specific antibiotic therapy was administered, and the driveline exit site was treated in a conservative manner with antiseptic solutions. During a 20-month period, repeated culture samples were taken showing changes in the bacterial flora, first *Klebsiella* and then *Pseudomonas aeruginosa* requiring antibiotic therapy adjustments. Despite antibiotic therapy and topical management, the signs of infection got worse and fistula formation was seen along the driveline course (Figures 1B-1D).
