6.2.8.1 In-depth analysis in the framework of BIM modeling through “3muri software”, analysis and investigations into possible masonry collapse scenarios

6.2.9 Case II, Conclusions and recommendations

6.2.8.1 Conclusions regarding the analysis and investigations applied in 3Muri software, recommendations for possible effective interventions

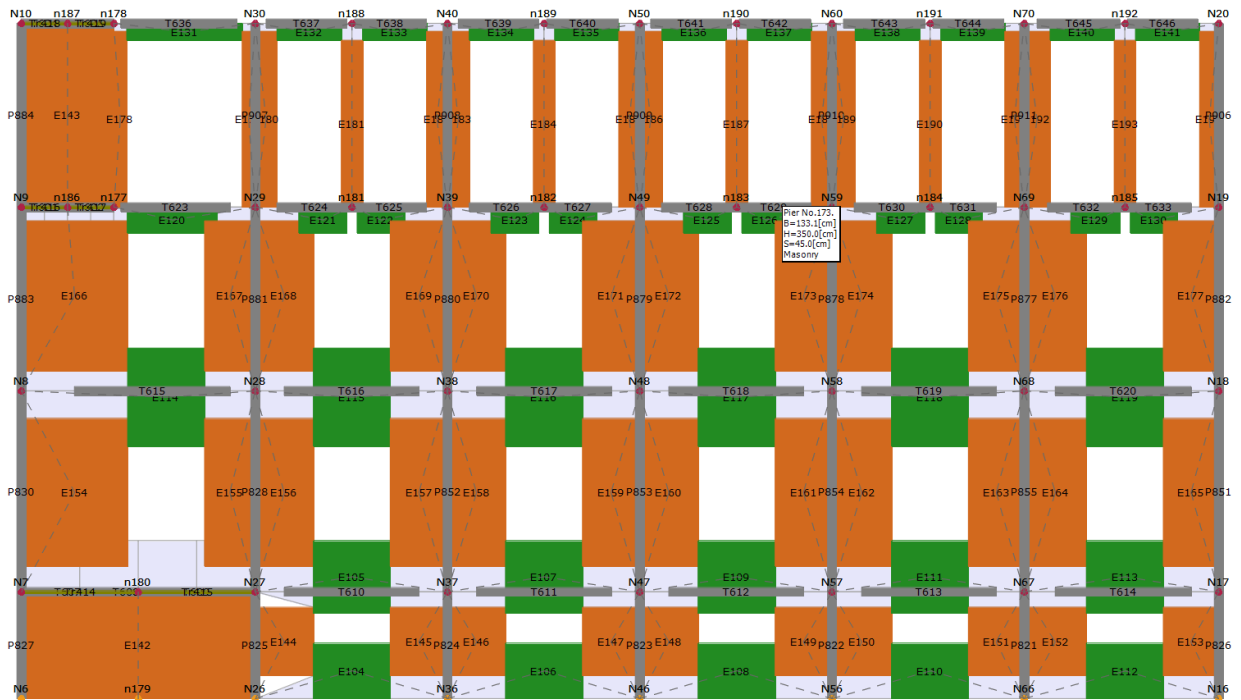
Figure 131. Numerical model of the main facade processed in 3Muri software

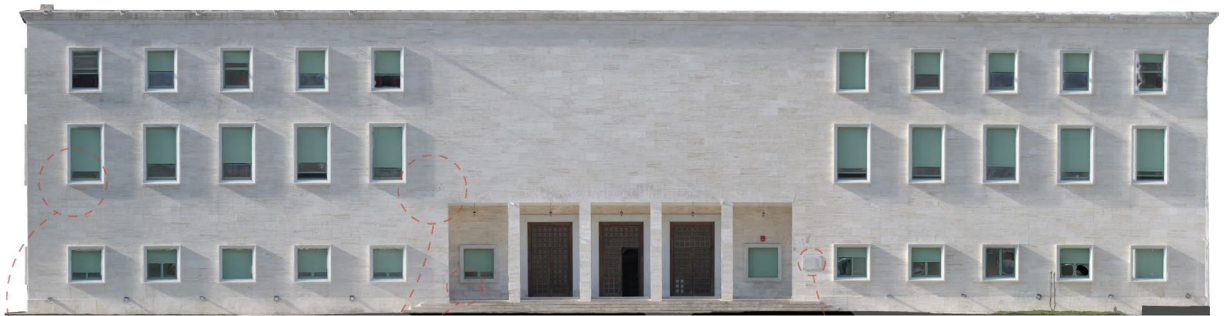
FASADA ANALIZA E PASME

Figure 146. Survey of the main façade through forogrammetry; sketching of marble panels; and extraction of the complete model of the southern façade after filling in the missing parts

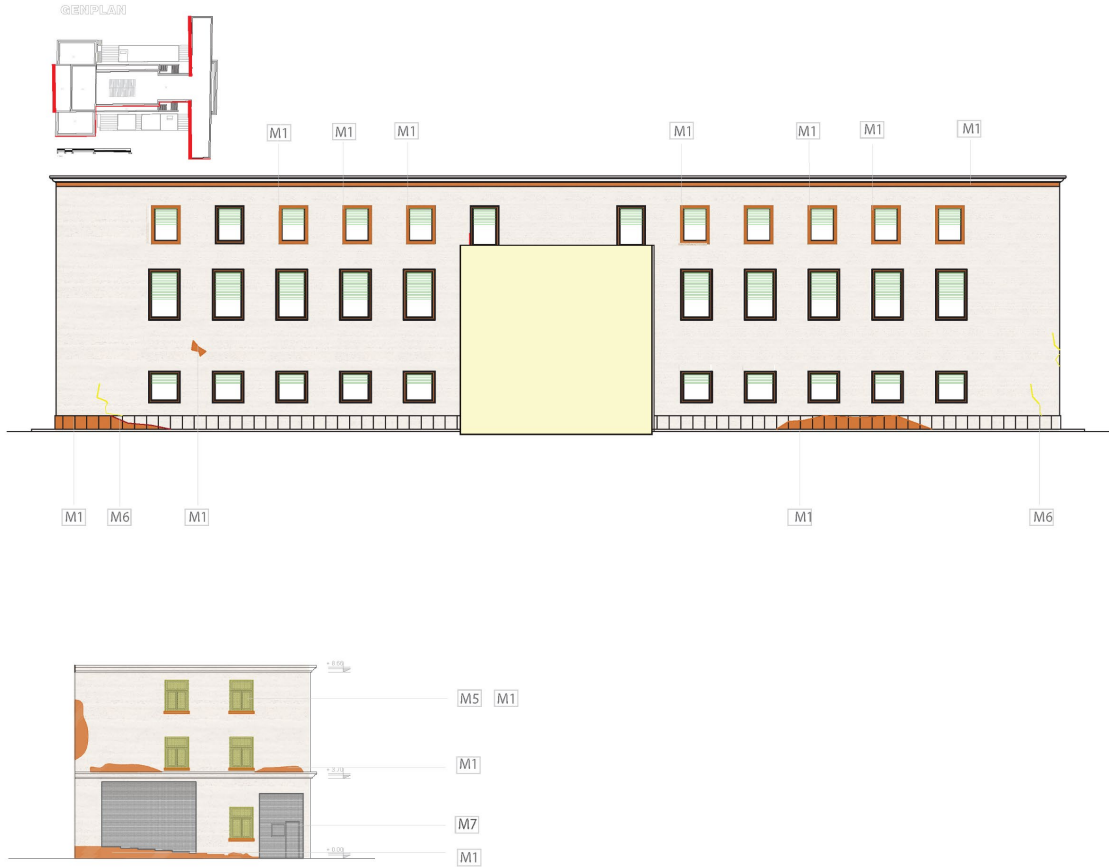
Figure 152. Analysis panel on the east main façade, investigations on degradation issues, part.02

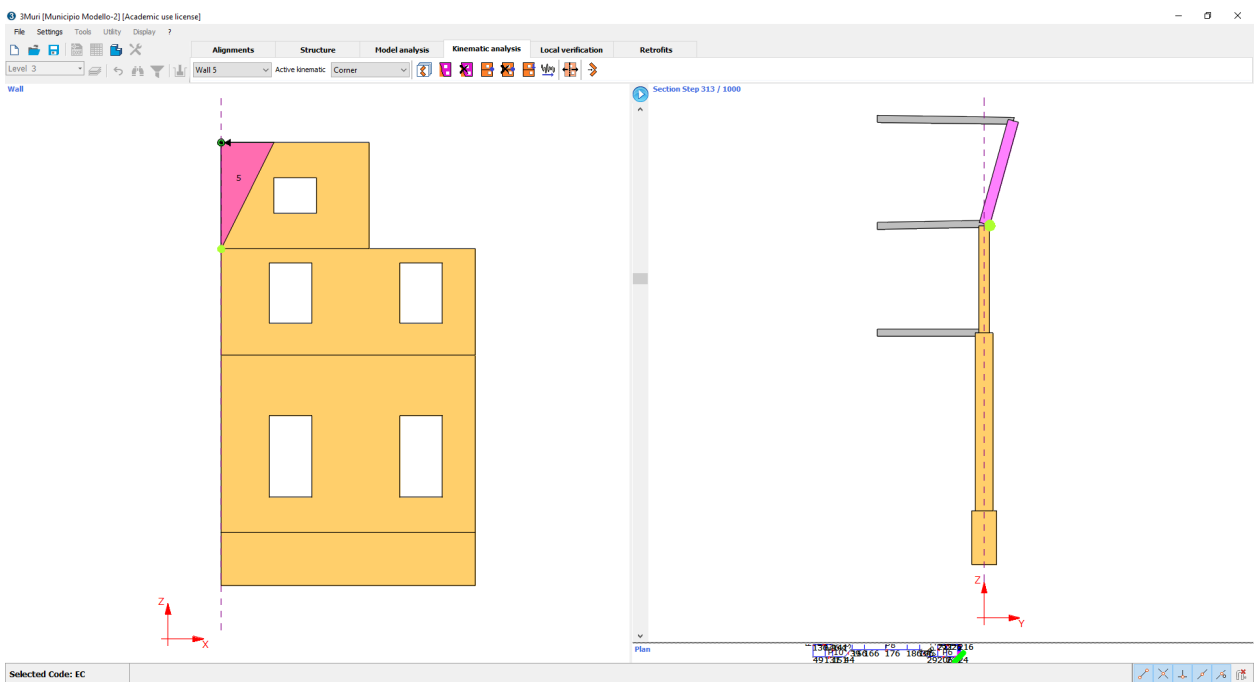
Figure 198. Simulations of local failure mechanisms north side facade, second typology of possible collapse scenarios

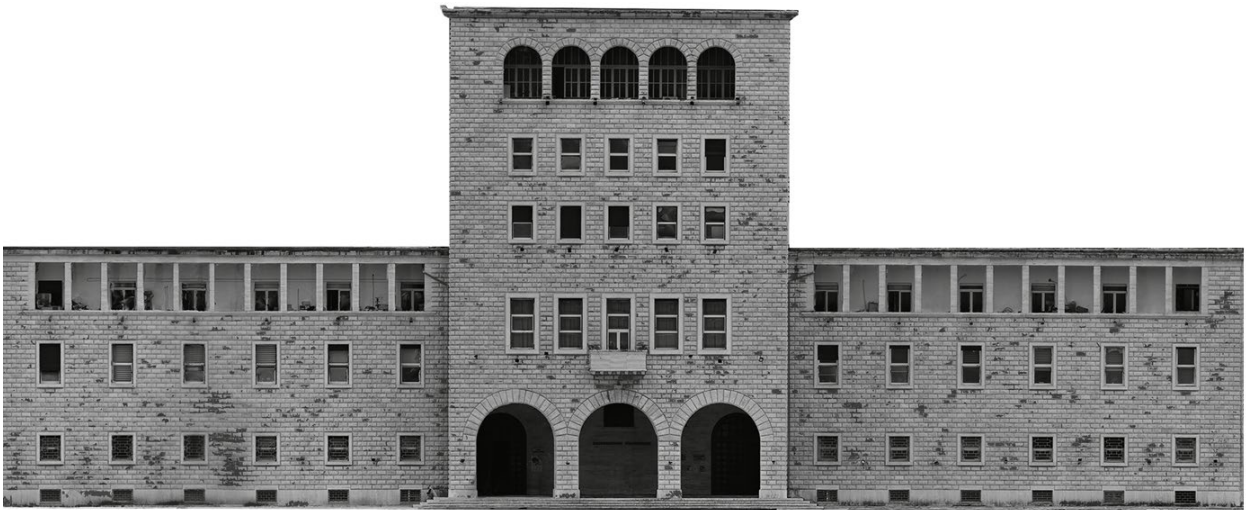
Figure 205. Architectural survey of the facade in the framework of the investigation of pathologies, cracks distribution and fractures

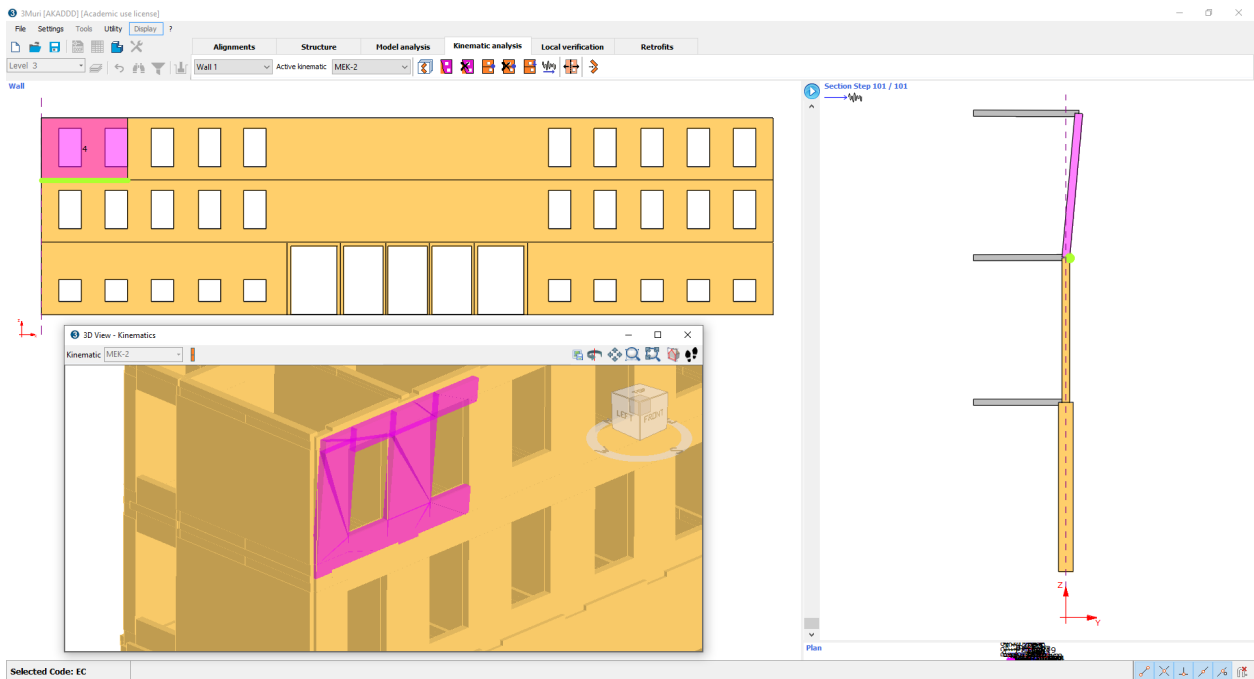
Figure 218. Simulations in the framework of the local mechanisms investigations, mechanism one
