Case Report

Contribution of Geosciences to Cultural Heritage Conservation Assessment: The Case Study of the Loggiato dei Cappuccini in Comacchio (Italy)

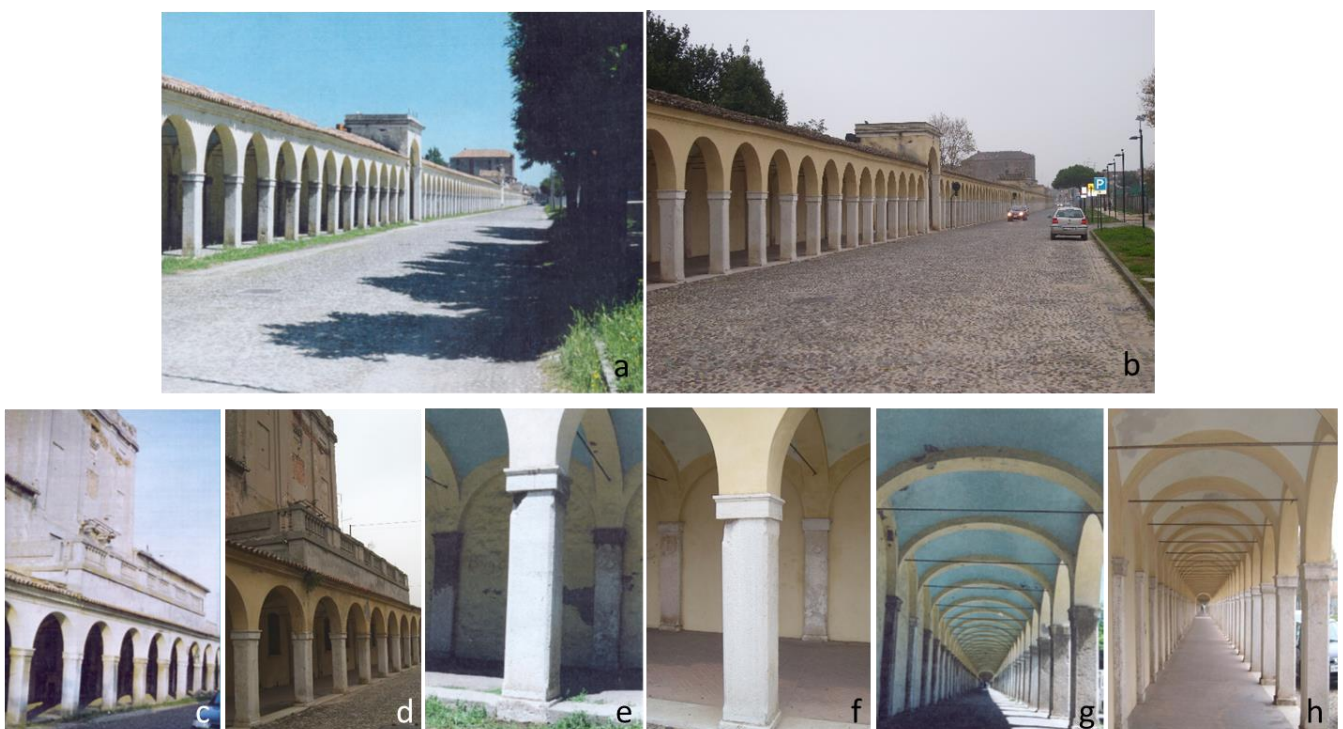
This study site was the Loggiato dei Cappuccini, which was built, with both civil and military defense intentions, between 1646 and 1647 and consists of a succession of 142 arches [23,24]. Figure 2 shows a series of photographic illustrations of the Loggiato dei Cappuccini: Figure 2a,c,e,g, before the 2009 restorations, obtained from the municipality of Comacchio, and Figure 2b,d,f,h, the analysis campaign in 2019.

Figure 2. Pictures of different part of the Loggiato dei Cappuccini: (a,c,e,g), before the 2009 restorations (images from the municipality of Comacchio); (b,d,f,h), the corresponding current state condition.

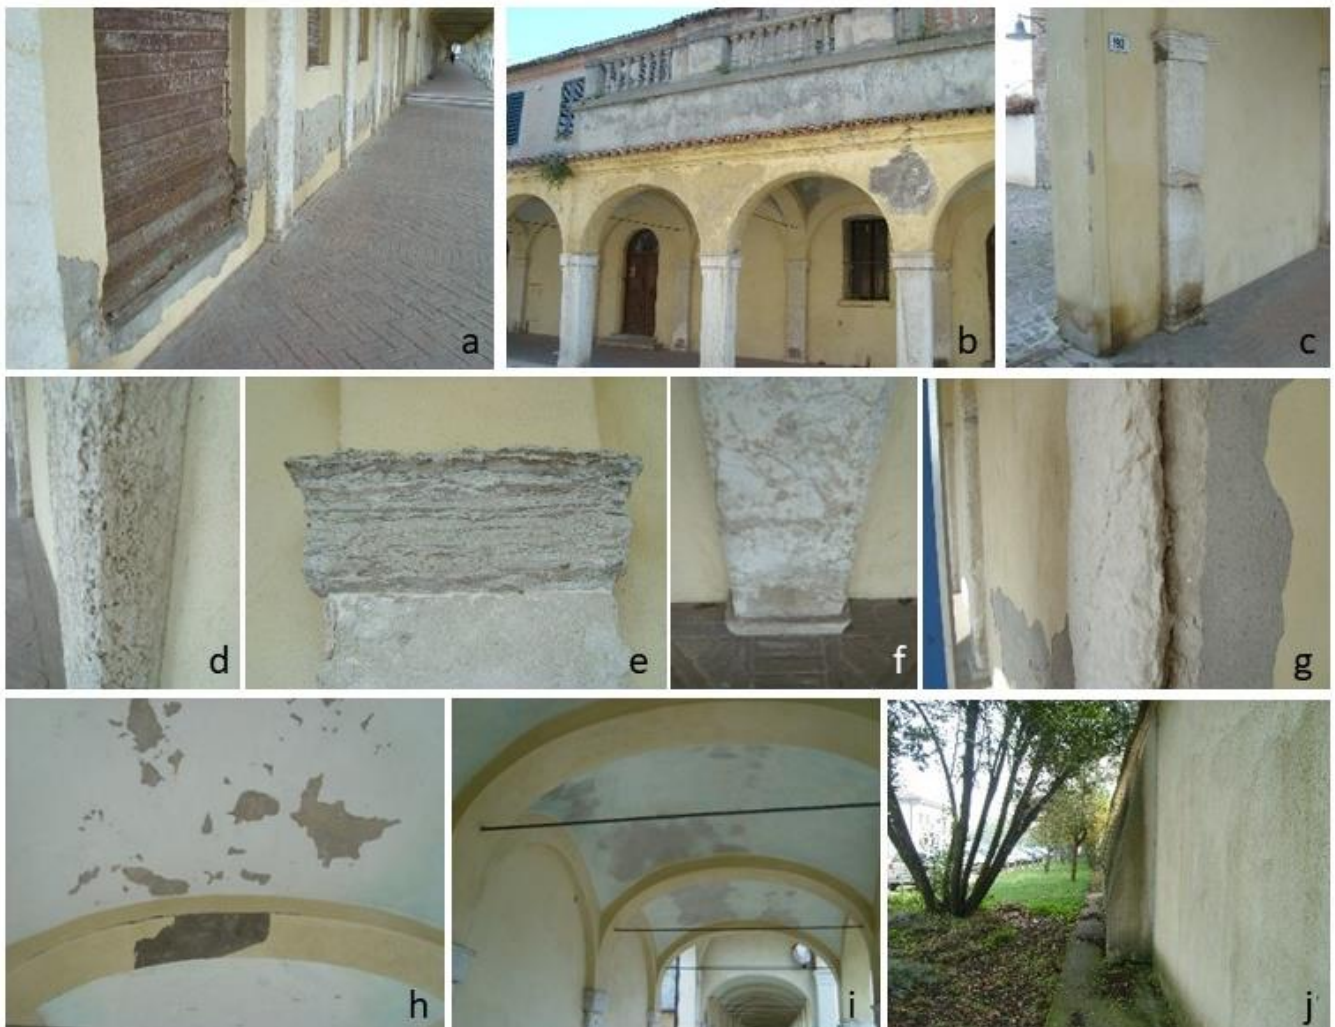
As shown in Figure 3, the monument in 2019 was affected by the following forms of decay:

- lack of plaster placed on the internal wall of the Loggiato (Figure 3a,b);
- degradation on the internal columns: formation of black crusts (Figure 3c), alveolization (Figure 3d), physical disintegration (Figure 3e,f), and flaking (Figure 3g);
- degradation of the painting layer (Figure 3h,i);
- degradation caused by trees not being cut back (Figure 3j).

Figure 3. Degradation phenomena observed on the Loggiato dei Cappuccini during the analysis campaign on summer/autumn 2015: (a) degradation of the plaster placed on the internal wall; (b) lack of material on the external wall; (c) black crust at the base of the column; (d) alveolization phenomenon on the columns; (e) physical disintegration on the top of the columns; (f) physical disintegration on the basement of the columns; (g) flaking of the columns along the sedimentation floors; (h,i) degradation of the painting layer; (j) degradation caused by trees.

After this campaign, restorations were carried out relating to the replacement of the plaster of the internal wall and to the cleaning of the black crust on the columns.

Compared to the observations made in 2015, the deterioration of the plaster observed in the sampling of 2019 has expanded. In 2015, the phenomenon still appeared to affect only the finishing layer (Figure 3a), but a probable negative evolution in the underlying layers cannot obviously be excluded. Along the extension of the Loggiato, various traces of humidity were seen, located on the same internal masonry and on the surface of the plaster analyzed in our research work (Figure 4a).

The 2015 survey highlighted the phenomenon of blackening on the bases of the columns (Figure 3c), and the 2019 analysis campaign confirmed the persistence of the same phenomenon. Microscopic observation revealed the presence of a black patina. This appears to impregnate the underlying natural stone, reducing its cohesion. This may have important implications for conservation protocols; in fact, removing the patina will weaken the monument by exposing the chemically weathered, detached parts of the natural stone, thus accelerating its disintegration. For these reasons, based on this information, different restoration actions should be taken into account, for example: (a) leave the patina in place: given that removing the patina could accelerate the disintegration of the natural stone surface, one possible approach would be to leave the patina in place. This approach would involve taking steps to stabilize the monument and prevent further degradation, without attempting to remove the patina. (b) Test removal techniques: if removal of the patina is deemed necessary, a range of techniques could be tested to determine the most effective and least damaging method. For example, mechanical, chemical, or laser-based methods could be evaluated to determine which approach would be most appropriate for the specific type of stone and patina present. (c) Monitor the monument: regardless of whether the patina is removed or left in place, ongoing monitoring of the monument will be necessary to assess its condition and determine whether any additional conservation measures are required. Regular inspections could help identify any changes in the stone surface or patina and enable conservationists to take action before further damage occurs. (d) Assess the source of the patina: understanding the source of the patina could be important in determining the appropriate course of action. For example, if the patina is the result of pollution, steps could be taken to reduce emissions in the surrounding area to prevent further damage. Alternatively, if the patina is the result of a natural process, conservationists may need to take a different approach to address the issue [54,55]. In addition, the base of the columns showed signs of degradation, such as progressive flaking along the sedimentation planes, due to combined chemical-physical aggression phenomena—the latter related to wind activity, which is of particular importance in relation to the architectural conditions of the Loggiato. Indeed, images as in Figure 3c–f evidence that the phenomenon of alveolization is more present on the sides of the columns perpendicular to the inner masonry of the Loggia (Figure 3d). The circumstance suggests the formation of air currents inside the Loggiato, mixed with the components illustrated above, running through the closed side, which impact their load specifically and predominantly on the shorter sides of the pilasters. In the preservation actions of the Loggiato, it would be interesting and extremely useful to

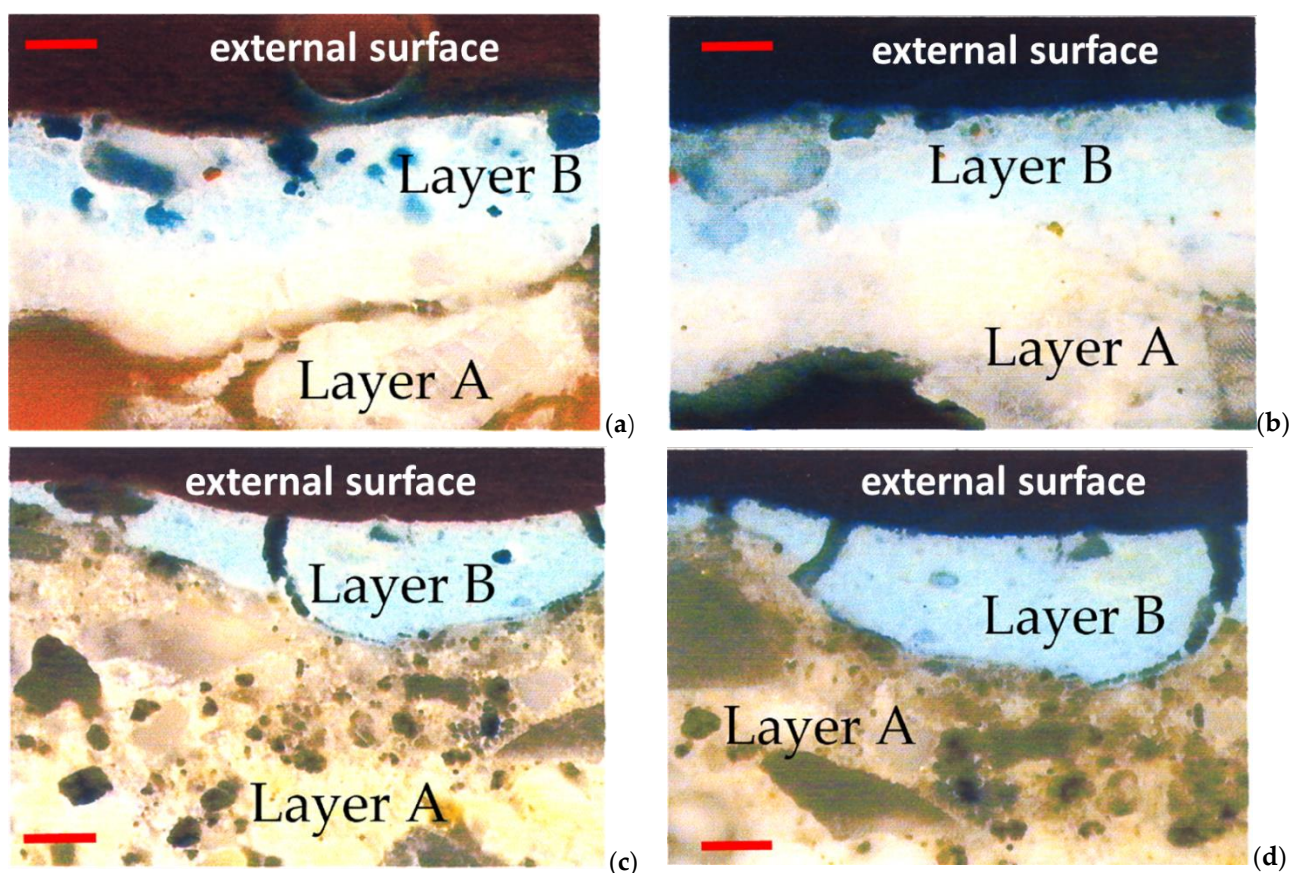
Sample LC-4 (Figure 8a,b):

- LAYER A: overall white plaster, composed of binder and carbonate aggregate. The thickness was indefinable. The boundary with the overlying layer was blurred and the adhesion was good.
- LAYER B: pictorial layer of overall blue color. The thickness varied from 80 to 220 μm . No powdery blue pigments were clearly observed, from which the use of liquid organic pigments (probably phthalocyanine) was deduced. Rare red ochre grains were observed.

Sample LC-5 (Figure 8c,d):

- LAYER A: overall white plaster, composed of binder and carbonate aggregate. The thickness was indefinable. The limit with the overlying layer was instead clear and the adhesion was altered.
- LAYER B: pictorial layer of overall blue color, with evident superficial discoloration and patches of leopard in the mass. The thickness varied from 20 to 240 μm . No powdery blue pigments were observed, from which the use of liquid organic pigments (probably phthalocyanine) was deduced.

Figure 8. Stratigraphic analysis by stereomicroscopy of the pictorial layers: (a) sample LC-4 at 270 \times magnification; (b) sample LC-4 at 540 \times magnification; (c) sample LC-5 at 270 \times magnification; (d) sample LC-5 at 540 \times magnification. Scale bars 200 μm for images at 270 \times magnification and 100 μm for images at 540 \times magnification.

Relating to the pigment of the vaults, the investigations carried out concerned the presence of conspicuous discolored spots on the blue color. The analyses showed that the blue paint has a composition based on organic resin colored with a liquid organic pigment. This pigment could very likely belong to the Phthalocyanine family [57,58]. Further detailed analyses using SEM-EDS and μ -Raman will allow this aspect to be better defined, enabling more targeted and effective restoration work. The stratigraphy showed the complete superficial discoloration of the altered sample, to which a leopard spot discoloration is added that affects the entire pigmented thickness. In the “healthy” sample, the surface does not appear discolored, while some discolored spots can be observed inside. The investigations carried out suggest that the discoloration is most probably caused by the degradation of the organic chemical species [59,60] and depends on the stability of the pigment rather than being the consequence of a phenomenon of physical surface degradation [55]. The cause is therefore identified in the poor quality of the pigment used. The conservation of a historical artifact does not end with restoration work, since the phenomena of degradation are linked to the surrounding environment and the reactions that take place within it. In order to allow longer survival, continuous maintenance is indispensable to prevent the action of any degradation. In this context, it is important to develop an adequate communication of geological knowledge, which can significantly contribute to the construction of social knowledge for human communities, in order to extend this awareness to the entire civil society and promote the recognition of the usefulness of geosciences in everyday life [61–65]. In fact, according to Zafeiropoulos [61] and reference therein, by recognizing the value of a region’s geological heritage, “geological culture and geoethics can strengthen the bonds between people and their land, between their places of origin and their own memories”.
