A methodology on the treatment of the issue of Cultural heritage restoration in  
Tirana, period 1920-'40

BIM modeling, Seismic simulation and  
Theoretical interpretatios

**A methodology on the treatment of the issue of Cultural Heritage Restoration in  
Tirana, period 1920-40'  
BIM Modeling, Seismic simulations and Theoretical interpretations**

**Curriculum:** Architecture / IDAUP, **Topic:** Cultural Heritage Restoration, Seismic analysis and  
Retrofitting, BIM Tools (Area – SSD: ICAR19)

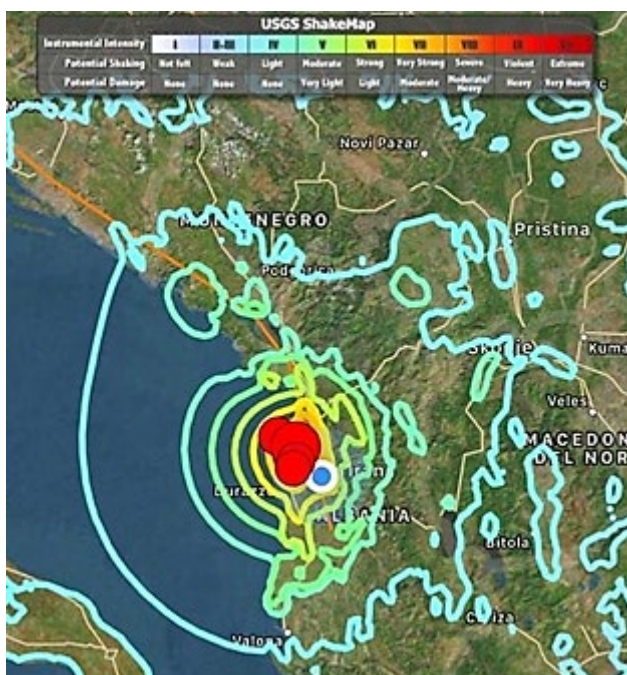
The strong earthquake with a magnitude of 6.4 Mw in Albania, occurred exactly two months after the other two earthquakes considered moderate. The quake event started at 03:56 in the morning of November 26, 2019, emphasizing in addition to the damages mentioned above, causing severely damaged over two thousand buildings in the cities of Durres, Tirana and the surrounding area. The epicenter was reported below the Adriatic coast, 7 km north of the coastal city of Durres and about 30 km west of Tirana, the capital of Albania. (Figure.17)

**Figure 17.** Quake M6.4 affected area and the lines distribution of shakes intensity (Charleson & Vesho, 2020)

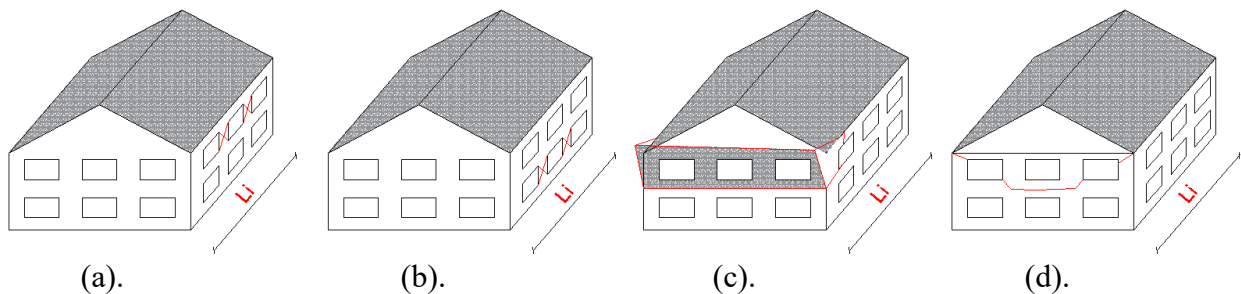
Partial wall overturning – This kind of failure mechanisms is mainly caused by the following “reasons large distance between panels”, thrusting roof and lack of connections between wall and roof panel, also high percentage of the openings creating potential regions and areas for cracks and deformations on the panel.

**Figure 33.** (a) Failure mechanism of Storey shear located on Upper storey, (b) Failure mechanisms related to Storey shear, (c) the failure mechanisms of whole wall overturning, (d) the failure mechanisms related to partial wall overturning.

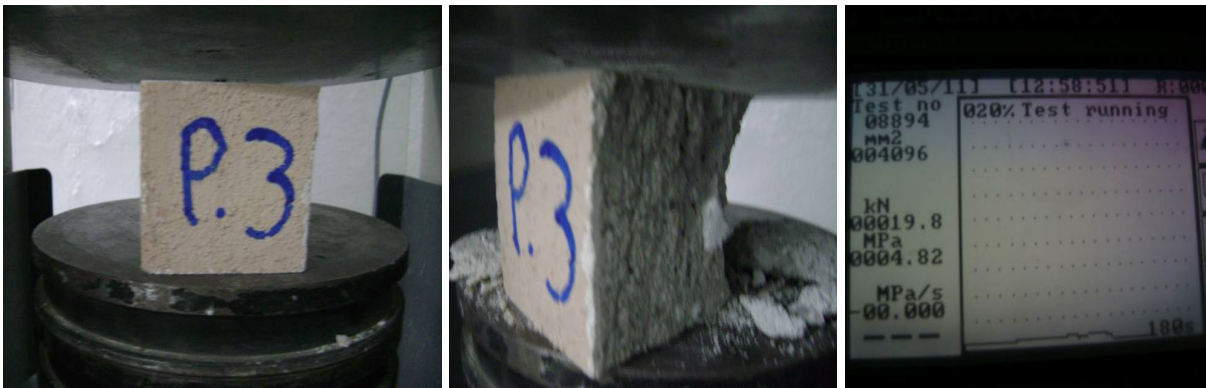
**Figure 54.** (a) sample of mortar during the compression test, (b) sample of mortar after completion of the test, point of collapse, (c) test result in digimax (Altea & geostudio, 2019)
