A methodology on the treatment of the issue of Cultural heritage restoration in Tirana, period 1920-'40

BIM modeling, Seismic simulation and
Theoretical interpretatiois

A methodology on the treatment of the issue of Cultural Heritage Restoration in Tirana, period 1920-40' BIM Modeling, Seismic simulations and Theoretical interpretations

Curriculum: Architecture / IDAUP, **Topic:** Cultural Heritage Restoration, Seismic analysis and
Retrofitting, BIM Tools (Area – SSD: ICAR19)

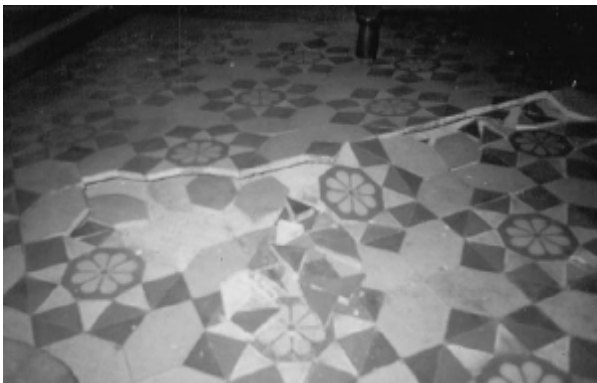
Figure 4. Complete collapse of a tiled floor after severe water penetration (Oddy & Linstrum, 2005)

Excessive volumes of water following flood damage frequently cause the mortar's adhesion qualities to fail while the grout structure remains intact, frequently resulting in a hole behind the tiles despite their continued attachment to one another. While the same problems might occur purely as a result of shifting load, when water infiltration is also present, the situation is typically aggravated. When mortar adhesion deteriorates in combination with external stress, such as footfall or vibration, or with continued settling or subsidence, the tile layer can suffer catastrophic failure in the form of fracturing or spalling around the tile edges, or even complete structural collapse, as illustrated in Figure 4 .

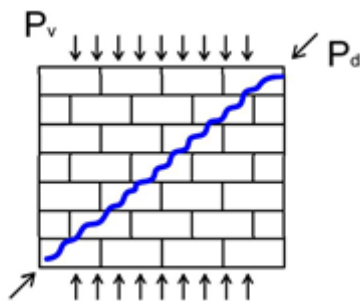
Figure 9. Second shape of the collapse mechanism, Cracking of blocks

This rupture is caused by the tensile failure of the block. Generally it involves the central part of the panel. The inclination α depends on the ratio between the vertical and horizontal components of the applied loads. Generally affects bricks perforated with the use of high-strength mortars.

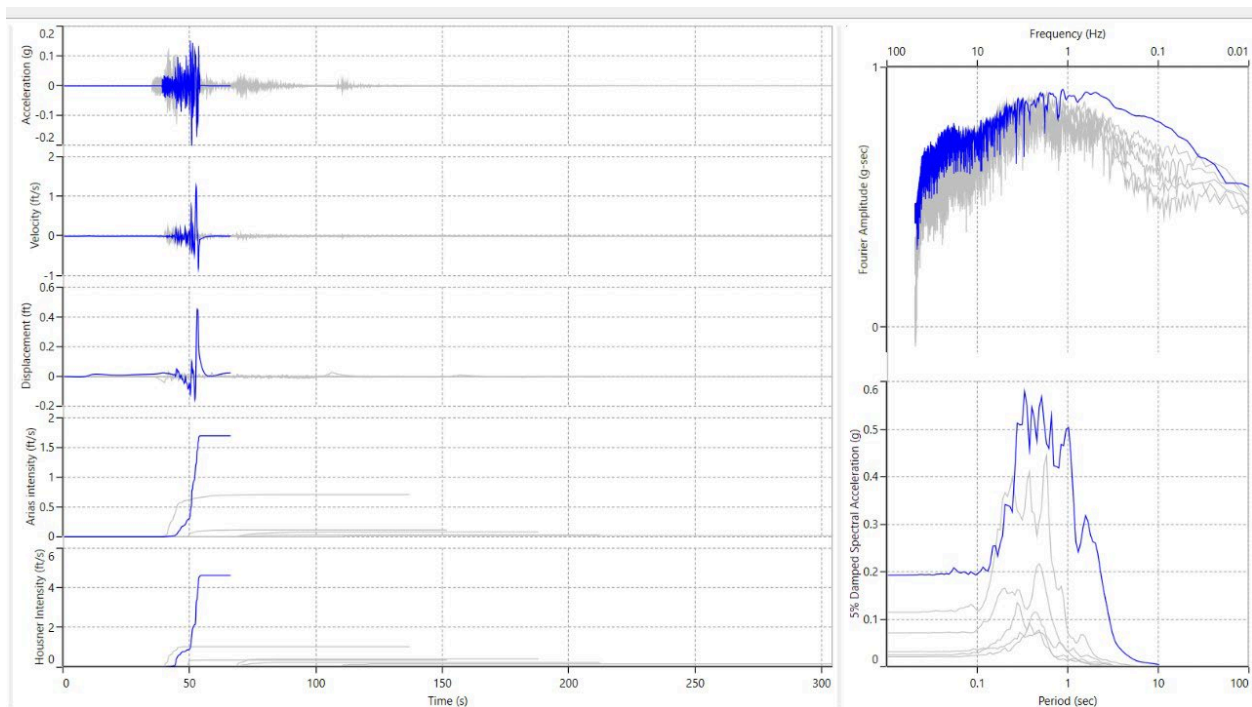
Figure 16. Summary diagram developed by the institute of seismology, after the seismic events of 2019 (Source: IGJEUM)

The diagram below shows a summary of parameters and data on the accelerations of the 5 strongest seismic events captured by the Institute of Seismology in Albania, including the moderate seismic event of 2019. In the left part of the diagrams are given evaluation parameters of a seismic event, specifically "earthquake acceleration, quake velocity, ground displacement, arias intensity and housner intensity". While the diagram summarized on the right contains in the form of diagrams the comparisons of the 5 strongest seismic events recorded in the Albanian territory since 1978. Above on the right is the diagram "amplitude-frequency oscillation", while on the bottom right, is the summary of elastic-spectrum process of these seismic events, specifically "spectral acceleration-periods". This summary gives us a more complete information of the seismic risks of the Albanian land and the risk of these buildings for the future.

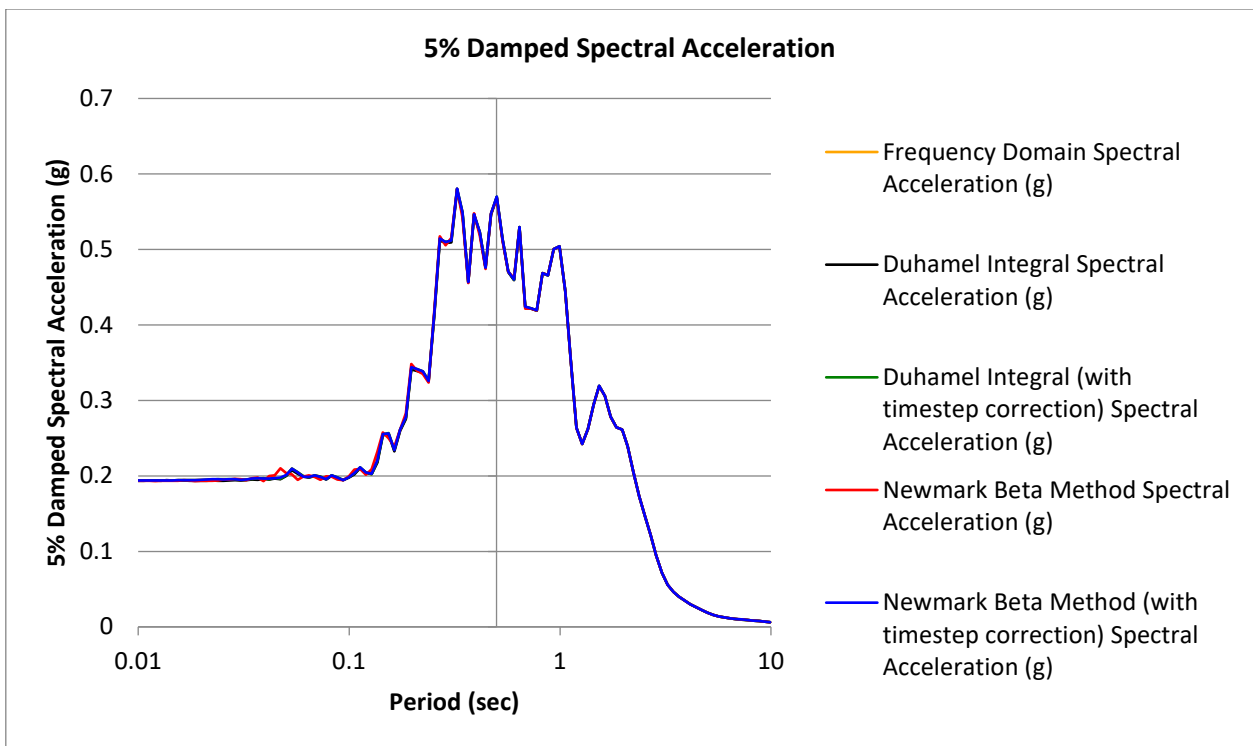
Figure 19. Data related to M.6.4 Durres earthquake spectra, 5% damped spectral acceleration – period (Source: IGJEUM/ Graphically processed by author)

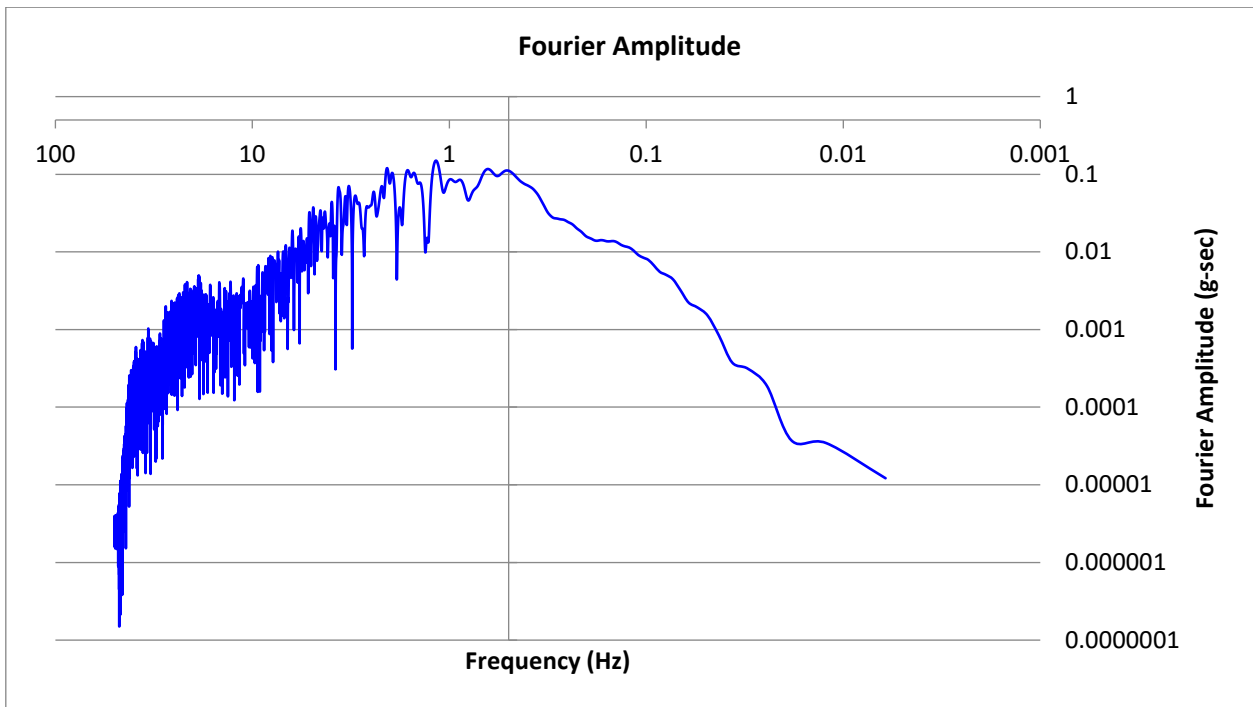
Figure 20. Data related to M.6.4 Durrës earthquake fourier amlitude based on frequency and amplitude (Source: IGJEUM)

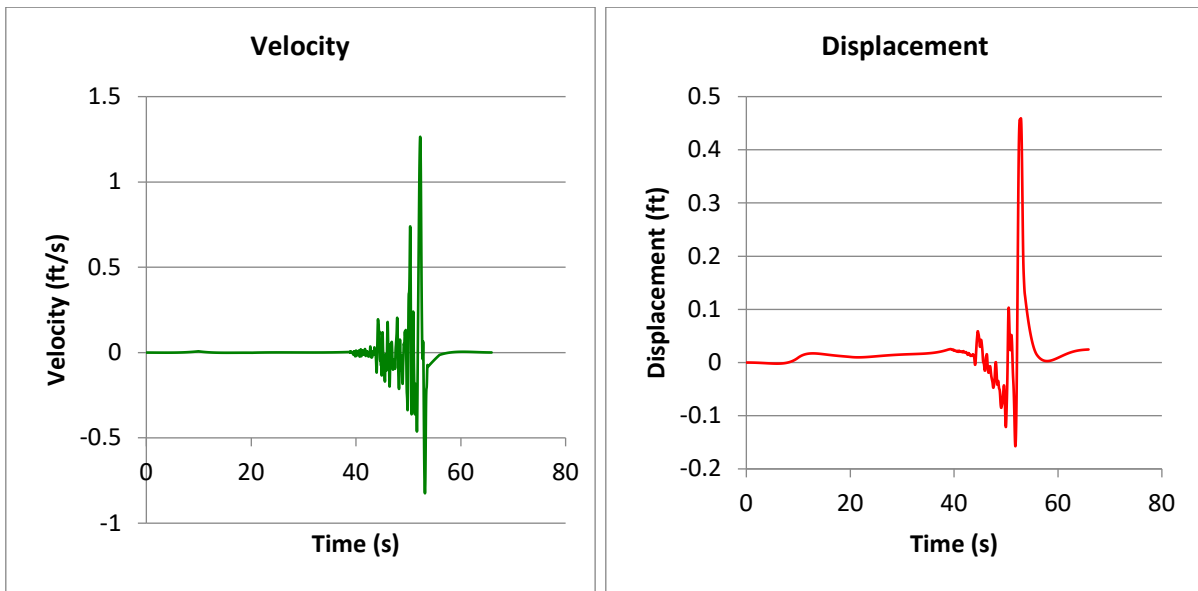
Figure 22. Data related to M.6.4 Durres earthquake Velocity and Displacement recorded (IGJEUM)

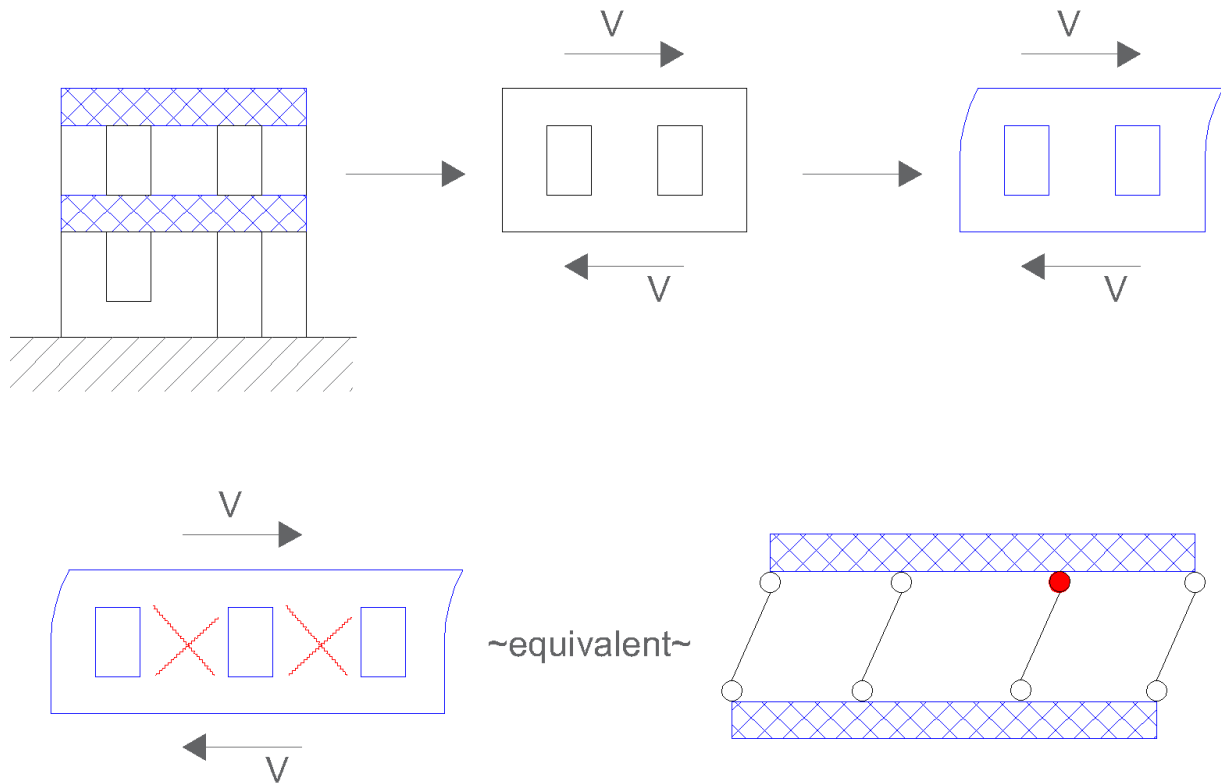
Figure 30. The stages that the resistance model goes through until deformation, and how it is conceived in static aspects

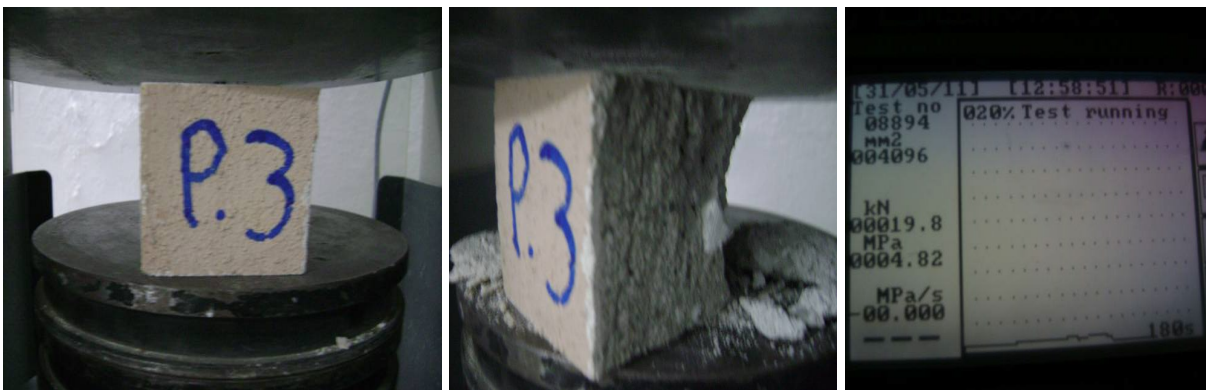
Figure 54. (a) sample of mortar during the compression test, (b) sample of mortar after completion of the test, point of collapse, (c) test result in digimax (Altea & geostudio, 2019)

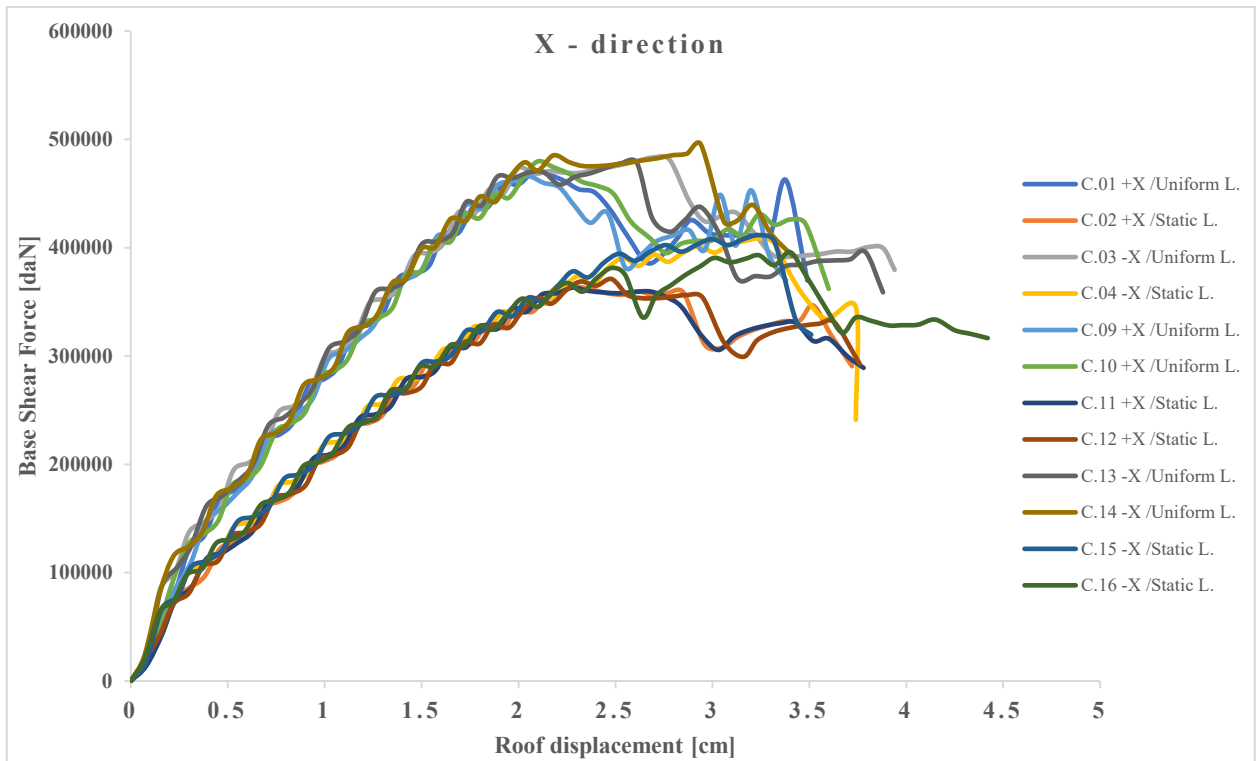
Figure 81. +X and -X direction combined capacity diagrams, processed from 3Muri numerical data

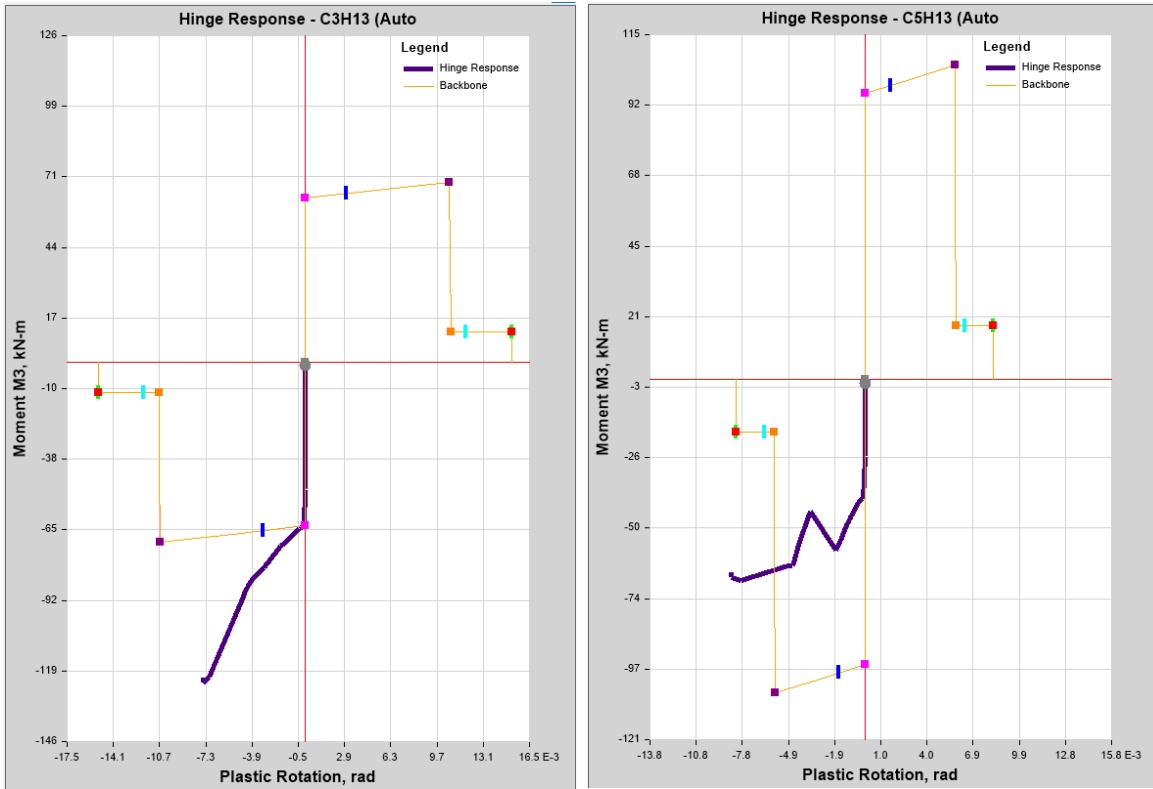
Figure 122. Column C3H13 and C5H13 hinge response diagrams, according to push-Y load

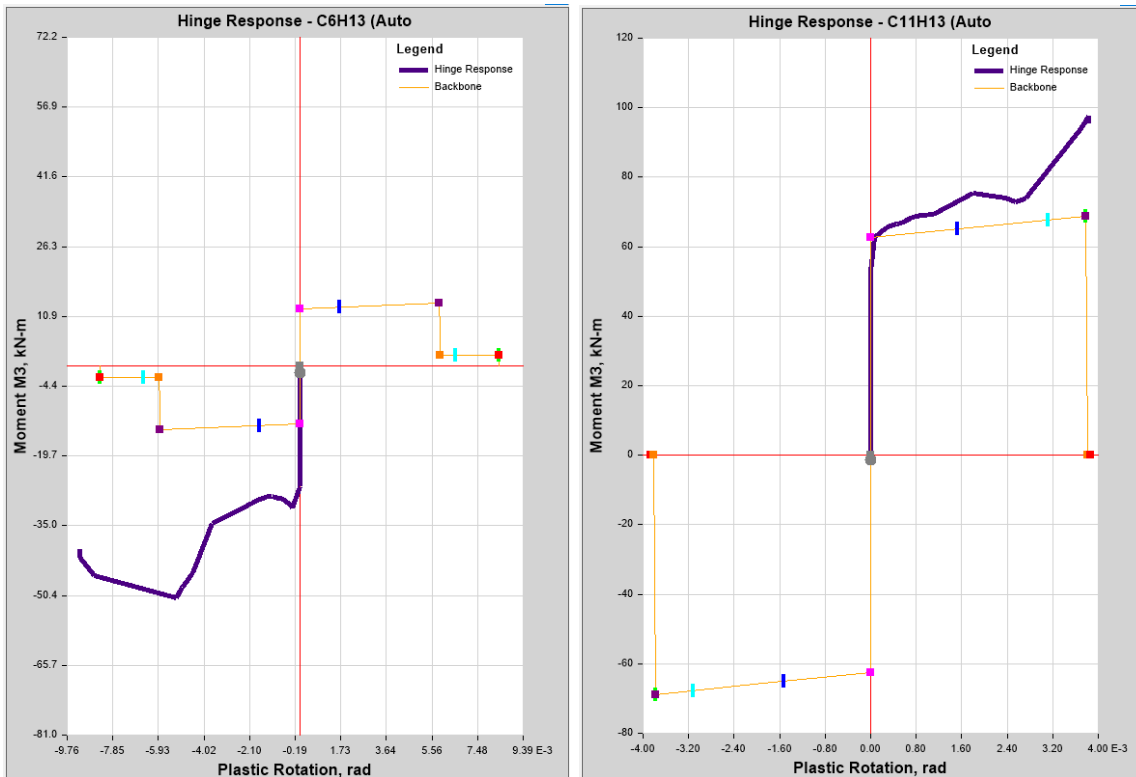
Figure 123. Column C6H13 and C11H13 hinge response diagrams, according to push-Y load

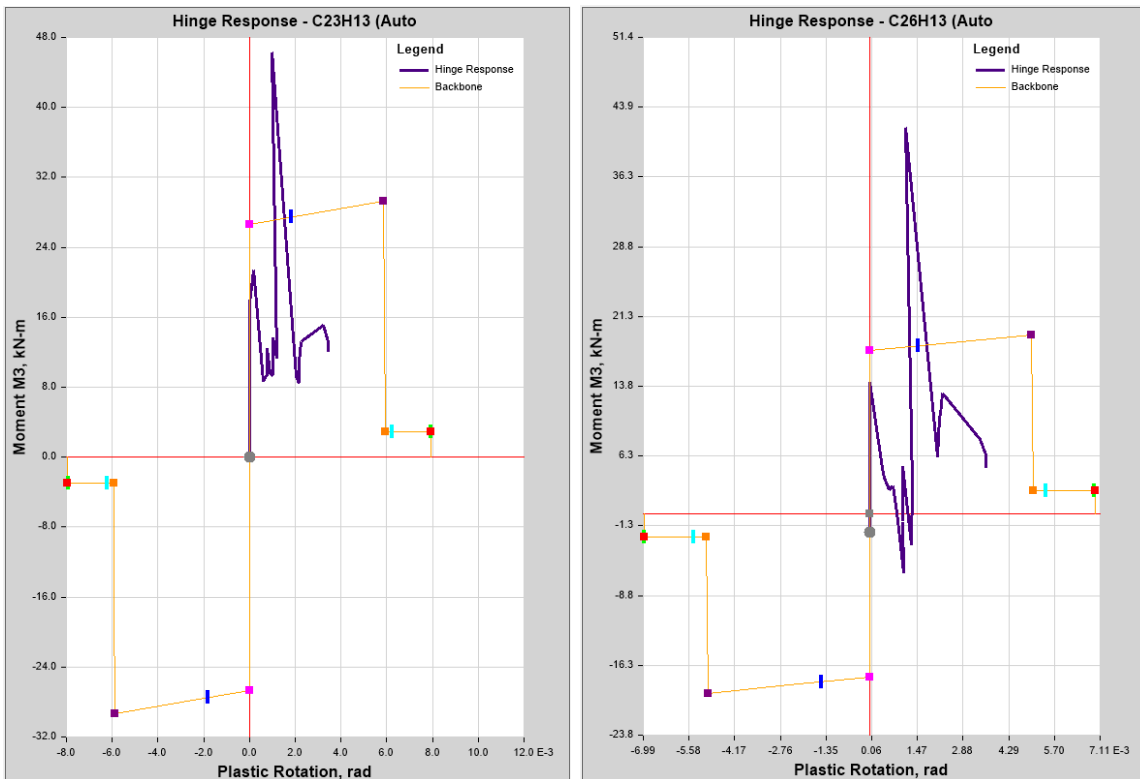
Figure 125. Column C23H13 and C26H13 hinge response diagrams, according to push-Y load
