A typological approach contribution  
to risk analysis:  
a GIS system based on widespread seismic  
damage for cemetery type

Cycle XXXIV

**Curriculum** Architecture / IDAUP Topic 1.5 - Cultural heritages. Innovations and ICT processes  
for cultural heritages use and conservation  
(Area 08 – SSD: ICAR/19 Restoration)

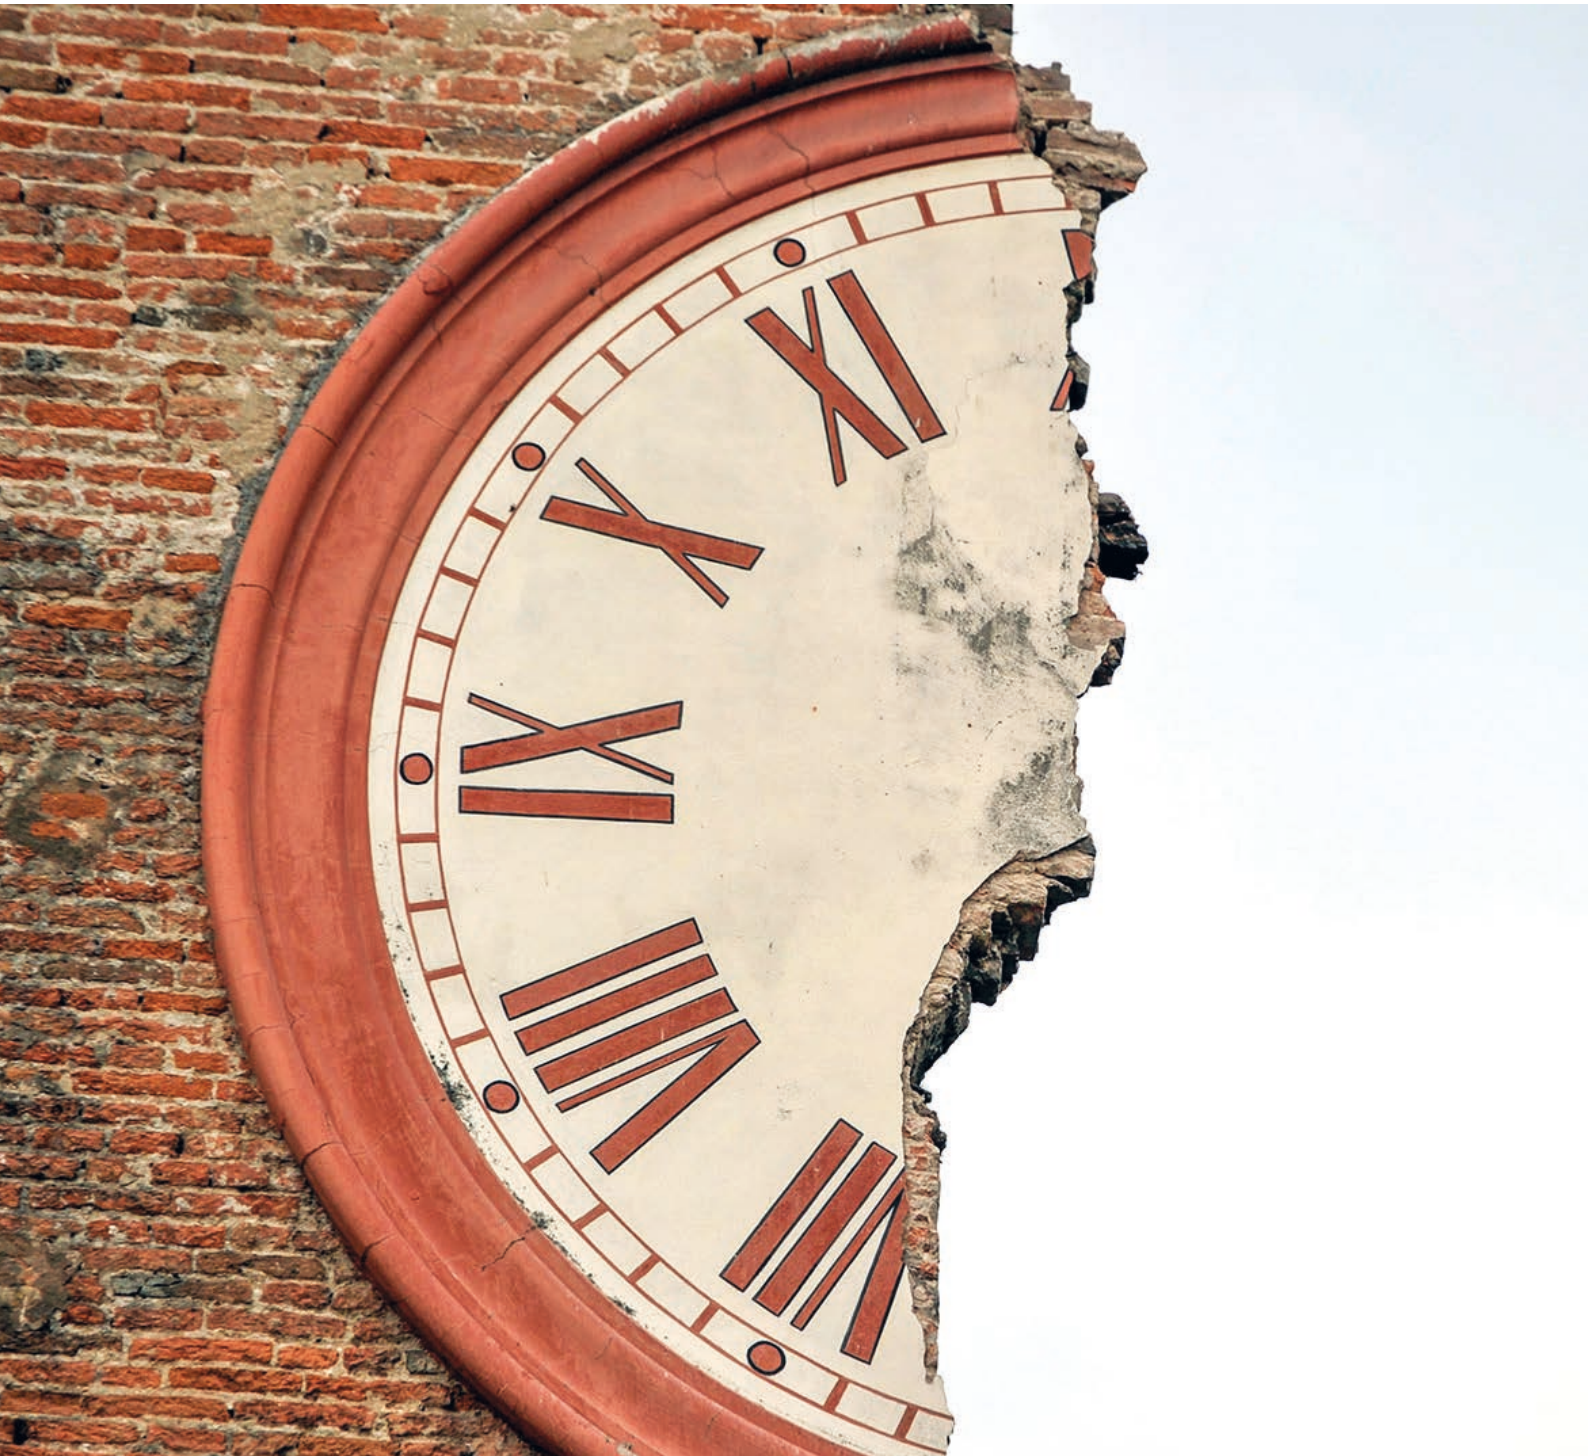
On the previous page the Modenesi tower, symbol of the 2012 earthquake. Source: <https://www.lapam.eu/notizie/normative/sisma-regione-emilia-romagna-proroga-le-scadenze-di-fine-lavori-e-rendicontazione/>
