POINT CLOUD ANALYSIS FOR CONSERVATION AND ENHANCEMENT OF MODERNIST ARCHITECTURE

M. Balzani ^a, F. Maietti ^{a*}, B. Mugayar Kühl ^b

The integrated diagnostic survey of the external surfaces of FAUUSP, designed by João Batista Vilanova Artigas in 1961, built between 1967 and 1969, was performed in conjunction with the 3D laser scanner survey.

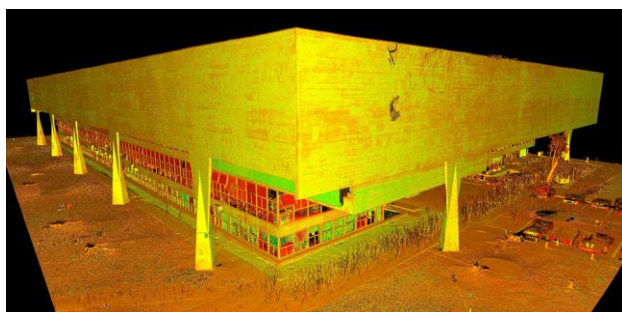
Figure 2. The 3D model of the building in point cloud visualization

The 3D survey has allowed the realization of a point cloud model of the external surfaces, as the basis to investigate in detail the formal characteristics, geometric texture and surface features.

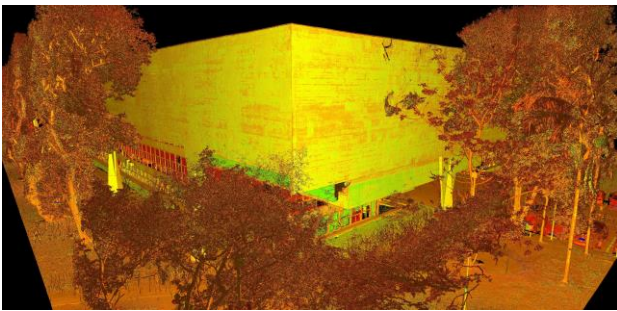
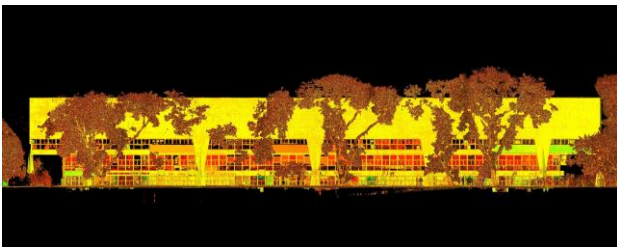
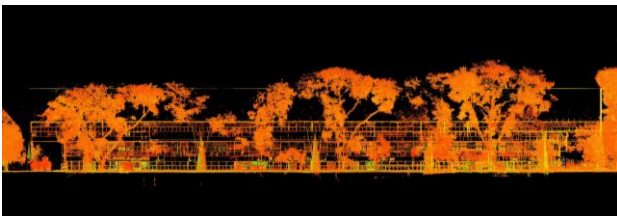
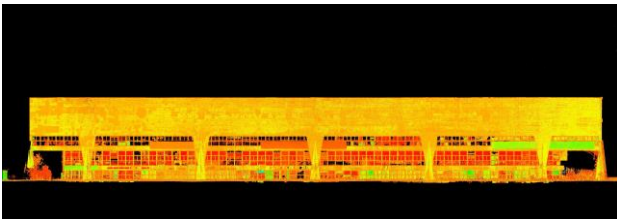
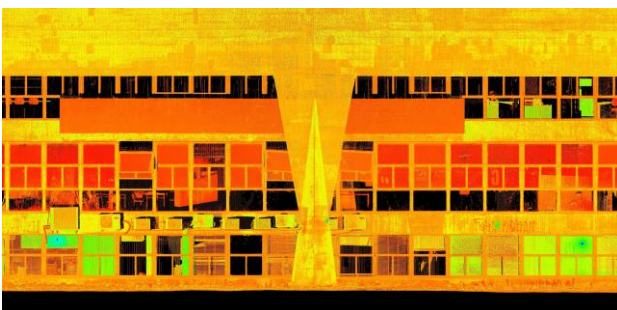
Figure 3. Different point cloud visualizations of the exteriors of the FAUUSP building

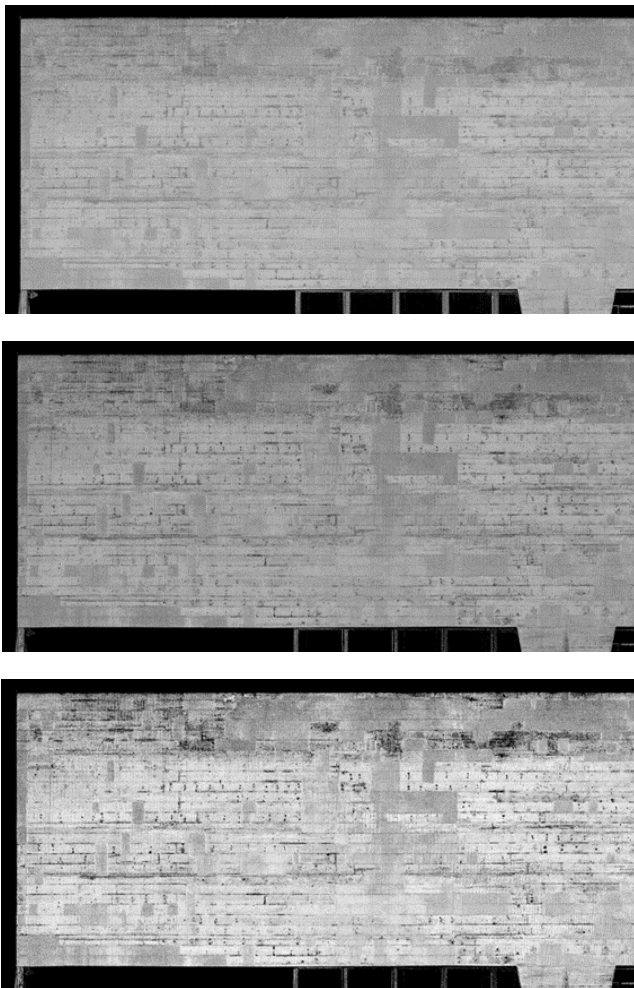
Figure 4. Greyscale visualization of a sample are of the point cloud

Each point acquired with the laser scanner has an intensity value attached, calculated within the range of -2048 - + 2048 (pts export) related to the range of 0-1 (ptx export).

According to instrument' specifications (pulsed scanner Leica ScanStation C10), different visualizations of the point cloud have been displayed in order to help accentuate variations of surfaces' characteristics, starting from the full range of colors mapped in the software by default.

By changing the intensity range for specific visualizations, the processing of acquired data highlighted areas with specific features to be mapped (different materials, degradations, previous restoration works, etc.).

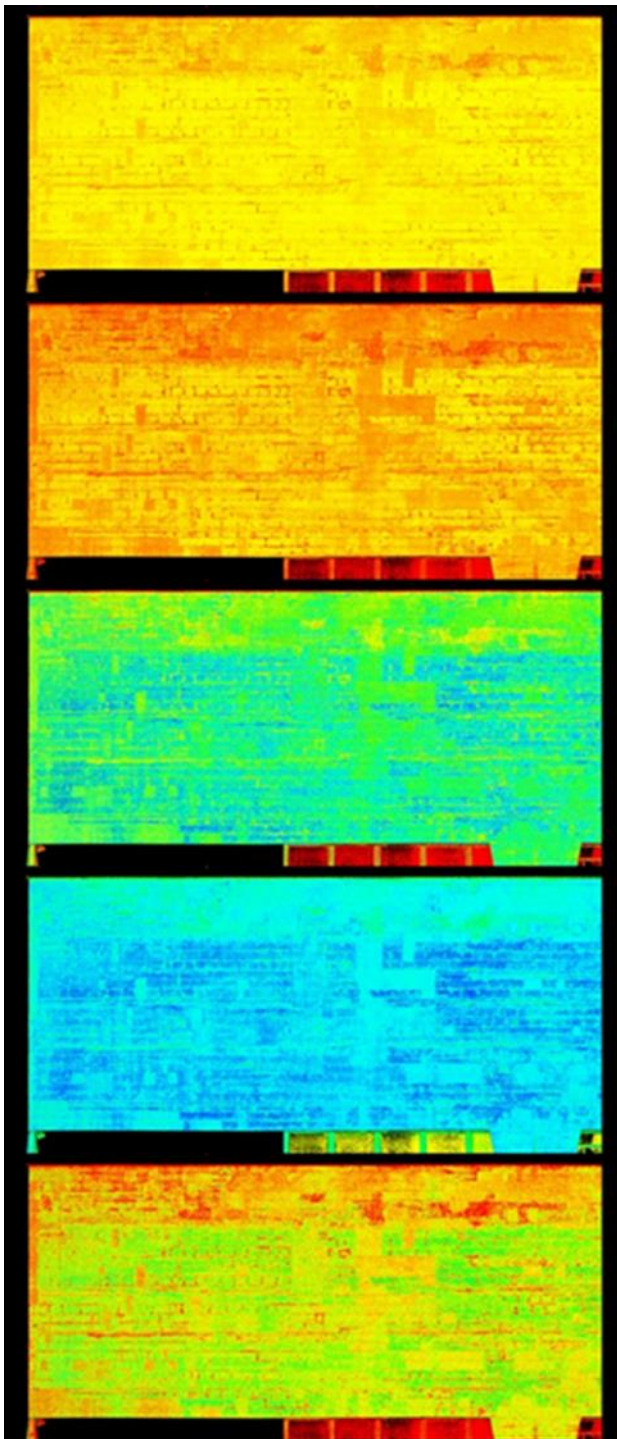
Figure 5. “False coloured” visualization of a sample are of the point cloud

In the case of the FAUUSP building survey and post-processing, several tests on intensity value were performed in order to analyse the 3D point cloud for supporting conservative issues. Different display variations of the surveyed intensity value allowed selecting the best display mode for highlighting specific surface characteristics. For example, in data processing, it was critical to get the best possible visualization of the concrete additions included in the four elevations during a previous restoration work; or to analyse the amount of surface involved in biological deposits.

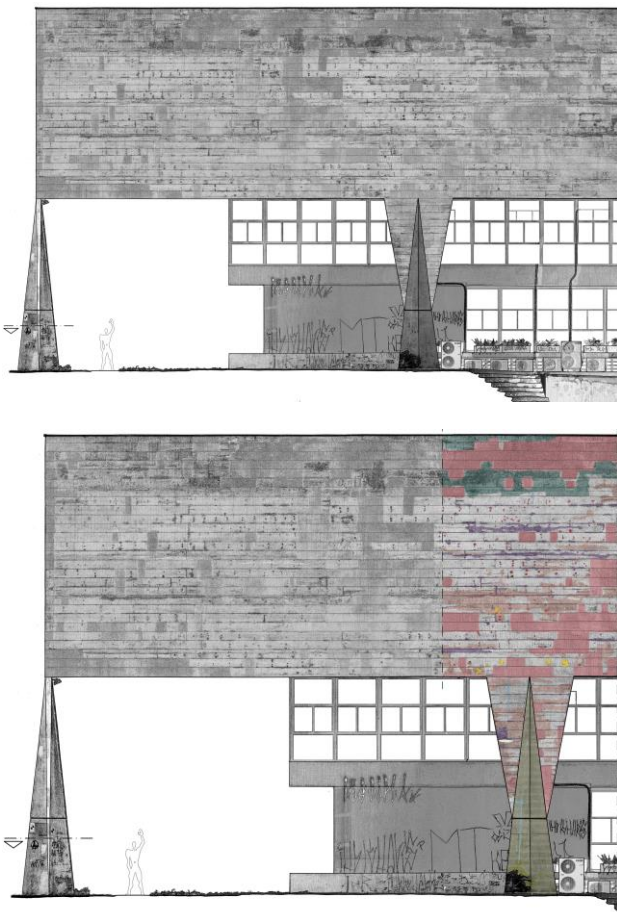
Figure 6. Data representation of a sample of elevation; above, view of the CAD two-dimensional representation superimposed to the DEM; below, example of degradation characterization

Taking as a baseline the UNI Normal 1/88 document, a schedule has been drawn by listing the main degradation' morphologies identified. Each morphology was linked to a specific layer on CAD files with a specific texture for its representation in technical drawings. In the case of the building by Artigas, the surface characteristics have a natural aging and a natural response of the particular cement mixture to weathering, conferring a series of particularities not definable as degradation but as alterations or modifications which do not necessarily imply a worsening under the conservative point of view (where do not cause damage or do not create worse conditions that could lead to the loss of portions of material).

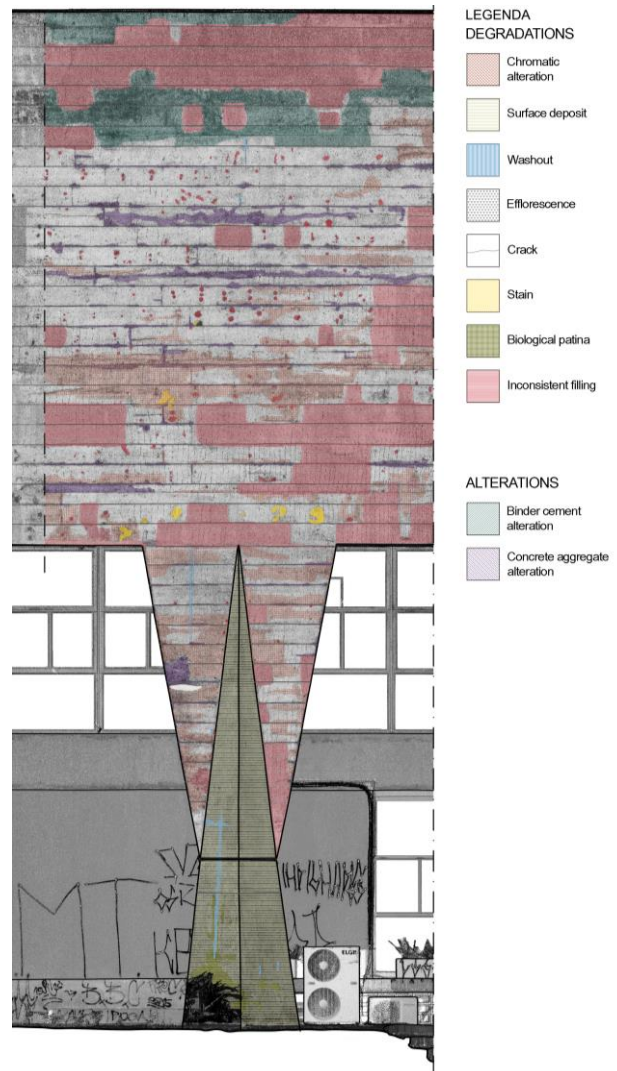
Figure 7. Detail of degradation mapping
