Some laser-scanner applications in structural analysis

Abstract: In the present work, the authors intend to describe some recent experiences in the application of the laser scanner technique to the structural analysis. Three main examples are provided, the former involves a typical Renaissance Palace in Ferrara, the second one is developed in the framework of the damage analysis carried out for the Nativity Church in Bethlehem, and the latter deals with the non-destructive testing of a common historical masonry building in Ferrara. In such examples the laser scanner data acquisition is mainly aimed at investigating the structural behaviour and not at the geometrical representation. The contribution ends with some comments on the current open issues.

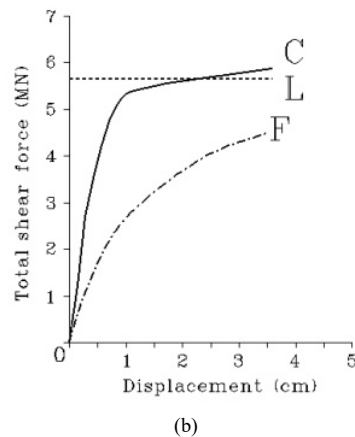
Figure 2. (a) F: equivalent frame model, C: Adina 2D mesh, L: homogenised limit analysis discretisation (b) Global structural response (see online version for colours)

A seismic analysis was then carried out on the wall to measure its vulnerability. Three approaches were used: equivalent frame model (F), inelastic plane stress model (C) and a homogenised limit analysis (L). Mesh adopted and global numerical results are depicted in Figure 2.

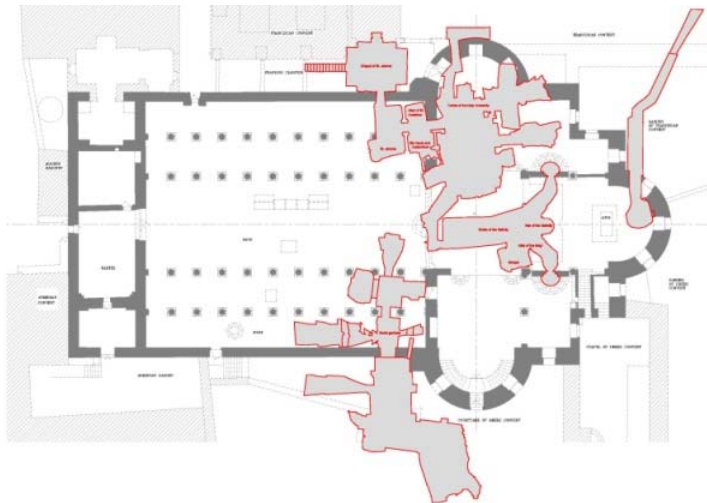
Figure 5 Plan of the grottoes under the church (see online version for colours)

The laser scanning survey found its best application in the survey of the underneath grottoes (see Figure 5). The absence of finings and the well-known high complexity in the alternative manual mapping, make the laser scanning an excellent alternative. The output data were obtained with 25 different stations and a grid of 10×10 cm as the required detail was rather coarse.

The data were useful to perform the structural analysis of some meaningful 2D sections of the grottoes and to provide a more realistic measure of the safety level in the areas of the church subjected to the highest crowding of pilgrims.

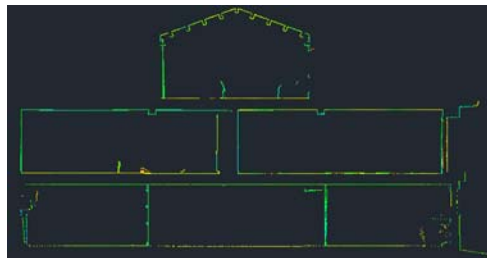
Figure 6 A vertical section provided by the laser scanner acquisition system (see online version for colours)

A laser scanner survey was performed in all the rooms of the building and the acquired data were merged in order to provide meaningful vertical sections (see an

example in Figure 6). The cloud of points was first amplified [see Figure 7(a)] and then averaged in order to replace them with lines [see Figure 7(b)]. The final drawing represented the actual position of the bottom external surface of the beams bearing the slab. As the wooden beams were supported at their extremes by thick masonry walls (in Figure 7 located at the intersection with the vertical line), such lines provided a visual representation of the typical vertical deflection of simply-supported beams.

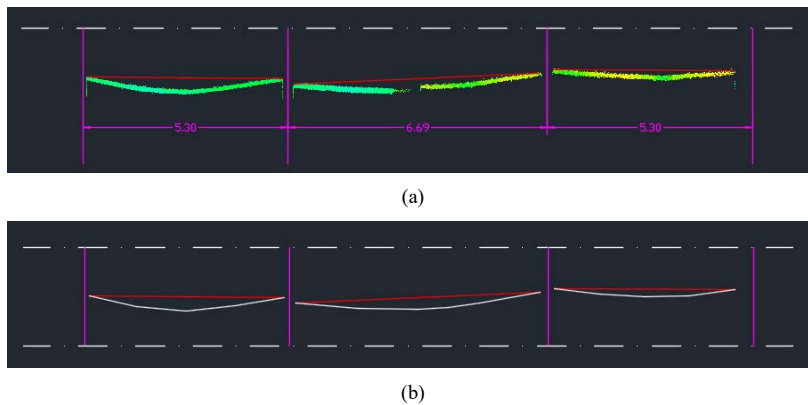
Figure 7 Amplification and lining of the vertical section (see online version for colours)
