Sinkhole risk assessment by ERT: The case study of sirino lake (Basilicata, Italy)

V. Giampaolo, L. Capozzoli, S. Grimaldi, E. Rizzo

*Keywords:* piping; sinkhole; hydrogeology; ERT

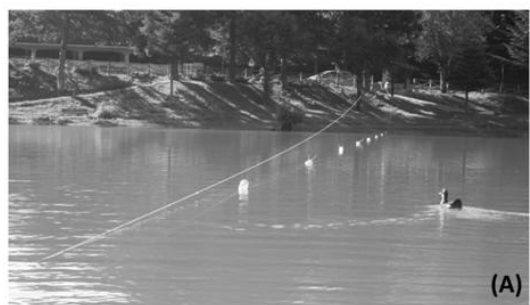
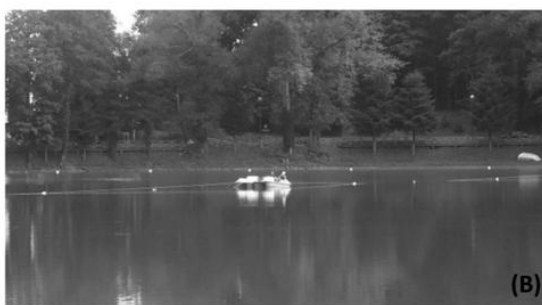
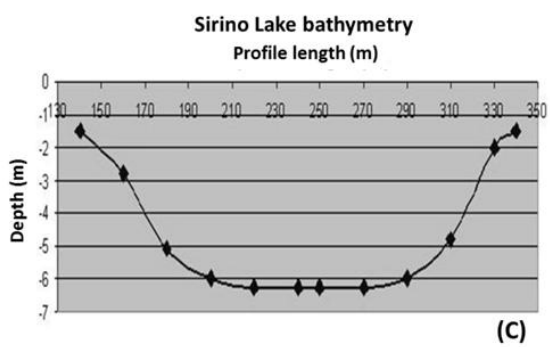
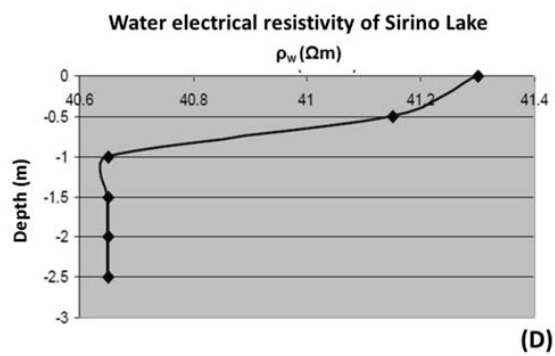
FIGURE 3

In July 2009, an electrical resistivity survey was carried out on land and on water to study the sinkhole phenomena along the Sirino Lake shores and to analyse the state of health of the impervious layer under the lake (Fig. 3).

Junior was placed on board a small boat and held steady in the lake centre for the whole duration of measurements (Fig. 3A and 3B). For the ground measurements, standard stainless steel electrodes connected to the cable were used. The ERT1, acquired across the lake, was done using Wenner-Schlumberger (WS) and dipole-dipole (DD) arrays. This ER profile was carried out between the northwestern and the southeastern lake shores, with a total length of 450 m, of which 210 m extended into the lake with electrodes floating on the water surface. Furthermore, water electrical conductivity and lake bathymetry and temperature were measured along the ERT profile (Fig. 3C and 3D).

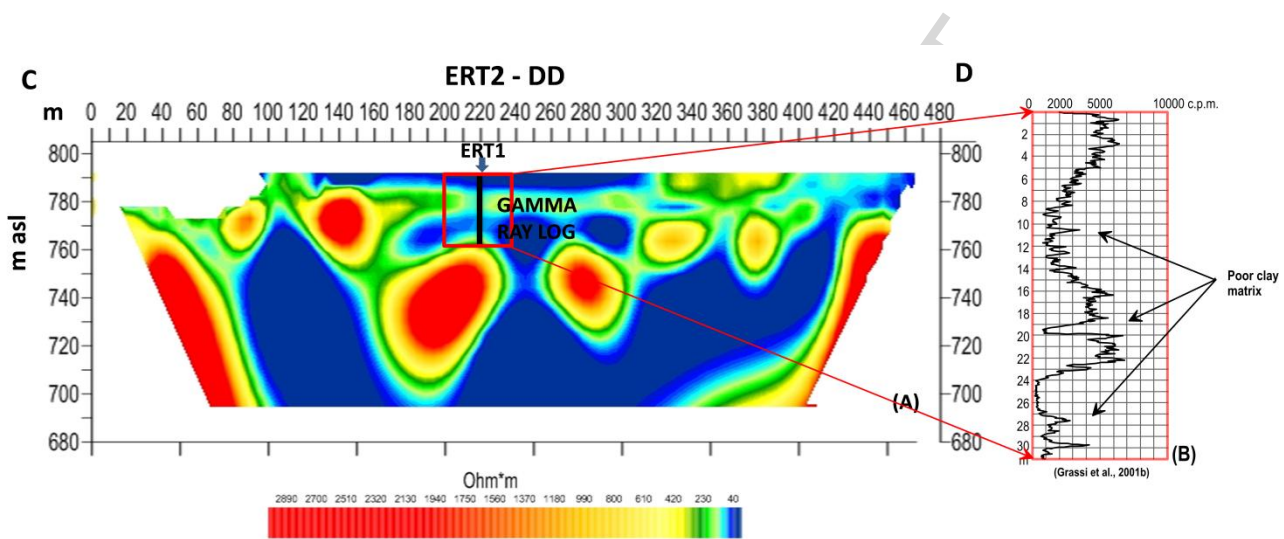
FIGURE 5

Figure 5A defines the ERT2 carried out along the lake shore, perpendicular to the previous one. The electrical image shows a main deeper conductive electro-layer ( $<100 \text{ Ohm}\cdot\text{m}$ ) and localised discontinuous resistive zones ( $>500 \text{ Ohm}\cdot\text{m}$ ). The RMS error was 4.5%. The correlation between gamma ray log information and the first 30 m of ERT2 (Fig. 5B) shows clear alternations between levels: still plenty of clay characterized by low resistivity values and layers poor in clay matrix down to -24 m with a more resistive behaviour. In the deeper part, the gamma ray log shows the presence of a different lithotype poor in clay matrix probably correlated with landslide debris of the Siliceous Schist Formation (Fig. 5B). From a geophysical point of view, the ERT1 and ERT2 highlight the strong heterogeneity of the investigated area, closely correlated with the large number of landslides involving this flank of the Sirino Mountain.
