Fiber Bragg grating–differential settlement measurement system for bridge displacement monitoring

M. Bonopera^{1,4*}, K.-C. Chang², C.-C. Chen¹, Z.-K. Lee¹, Y.-C. Sung^{1,3}, N. Tullini⁴

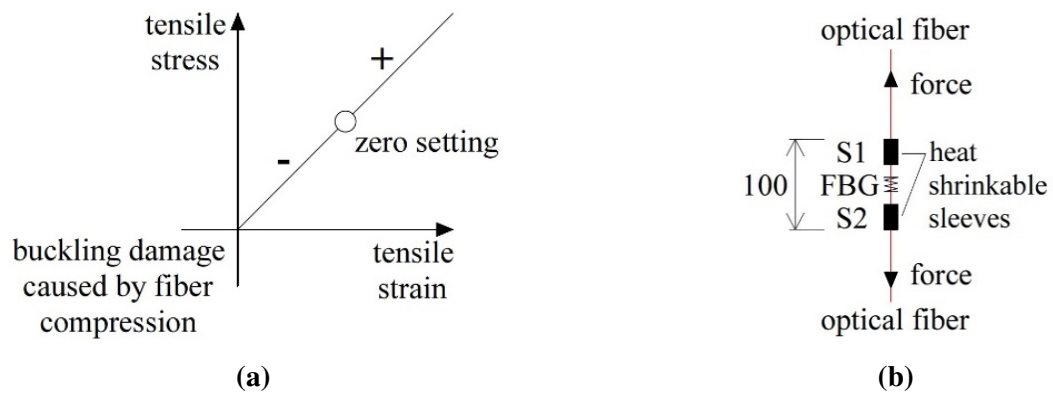
Fig. 1. (a) Exerting prestress and setting sensing origin. (b) Connector introducing external force into the FBG (dimensions in mm).

256 **FBG–DSM system:** Nine FBG–DSM sensors with total length “S1+FBG+S2” of 100 mm (Fig. 1),
257 maximum stroke of 40 mm, suspended cylindrical object of 60 mm–diameter and 0.1 mm–tolerance
258 were employed (Fig. 10(c)). Similarly, the single–mode optical fiber with acrylic coating was used
259 (Table 1). The FBG–DSM sensors were located inside the two box–girder spans at the cross
260 sections $i = 0, \dots, 8$ (Fig. 11), in correspondence of the bridge axis. Likewise, two reference FBG–
261 DSM sensors, labeled “B” and “C”, were placed at the support “RP8” at $i = 1$ and 2, while one
262 reference FBG–DSM sensor, labeled “I”, was positioned at the beam end at $i = 8$. Two additional
263 FBG–DSMs, labeled “J” and “K”, were positioned on the opposite side of the midspan cross section
264 at $i = 5$ to measure possible rotations along the span (Fig. 11). Therefore, the reference line for the
265 system between the boundary conditions was formed by the FBG–DSMs at support “RP8” and the

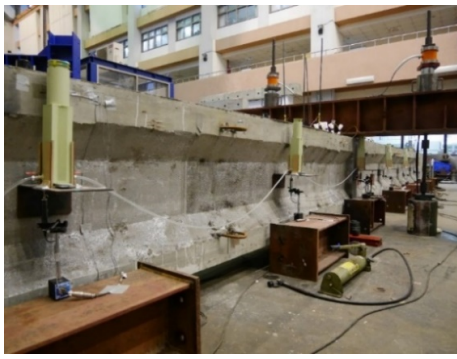
(a) FBG-DSM sensors and LVDTs along the PCI beam span.

199 Seven FBG–DSM sensors and seven LVDTs (labeled L0, ..., L6) were positioned along the
200 PCI beam’s length at the cross sections $i = 0, \dots, 6$, based on the test layout shown in Figs. 6 and

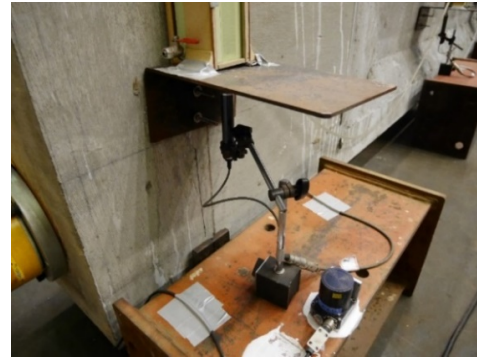
(c) Reference FBG-DSM sensor and LVDT at one PCI beam end.

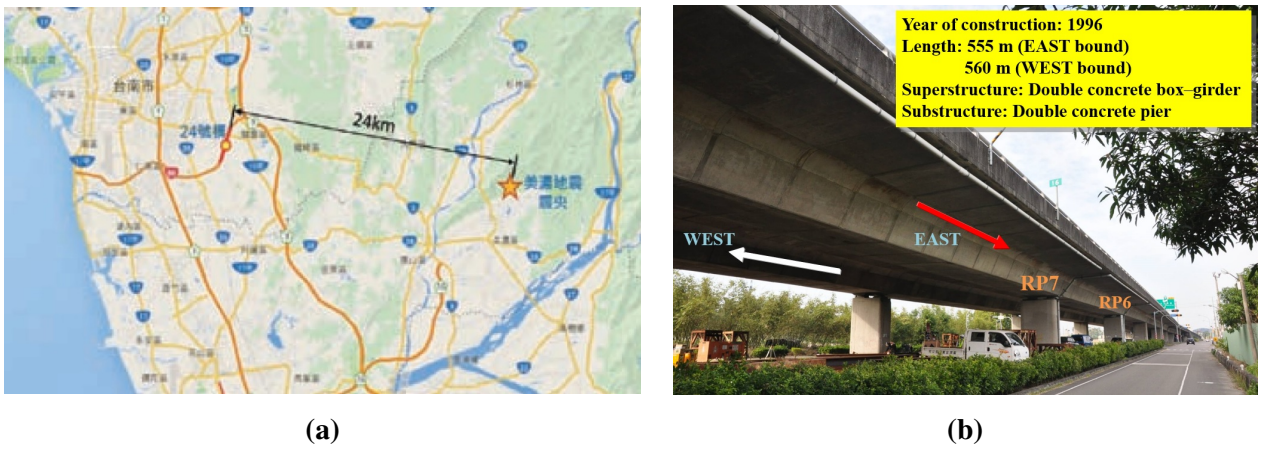
Fig. 8. (a) Location of “2016 Southern Taiwan earthquake”. (b) Bridge No. 24 of Highway No. 86, Taiwan.

238 7.0 m. After the “2016 Southern Taiwan earthquake”, many bridge’s supports were damaged.
239 Specifically, one box-girder dislocated outwards from the original line at expansion joint labeled
240 “RP7” (Fig. 8(b)). The dislocation measured up to 59 cm (Fig. 10(a)). NCREE commissioned a
241 special inspection to be conducted on Bridge No. 24 in order to appraise its structural safety.

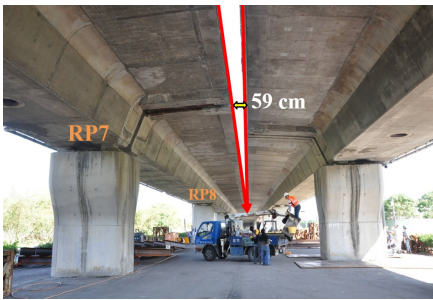
(a) View before installation and detail of the dislocation at joint “RP7”.

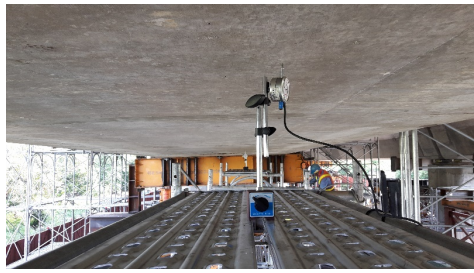
(b) One dial indicator fixed onto a stable platform.

248 **Dial indicator:** Nine dial indicators, of 0.01-mm tolerance, were positioned on the underside of the
249 two span bridges at the cross sections $i = 0, \dots, 8$ (Fig. 11). Scaffolding were used to fix each sensor
250 onto stable platforms in correspondence of the beam axis (Fig. 10(b)). In detail, two reference dial

301 indicator measurement v_i (Fig. 10(b)). In all test combinations, no relaxation occurred in the FBGs
302 inside the sensors and the tensile elongation along the fiber was considerably lower than its ultimate
303 tensile elongation (Table 1). The effect of temperature variation on wavelength changes (sensor
304 “A”) was almost constant, therefore, wavelength changes in the FBG–DSMs were only caused by
305 the span’s vertical deflections. The comparison shown in Table 3 indicated that the displacement
306 field of a bridge can be satisfactorily measured by the FBG–DSM system proposed in this study.

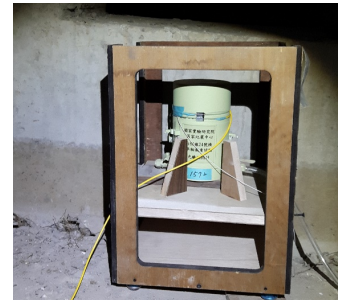
(c) One FBG-DSM sensor inside the box-girder span.
