# Università degli Studi di Ferrara

DOTTORATO DI RICERCA IN  
"SCIENZE DELLA TERRA"

ENVIRONMENTAL IMPACT ON UNESCO  
HERITAGE SITES IN PANAMA

Anni 2014/2016

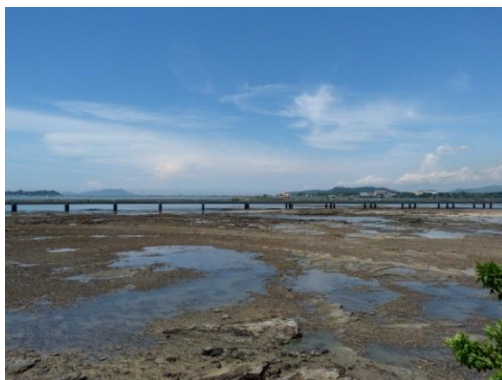
Figure 1.2.1.4 Low tide view at Casco Antiguo bastion (Panama City). Picture took in the end of August 2014 at 11:00 a.m.

This factor is responsible for the progressive coastal erosion in the last five centuries, which carried the ruins of Panamá Viejo to be distant only 100 m from the sea (Strong, 2009); causing also the erosion of the archaeological monuments, in particular of "Casas Reales", the complex erected in the part nearest the coast (Figs. 1.2.1.4-1.2.1.5).

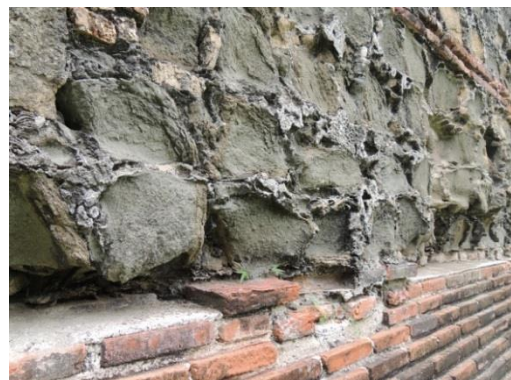
Figure 1.2.1.5 Walls of one of the structures belonging to the complex "Casas Reales" showing the erosion due to the sea waves action.

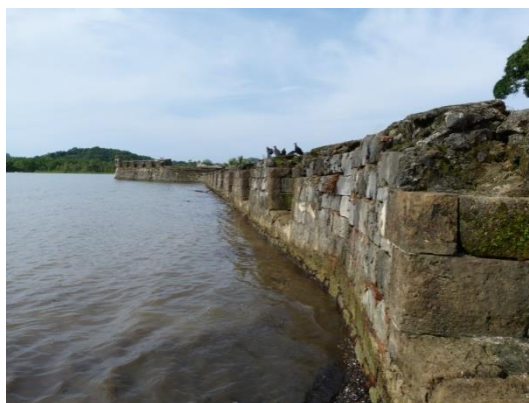
Figure 1.2.1.7. External view of sea-front walls of Fort San Jeronimo. Picture took in the beginning of September 2014 at 4:00 p.m.

Considering the Caribbean littoral (Fig. 1.2.1.6), the Fortresses located in Portobelo are principally exposed to the water action, mainly due to rainfall and sea water. In the specific case, San Jeronimo undergoes to the sea intrusion, especially during storms; however also the daily tidal variations causes the erosion of the external walls and water infiltration (Figs. 1.2.1.7-1.2.1.9).

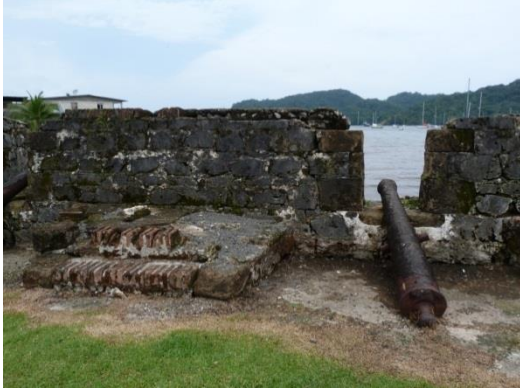
Figure 1.2.1.8. Inner view of sea-front walls of Fort San Jeronimo. Picture took in the beginning of September 2014 at 12:00 a.m.

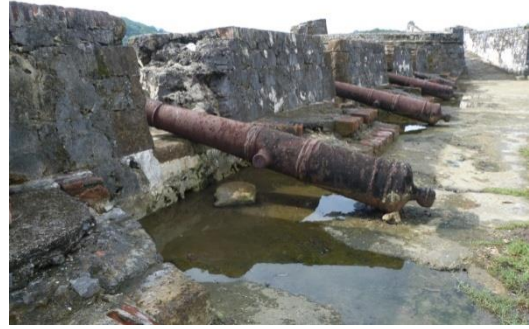
Figure 1.2.1.9. Inner view of sea-front walls of Fort San Jeronimo. Picture took in the beginning of September at 2014 4:00-5:00 p.m.

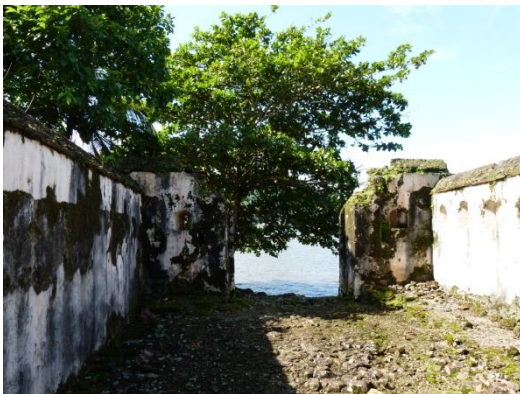
Figure 1.2.1.10 Entrance of the "Bateria Baja" of Fort San Fernando. The proximity of the sea is clearly visible.

This fortification shows also settling problems, due to the nature of the ground which is a sandy soil. Even San Fernando is subjected to the sea water permeation, additionally in the inner part of the Fort (Fig. 1.2.1.10). In the case of Santiago, *La Bateria*, it is built on a site with a high phreatic level, so often there is water emerging from the ground (Fig. 1.2.1.11). In addition, in 2010, a landslide occurred from the mountain above, causing the deviation of a natural spring, which gushed from a fountain located in a corner of the Fortress, leading to the water flooding from others splits or from the ground.

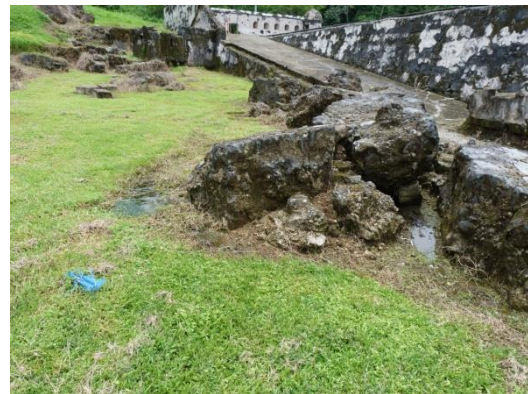
Figure 1.2.1.11 Water emerging in the ground of Fort Santiago – Bateria.

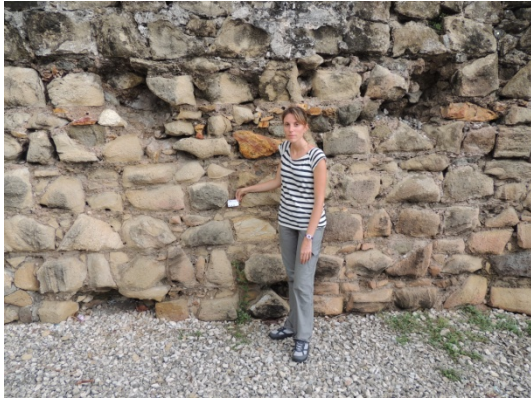
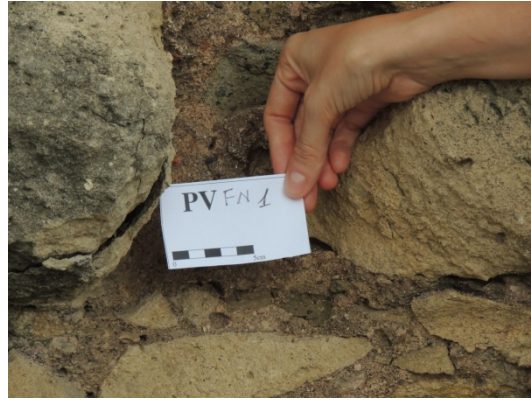
Figure 2.1.1. 4. Fortín de la Natividad, outer part of the Southern wall, PV FN 1 sampling.

Two fragments of breccia were sampled from the external part of the Southern wall. PV FN 1 sample showed biological colonization, with a darker colour on the external surface, and exfoliation phenomena, moreover, the decohesion phenomenon conferred to the stone low hardness (Fig. 2.1.1.4). Instead, the second one, PV FN 2 sample, presented a better state of conservation (Fig. 2.1.1.5).

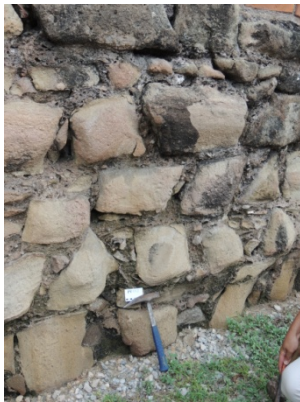
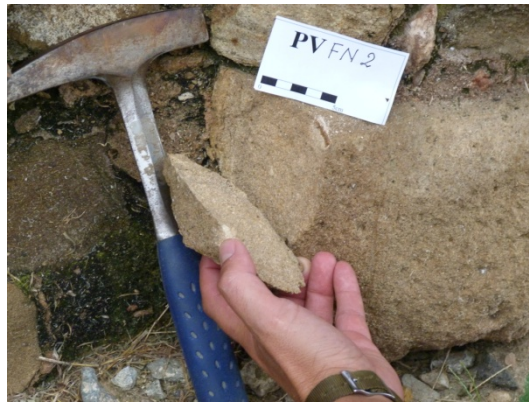
Figure 2.1.1. 5. Fortín de la Natividad, outer part of the Southern wall, PV FN 2 sampling.

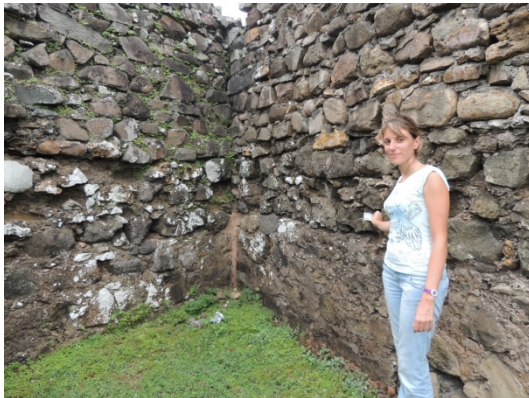
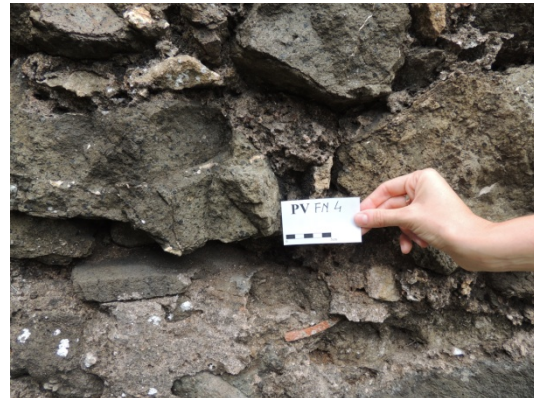
Figure 2.1.1. 6. Fortín de la Natividad, inner part of the Western wall, PV FN 4 sampling.

While two fragment of basaltic andesite were sampled: one from the Western wall of the inner part of the Fort (PV FN 4 sample, Fig. 2.1.1.6), and another one from the ground within the Fort (PV FN 5 sample, Fig. 2.1.1.7).

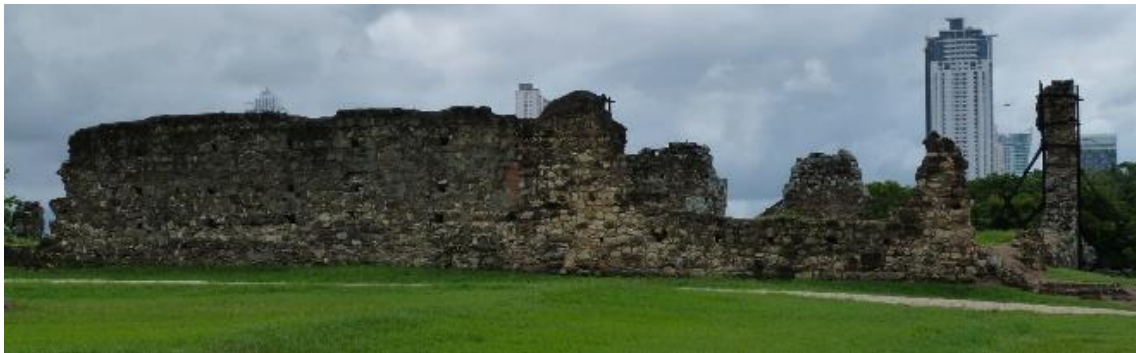
Figure 2.1.1. 8. Overview of the San Francisco masonry mainly composed by yellowish-grey breccias.

Observing the texture of the masonry of the wall facing East and the construction technique, the alternation of the two varieties is clearly visible, noticeable by the different hue, enhancing the hypothesis of belonging to the same outcrop (Fig. 2.1.1.8). The description of the sampling is reported below (Fig. 2.1.1.9)

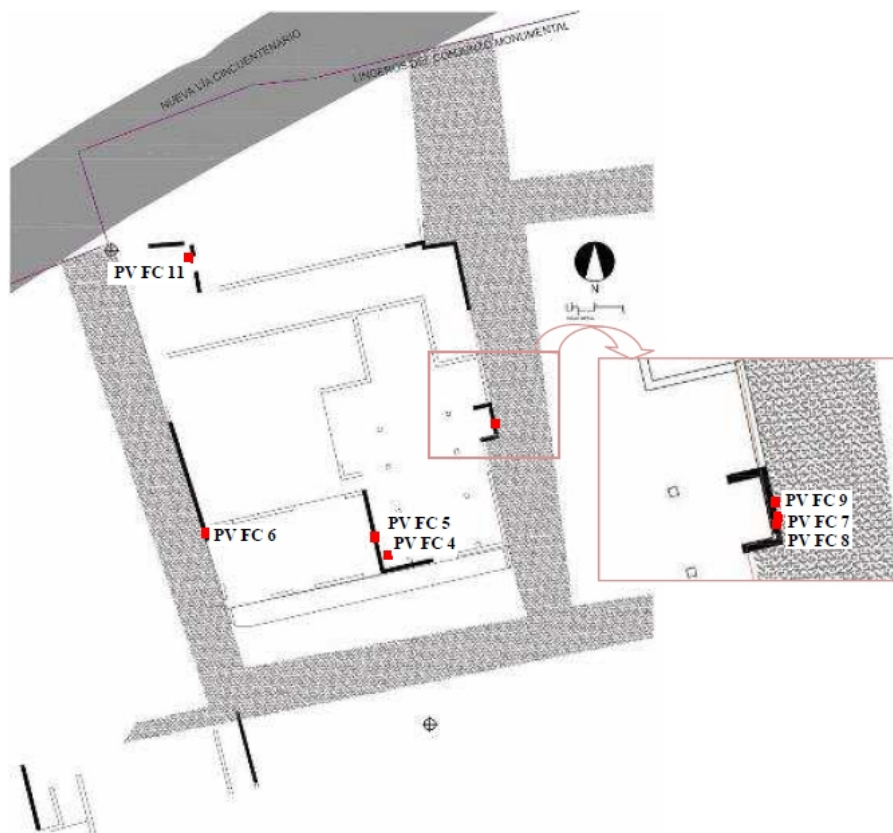
Figure 2.1.1. 9. Plan of the Convento de San Francisco and sampling points (Plans are Courtesy of the Patronato de Panamá Viejo).

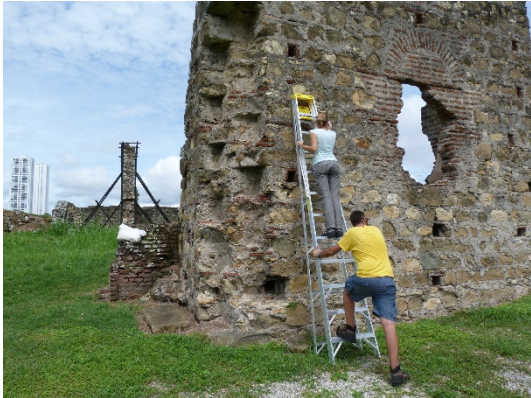
Figure 2.1.1. 10. Sampling of the yellowish breccia, PV FC 8 specimen.

The yellowish breccia was sampled from the masonry exposed to West, PV FC 8 sample (Fig. 2.1.1.10). This stone was deteriorated, showing exfoliation phenomena, and blackening. Another

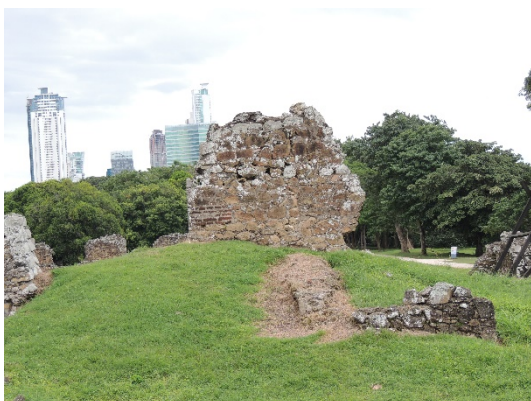
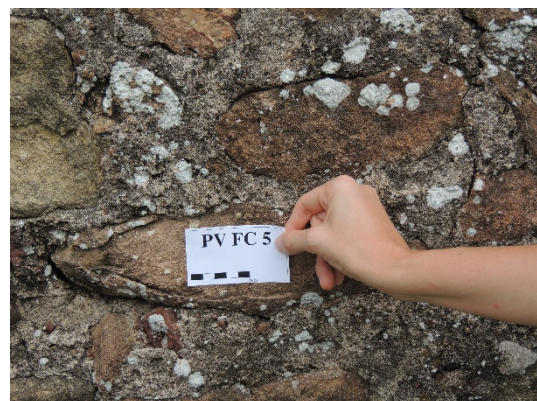
Figure 2.1.1. 12. Sampling of the breccia PV FC 5, showing a more reddish hue.

sample was collected from the ground, near the eastern wall of the navy, PV FC 4 (Fig. 2.1.1.11). From the eastern wall of the navy was collected PV FC 5, another volcanoclastic stone block in the masonry (Fig. 2.1.1.12). It showed deterioration phenomena, as presence of lichens and biological black patina. Moreover, PV FC 7 was sampled from the Eastern wall, above a putlog hole, and near the PV FC 8 sample (Fig. 2.1.1.13). Finally, another sample showing a greyish-green hue and showing blackening, was sampled from the wall closest to the new Via Cinquantanerio, exposed to North, from the S-W side (PV FC 11, Fig. 2.1.1.14).

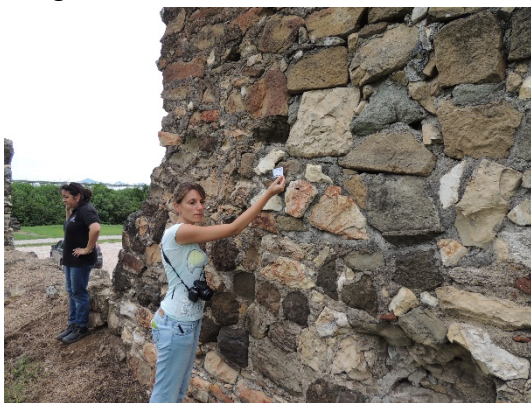
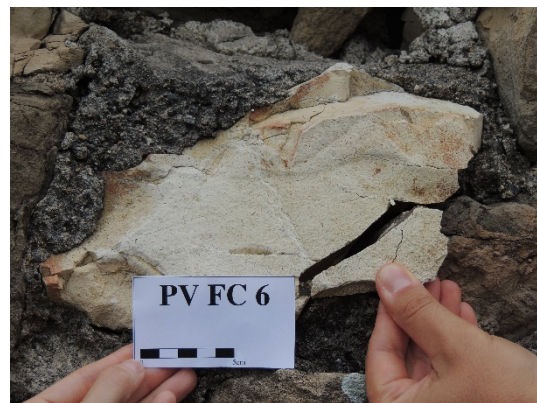
Figure 2.1.1. 15. Sampling of the creamy altered volcanic rock PV FC 6.

Concerning the creamy altered volcanic rocks they were sampled from two opposite walls: PV FC 6 from the base, near the south corner, of the Western wall (Fig. 2.1.1.15) and PV FC 9 sampled near PV FC 7 and PV FC 8, from the Eastern wall (fig. 2.1.1.16). This latter one showed deterioration phenomena as exfoliation, conchoidal fracture, due to differential erosion, and partial biological blackening.

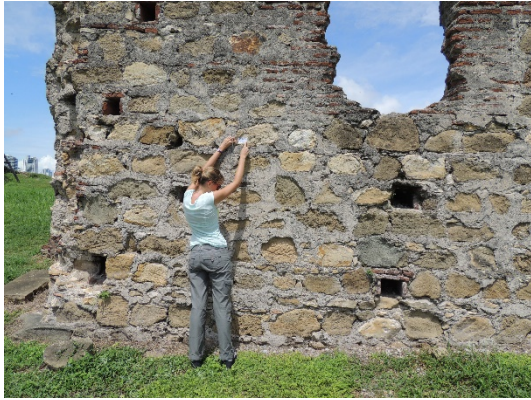
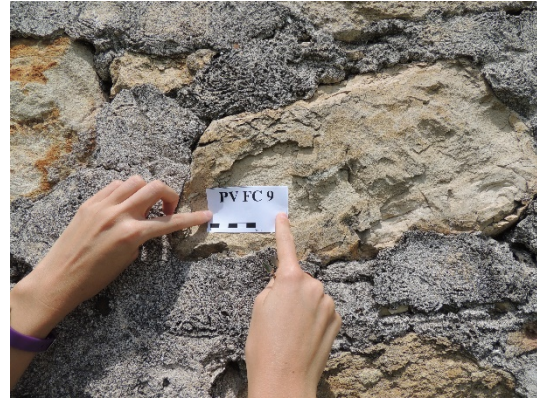
Figure 2.1.1. 16. Sampling of the creamy altered volcanic rock PV FC 9.

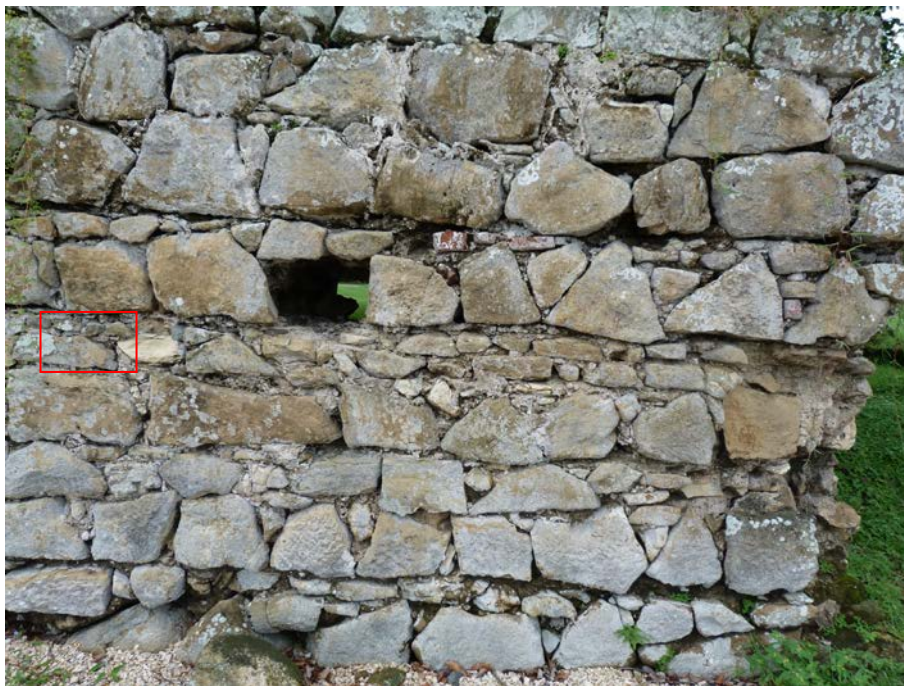
Figure 2.1.1. 17. Wall of the complex of the Hospital de San Juan de Dios, facing the old Via Cincuentenario.

Another sample of the just mentioned creamy, aphyric altered volcanic rock was collected from the wall of the Hospital de San Juan de Dios, facing the old Via Cincuentenario (Fig. 2.1.1.17). This kind of rock in this building seems to realize a horizontal line in the masonry, similar to a string course. PV SJdD sample is shown in Figure 2.1.1.18.

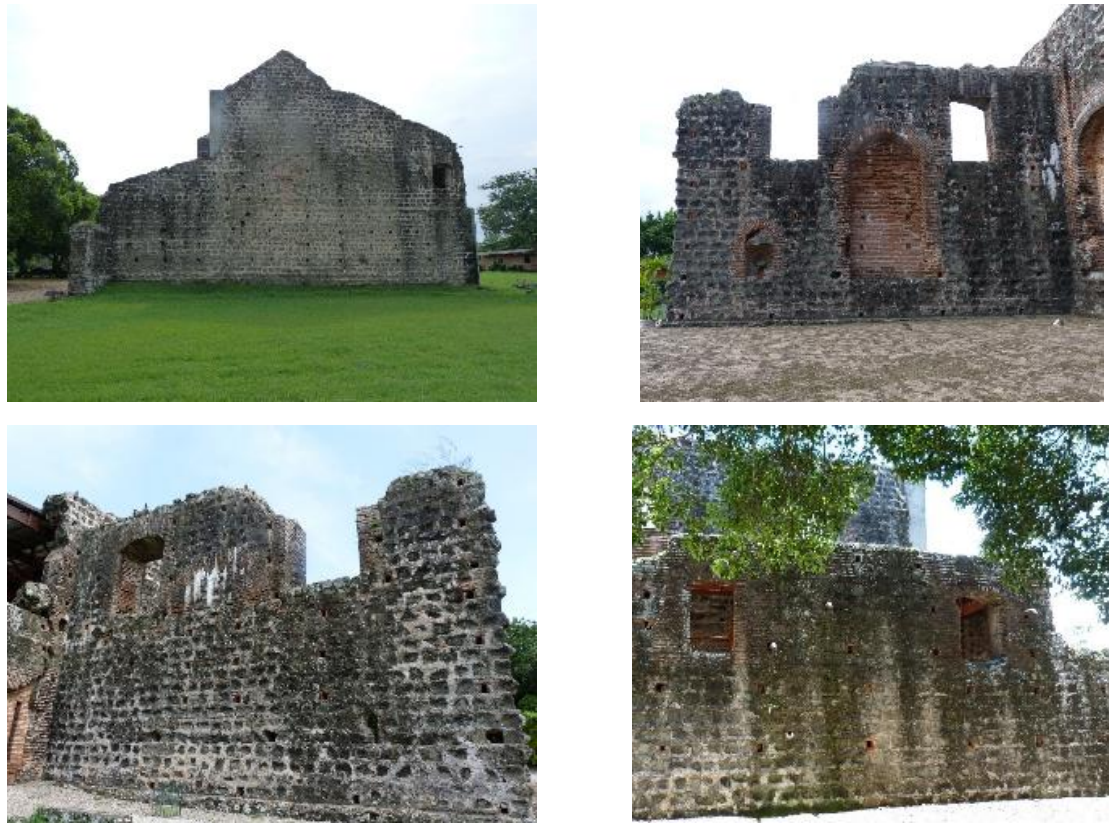
Figure 2.1.1. 19. Pictures of the Convento de las Monjas de la Concepción.

This complex is mainly composed by green and yellow breccias, as observed at Convento de San Francisco, and bricks (Fig. 2.1.1.19). Sampling points are highlighted in Figure 2.1.1.20.

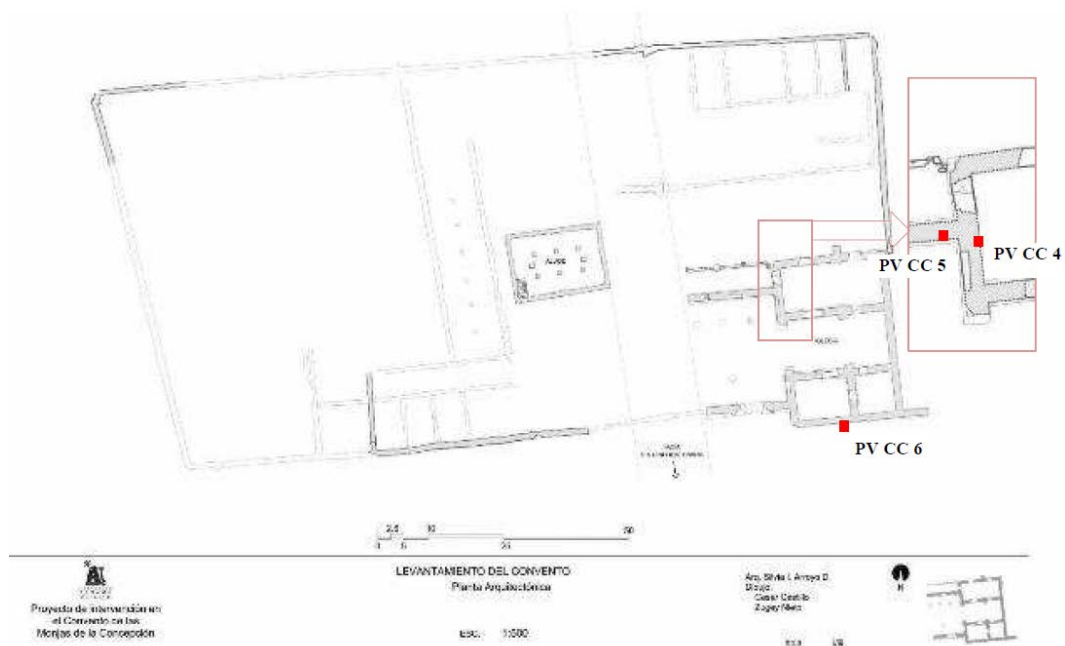
Figure 2.1.1. 20. Plan of the Convento de las Monjas de la Concepción and sampling points (Plans are Courtesy of the Patronato de Panamá Viejo).

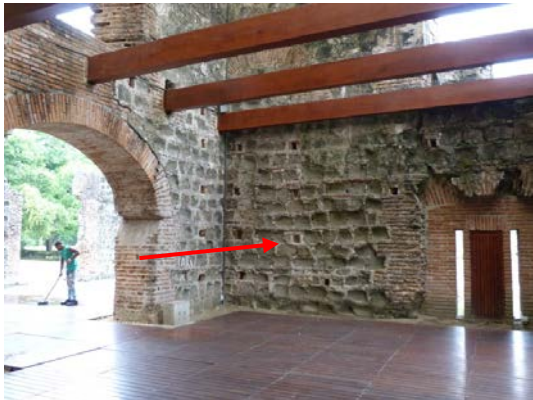
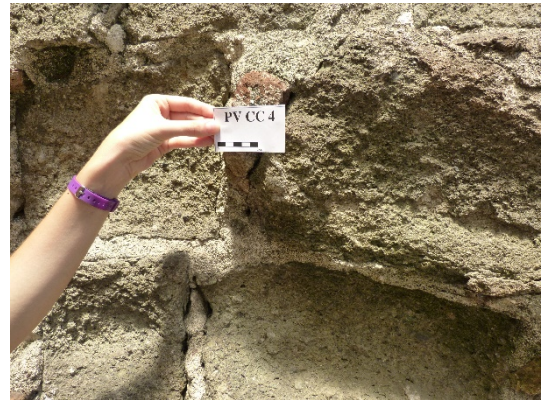
Figure 2.1.1. 21. Sampling of PV CC 4 specimen.

Three samples of breccias were collected respectively from the North side of the chapel (PV CC 4, Fig. 2.1.1.21), showing differential erosion. From the North wall of the nave, PV CC 5, showed a greenish-grey colour, presenting high decay, exfoliation phenomena and high biological growth; moreover, it was located near areas affected by water percolation (Fig. 2.1.1.22). The latter sample, PV CC 6 (Fig. 2.1.2.23), collected from the outer wall of the Church, near an eaves, faced S and exposed to the old Via Cinquantenario, has a greenish hue and it is highly altered (exfoliation and biological growth).

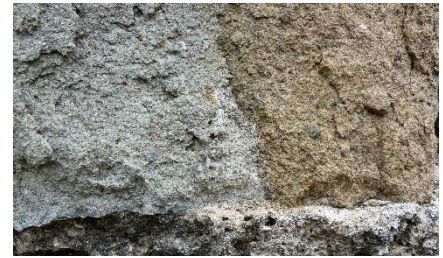
The breccia observed at this complex showed, in general, less exfoliation than the others aforementioned, on the other hand, the blackening, probably due to biological action, is still present. Moreover, in several rocks it is clearly visible the passage between the two different levels of the deposition, showing the two difference hues, the yellowish and the greyish-greenish (Fig. 2.1.1.24); nevertheless the variety mainly present is the yellow one. The sampling points are shown in Figure 2.1.1.25.

Figure 2.1.1. 24. Particular of a block of breccia, showing both greyish-greenish and yellowish colour.

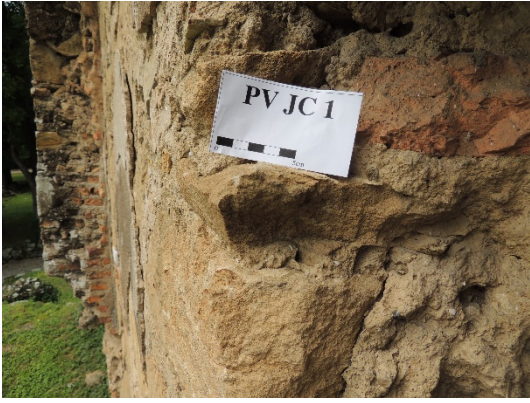
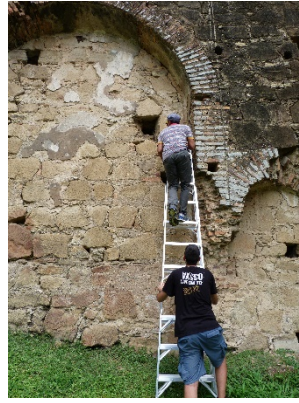
Figure 2.1.1. 26. Sampling of PV JC 1 sample.

Moreover, the surface of the rock showed stains. Regarding the PV JC 2 sample, it was collected from the same wall, and same side, but where there was blackening (Fig. 2.1.1.27).

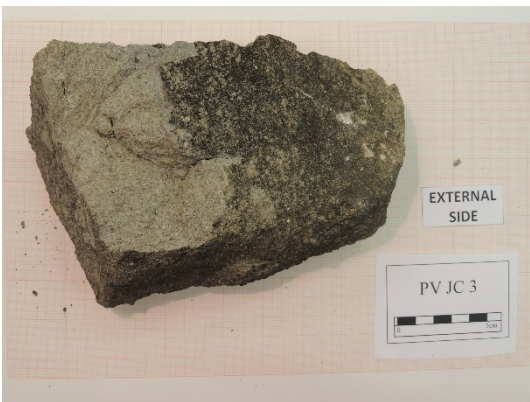
Figure 2.1.1. 28. PV JC 3 sample.

Considering PV JC 3 specimen, it was sampled from the ground, in the setting near the N façade (Fig. 2.1.1.28).

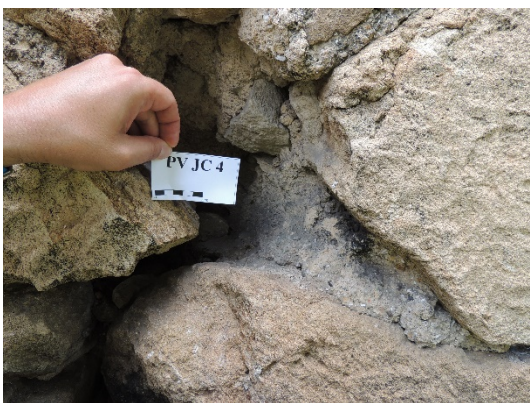
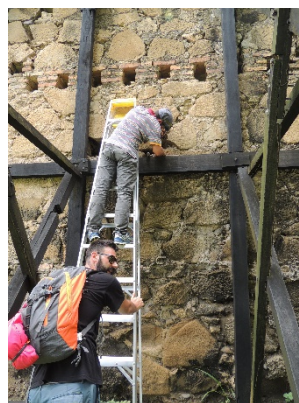
Figure 2.1.1. 29. Sampling of PV JC 4 sample.

Finally, PV JC 4 was sampled from the W wall, from the external side (Fig. 2.1.1.29).

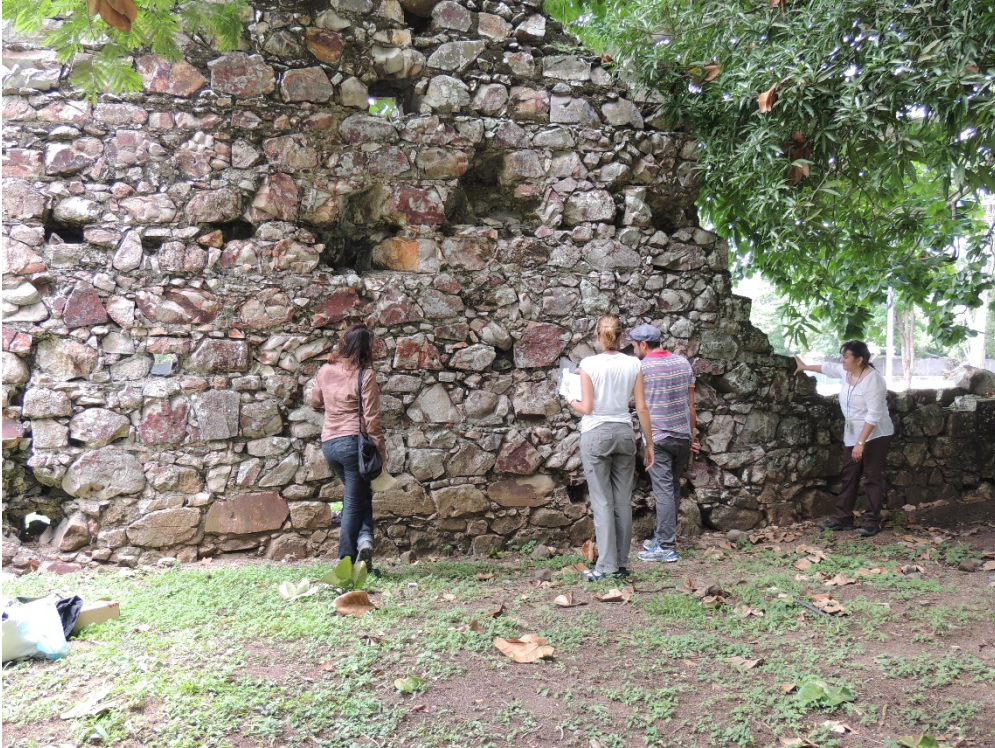
Figure 2.1.1. 30. Wall near the Casa Terrín, showing a reddish chromatic alteration.

A wall near Casa Terrín was sampled, since it is characterized by only one stone typology, observed here exclusively, that is a volcanic rock, showing aphyric texture and chromatic alteration, presenting a reddish hue (Fig 2.1.1.30). The location of the two samples collected is displayed in Figure 2.1.1.31.

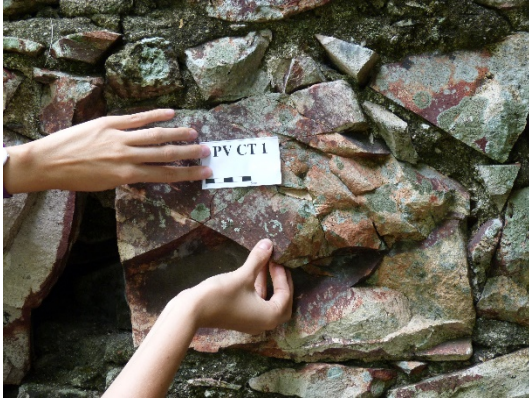
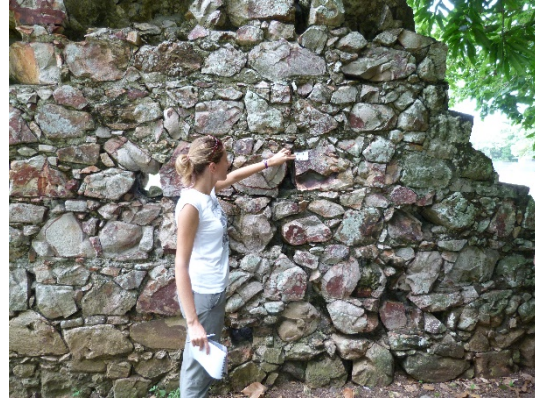
Figure 2.1.1. 32. Sampling of PV CT 1 specimen.

PV CT 1 sample was collected from the North side of the wall; it showed high chromatic alteration, also in the inner part of the rock, furthermore, on the surface there was lichens presence (Fig. 2.1.1.32)

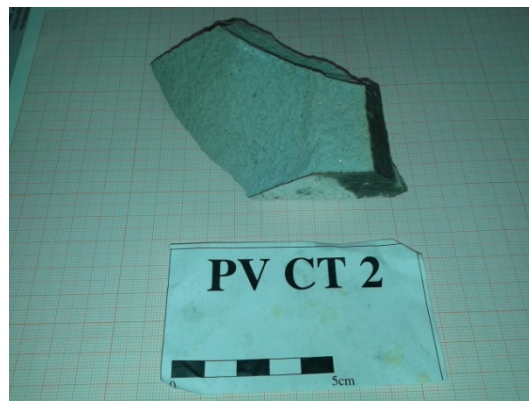
Figure 2.1.1. 33. PV CT 2 sample.

The second sample, PV CT 2, was collected from the ground near the S-E corner of the wall (Fig. 2.1.1.33). It also showed chromatic alterations, but with smaller thickness.

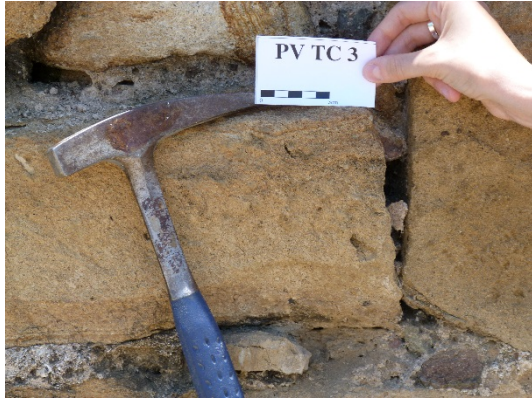
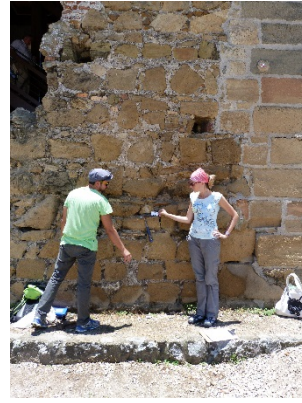
Figure 2.1.1. 35. Sampling of PV TC 3 specimen, W wall.

One sample of tuffite, showing exfoliation, was sampled from the W wall (PV TC 3, Fig. 2.1.1.34). From the Southern it was collected the second specimen (PV TC 4), showing high blackening (biological) (Fig. 2.1.1.36).

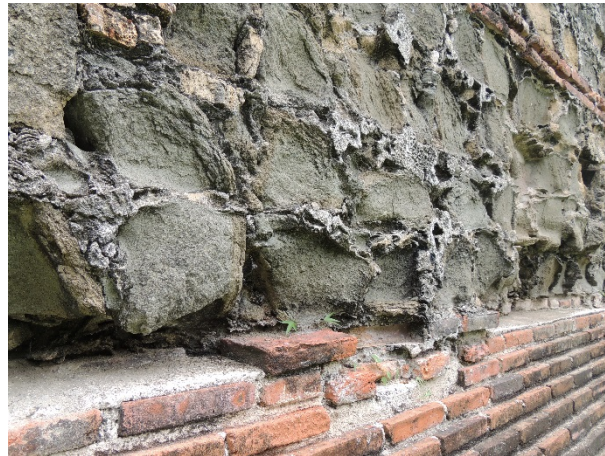
This complex was directly exposed to the sea erosion due to tidal variations, and the effects of the marine action is still clearly visible on the masonry surface (Fig. 2.1.1.37).

Figure 2.1.1. 37. Effects due to the marine erosion.

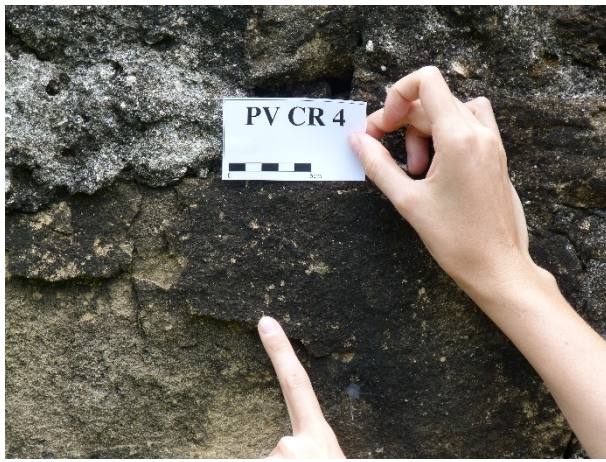
Figure 2.1.1. 39. Sampling of PV CR 4 specimen.

Specimen PV CR 4 was sampled from the Southern wall, facing the sea side and showing elevated blackening due to biodeterioration (Fig. 2.1.1.39).

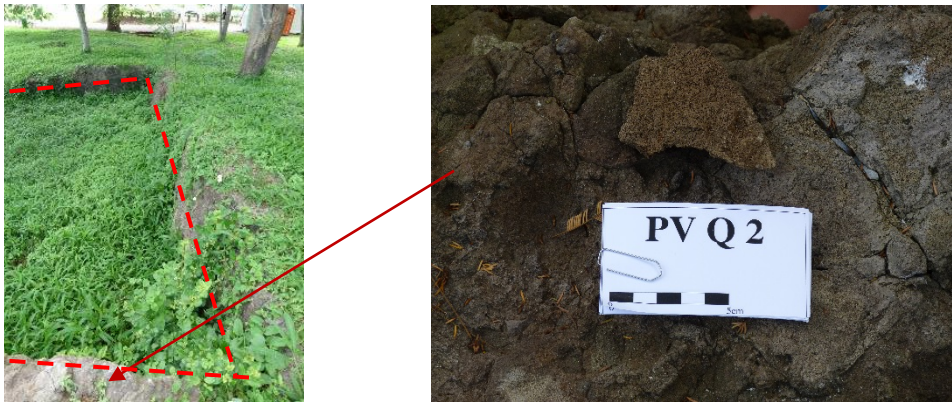
This quarry, near the Santo Domingo Convent, is obtained by an outcrop of breccia, which shows tracks of quarrying (Fig. 2.1.1.42).

Figure 2.1.1. 42. Sampling of PV Q 2 specimen. On the left image, with a red dotted line the tracks of quarrying are highlighted.

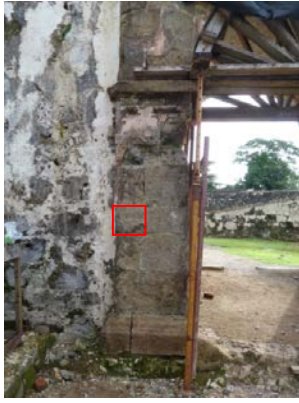
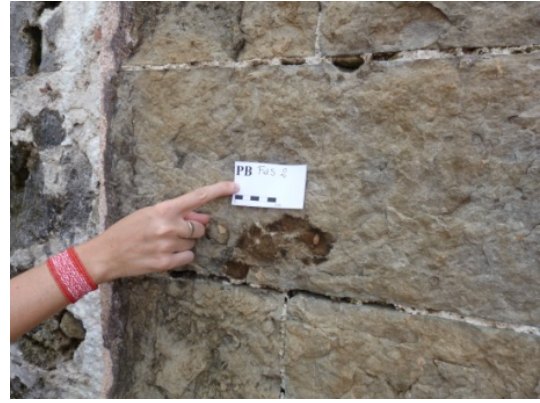
Figure 2.1.2. 7. Sampling of PB FdS 2 specimen.

Three samples of yellowish sandstone were collected respectively at: the column on the left of the arch of the external part of the *Camera de la inspeccion* (PB FdS 2, Fig. 2.1.2.7); the S-E corner of the wall of the internal part of the banquette, so exposed to South (PB FdS 5, Fig. 2.1.2.8); from the external western corner of the banquette, near the sea shore (PB FdS 9, Fig. 2.1.2.9). Generally, this kind of stone has been observed utilized in the corners in this Fort. Moreover, it has to be underlined the W internal wall is the most affected by the biodeterioration phenomenon.

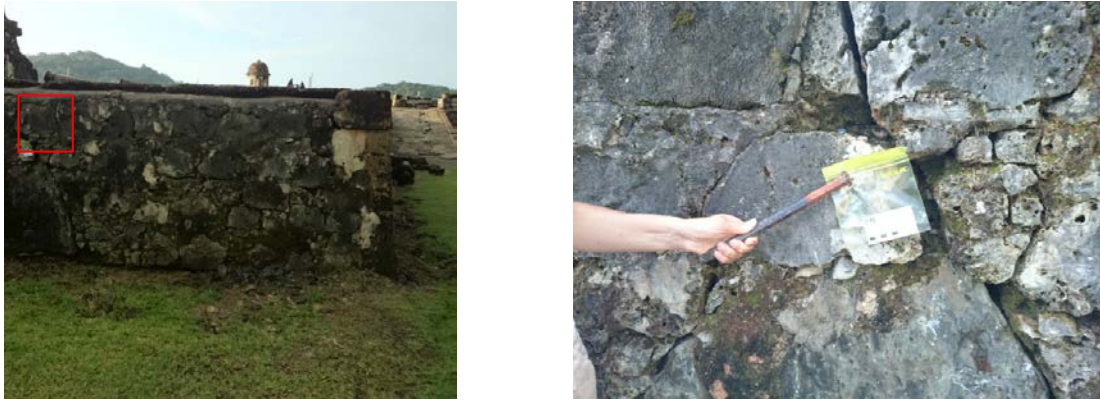
Figure 2.1.2. 10. Sampling of PB FdS 5 specimen.

Furthermore, two samples of coral limestone were collected respectively one at the S-E corner of the wall of the internal part of the banquette, so near to the PB FdS 5 sample (Fig. 2.1.2.10); while the other one was sampled near the external northern side wall of the Fort, facing the sea (PB FdS 8 sample, Fig. 2.1.2.11). This kind of rock showed a grey colour when exposed, probably due to a biological patina, while the inner part resulted with an ivory hue.

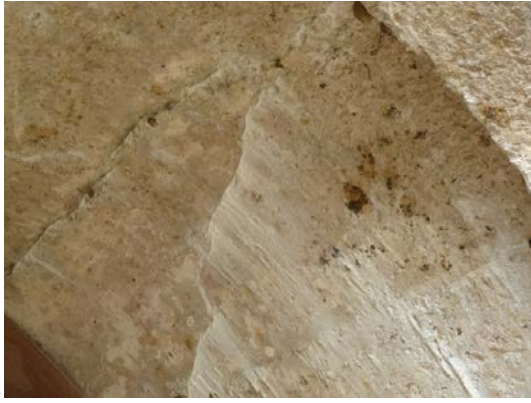
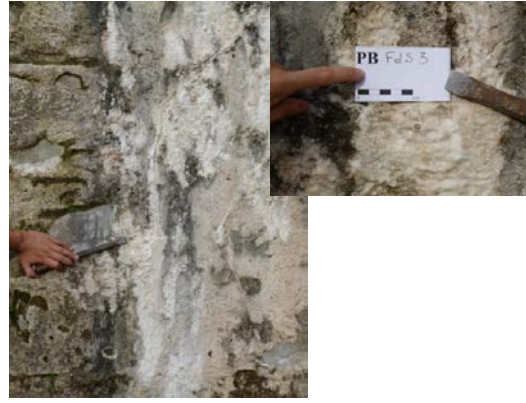
At the entrance of the Fort, at the *Camera de la inspeccion*, the masonry resulted affected by several salts efflorescences and encrustations, even in the vault (Fig. 2.1.2.13a). A sample of salt encrustation was collected at the internal side of the *Camera de la inspeccion*, moreover, it was noticed a whitish plaster under the salt layers (PB FdS 5, Fig. 2.1.2.13b).

Figure 2.1.2. 13. a. Salts efflorescences and encrustations in the vault of the *Camera de la inspeccion*; b. Sampling of PB FdS 5, specimen of salt encrustations.

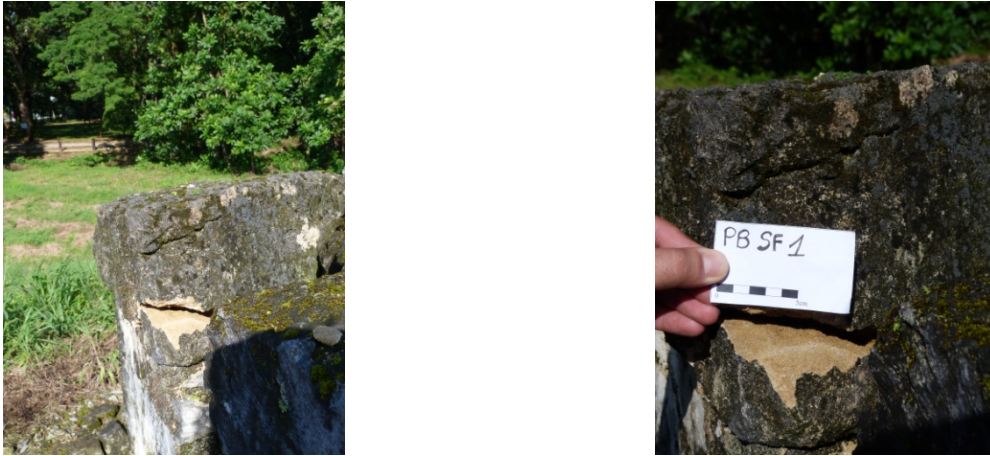
Figure 2.1.2. 16. Sampling of PB SF 1 specimen.

In particular, at the Lower Battery, a specimen of grainstone/packstone was sampled from the N-W wall, at the right corner of the mouth of the 2<sup>nd</sup> embrasure (counted from the N side). It showed a plaster covering and a high decay (Fig. 2.1.2.16).

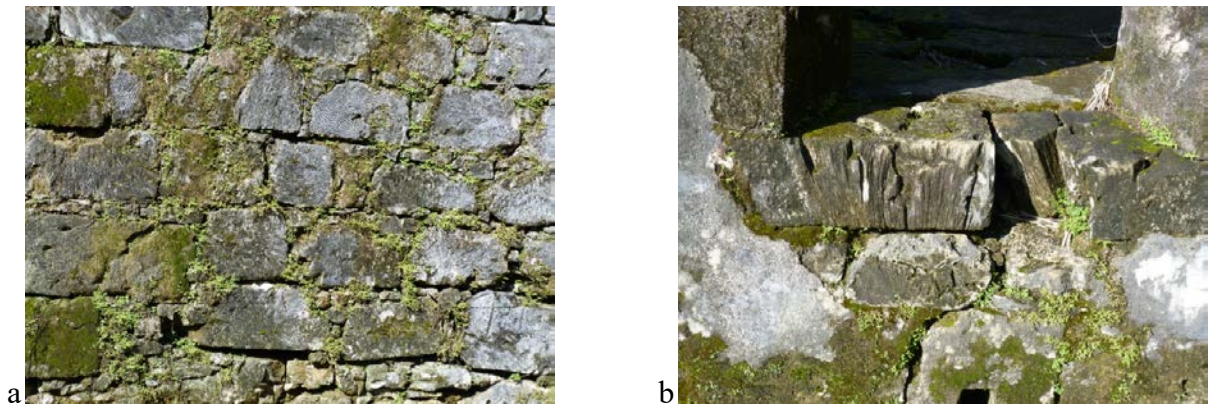
Figure 2.1.2. 17. Coral limestone utilized in the masonry: a. in a wall; b. in the neck soles of the embrasures.

Moreover, coral limestones are utilized in the masonry, in particular in specific zones like cheeks and the neck soles of the embrasures (Fig.2.1.2.17); in addition, it was observed at the Fort entrance, specifically in the centreline of the pavement (Fig. 2.1.2.18). Indeed, a sample of this boundstone, PB SF 2, was collected at the 2<sup>nd</sup> embrasure, left cheek (facing West) (Fig. 2.1.2.19). As observed in the previous fort, this stone shown an outer greyish hue, probably due to a biological patina.

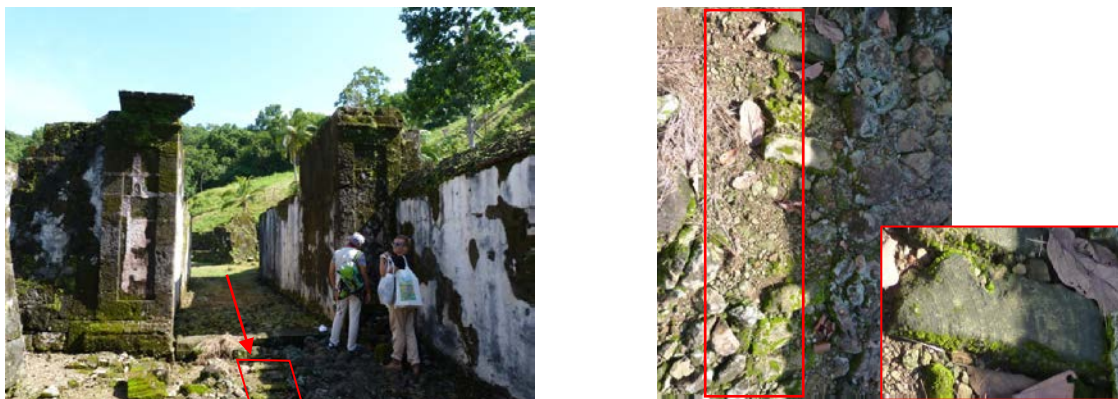
Figure 2.1.2. 18. Coral limestone utilized at the Fort entrance in the centreline of the pavement pavements.

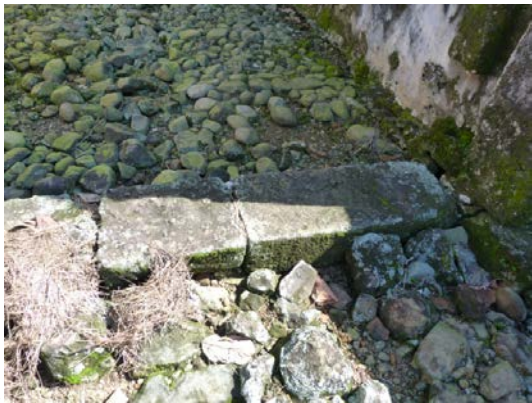
Finally, two volcanic rock, attributable to basaltic andesites, utilized in the pavements of the Lower Battery were collected on the upper part of the ramp, PB SF ramp sample (Fig. 2.1.2.20) and at the entrance of the Fort, PB SF 6 sample (Fig. 2.1.2.21).

Figure 2.1.2. 20. a. Basaltic andesite utilized in the pavement at the Fort Entrance; b. Sampling of PB SF ramp specimen.

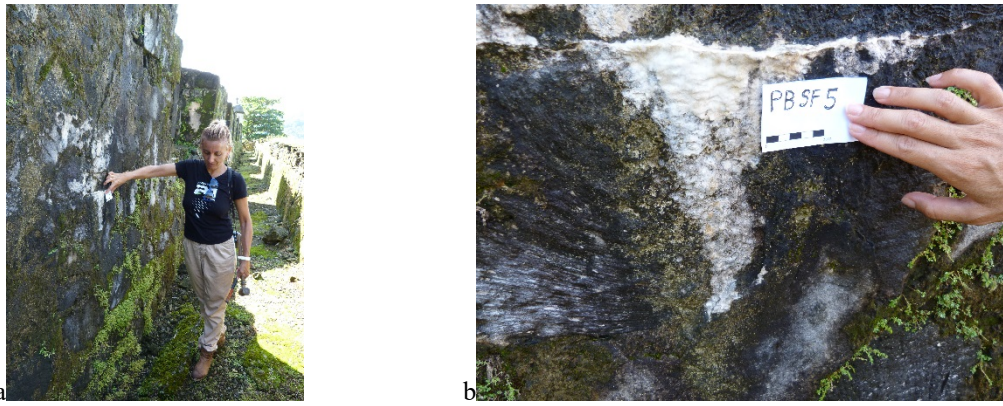
Figure 2.1.2. 22. a. View of the inner part of the moat, particular of the salt encrustations; b. Sampling of PB SF 5 specimen.

Moreover, salt encrustations were present in the internal wall of the moat, in particular a sample of them was collected from the inner west wall of it, PB SF 5 sample (Fig. 2.1.2.22).

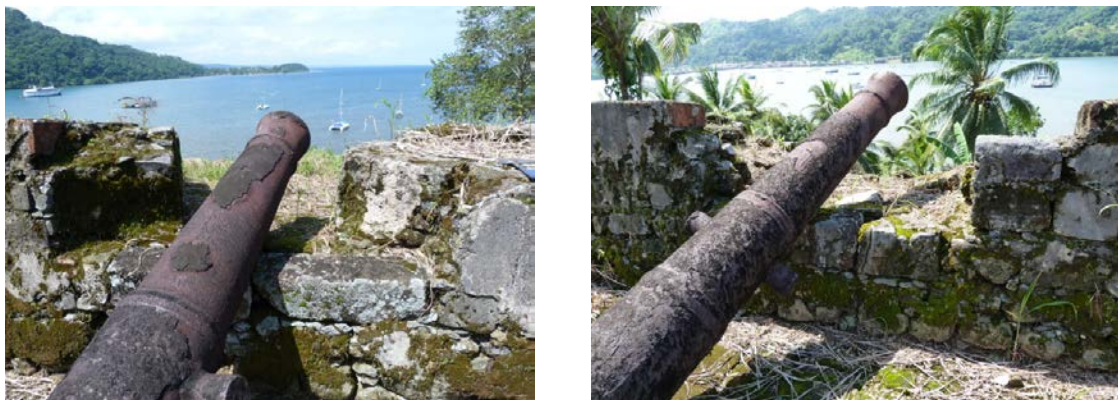
The same rock typology of the latter samples was observed also in the Upper Battery (Fig. 2.1.23), utilized in the masonry, especially in the sole of the embrasures (Fig. 2.1.2.24). It was sampled in the N-E masonry of the area called "*Nave para artillería y para la guardia*", PB SF 7, showing oxidation and high hardness (Fig. 2.1.2.25).

Figure 2.1.2. 24. Examples of volcanic rock utilized in the sole of the embrasures neck.

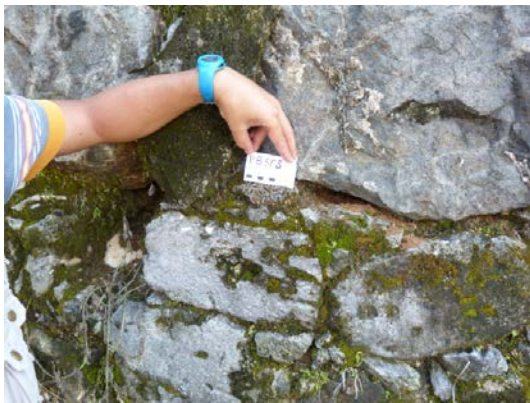
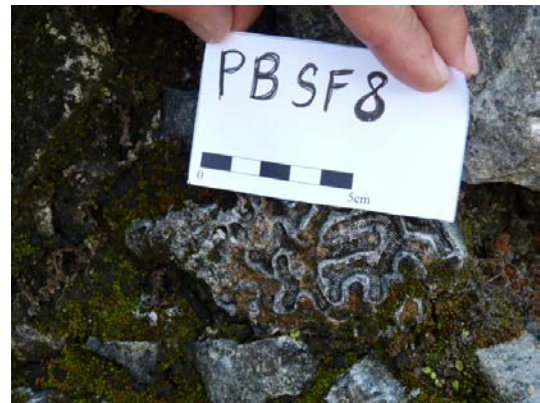
Figure 2.1.2. 26. Sampling of PB SF 8 specimen.

In the same masonry of the previous sample, next to it a coral limestone was collected (PB SF 8, Fig. 2.1.2.26). It is different from the species of the other one, which is the most diffused. Nevertheless, as the other one it showed a greyish external colour, but the inner part show the natural ivory hue.

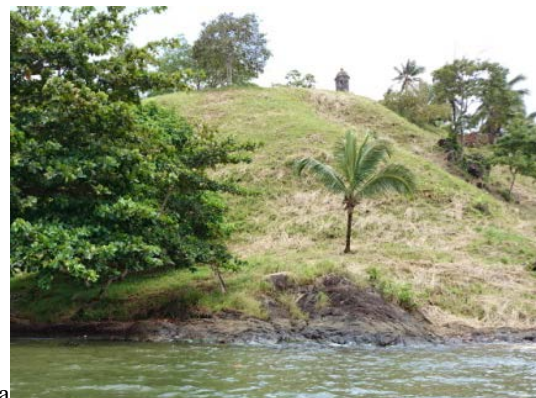
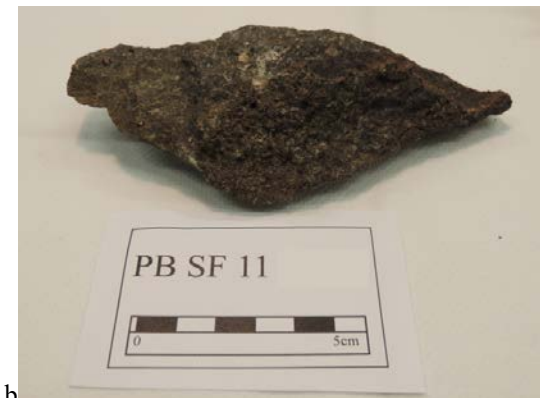
Near the entrance of the Fort, on the East part, just near the sea side, was discovered an outcrop of volcanic rock ascribable to basaltic andesite, possible quarry of raw materials utilized in the different part of the fortification (Fig. 2.1.2.27). Indeed, this complex is the only Fort of Portobelo, which presents this kind of rock utilized in the masonry.

Figure 2.1.2. 27. a. Outcrop of basaltic andesite; b. PB SF 11 sample.

Igneous rocks were observed at *Fuerte San Fernando*. In particular, in the samples belonging to the masonries of the Upper Battery PB SF 6 and PB SF 7 and PB SF 11 sample, belonging to the outcrop present next to the entrance of the Lower Battery. PLM observations carried out on the three samples, revealed mainly plagioclases, often in sericitization, followed by pyroxenes as phenocrysts and amygdales filled with zeolites (Figs. 3.1.2.43-48). In addition, metals (e.g. iron) oxides are also present. Furthermore, PB SF 7 sample clearly shows the presence of a fluid circulation (Fig. 3.1.2.44).

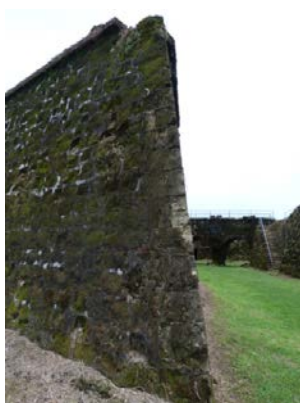
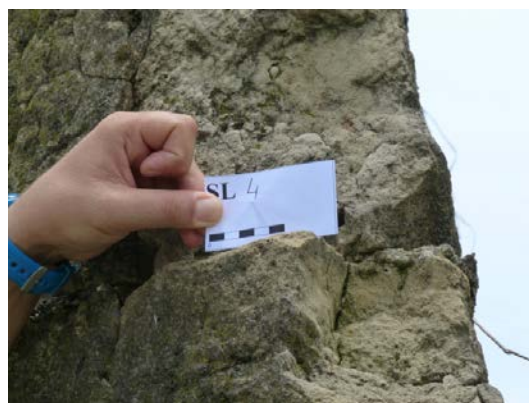
Figure 2.1.3. 3. Sampling of SL 4 specimen.

The Fort masonries are mainly formed by a tuffite/sandstone sampled in several parts of the fortification. Specifically, SL 4 sample was collected at the South corner of the bastion (quoins) (Fig. 2.1.3.3). SL 6 specimen was always sampled from a corner of the exterior part of the terreplain, at the moat side (Fig. 2.1.3.4). SL 9 sample was collected from the wall of the inner part of the bastion, between the 2<sup>nd</sup> and the 3<sup>rd</sup> opening-vault, moreover, it showed a partial jointing mortar and probably a finishing mortar (Fig. 2.1.3.5). They all show high decohesion and fracturing, covered by a black biological patina.

SL 4 sample is a tuffite with a silicate component mainly due to quartz and plagioclase grains and basalt/andesite fragments; in addition, bioclasts as bryozoan and foraminifera have been identified (Figs.3.1.2.19-20). Several bioclasts are filled with silicate minerals.

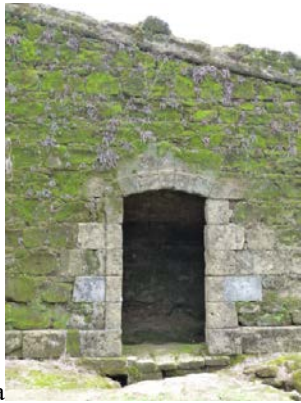
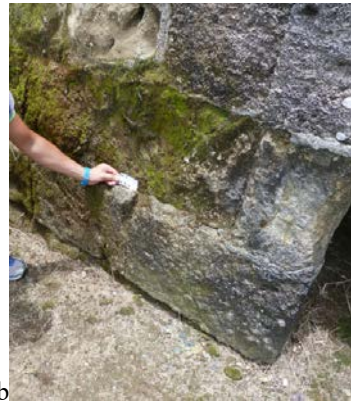
In the inner part of the bastion, blocks of grainstone compose parts showing bossage, forming the ornamental parts of the portal and the base blocks (Fig. 2.1.3.6a). In particular, this latter part was sampled, near the third opening-vault, SL 8 sample (Fig. 2.1.3.6b). This kind of rock shows high hardness, indeed it results better preserved than the previous one, in particular, showing less superficial biological colonization.

Figure 2.1.3. 6. a. Grainstone forming the ornamental parts of the portal and the base blocks; b. Sampling of SL 8 specimen.

Grainstone and Packstone (Dunham, 1962) have been detected at Fuerte San Lorenzo and Fuerte San Fernando. In particular, at Fuerte San Lorenzo in SL 8 sample, belonging to the masonry. It is a grainstone, showing also a packstone part, with bryozoans, echinoderms, bivalves and plankton foraminifera (Fig.3.1.2.37). Rich in manganese oxides and presenting high intragranular and intergranular porosity. Volcanic ejecta are also identified (Fig.3.1.2.38).

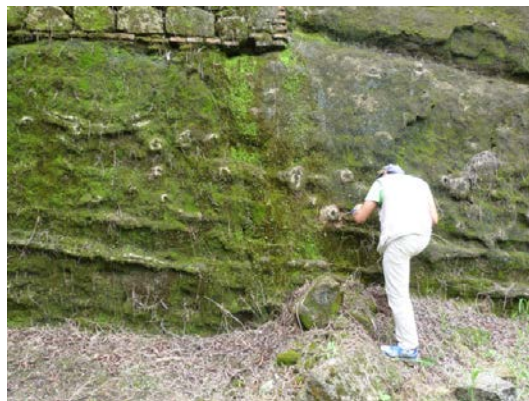
Two outcrops were sampled at Fort San Lorenzo, one at the site, collected from the bastion foundation (Fig. 2.1.3.7), formed by sandstone/tuffite SL 1 and SL 2 samples (Fig. 2.1.3.8). They show high decohesion and differential erosion, however, SL 1 showed more cohesion than SL 2 sample.

Figure 2.1.3. 7. Outcrop of sandstone/tuffite forming the bastion foundation.

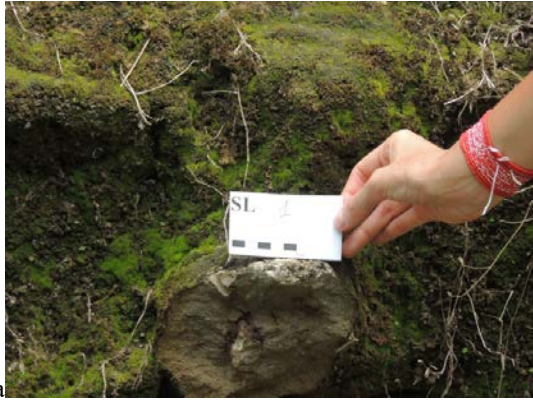
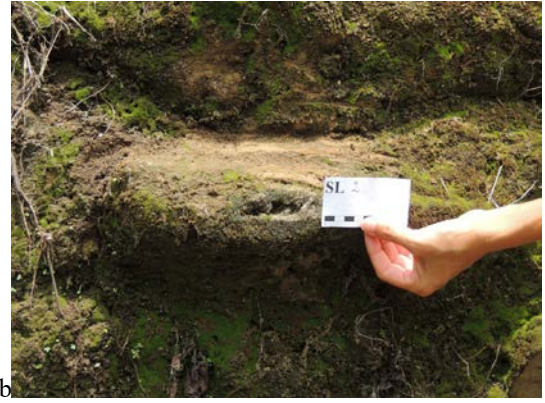
Figure 2.1.3. 8. a. Sampling of SL 1 specimen; b. Sampling of SL 2 specimen.

While samples belonging to *Fuerte San Lorenzo* present a sandstone grain-size distribution. Moreover, SL 1 sample was formed by an external and an internal part, this latter one showing higher hardness. In particular, SL 1 sample (external part) shows angular grains of quartz, plagioclase, and several bioclasts, as foraminifera (Fig. 3.1.2.13). Within several of them, it is noticeable the presence of metal oxides, probably ascribable to sulphurs (Fig. 3.1.2.14). In addition, there is the presence of volcanic clasts and glass, showing angular shapes.

SL 2 sample is similar to the previous ones, also presenting volcanic ash with diffused cracks (Fig.3.1.2.17), but having a coarser aggregate and numerous bioclasts filled with sulphurs and metal oxides (Figs. 3.1.2.18). It also show a better preservation state than the previously observed.
