# Università degli Studi di Ferrara

DOTTORATO DI RICERCA IN  
"SCIENZE DELLA TERRA"

ENVIRONMENTAL IMPACT ON UNESCO  
HERITAGE SITES IN PANAMA

Anni 2014/2016

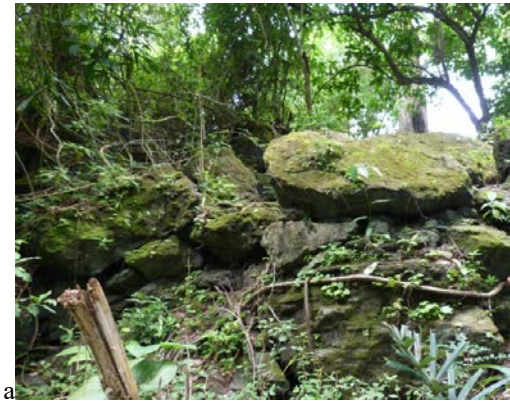
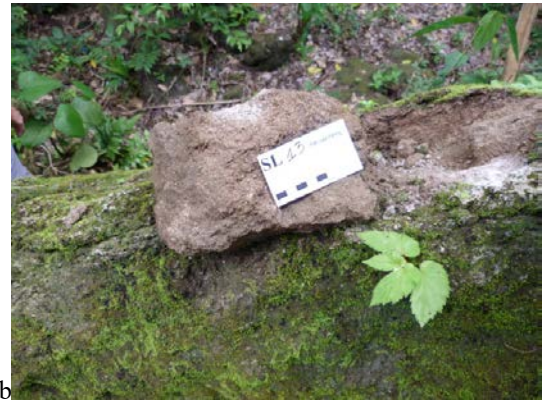
Finally, another outcrop was indicated by the personnel of Portobelo and San Lorenzo Patronage distant 5 km from the Fort and 1 km from the entrance in the San Lorenzo area (Fig. 2.1.3.9a). It was an outcrop of grainstone, thus sampled (SL 13 sample, Fig. 2.1.3.9b).

Figure 2.1.3. 9. a. Outcrop of grainstone; b. sampling of SL 13 specimen.

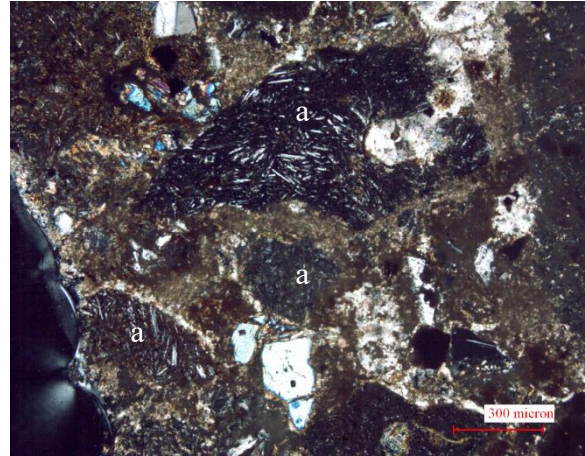
Figure 3.1.1. 2. Photomicrograph of PV CC 4 breccia sample (xpl, 10x). a. Basalt/andesite fragments.

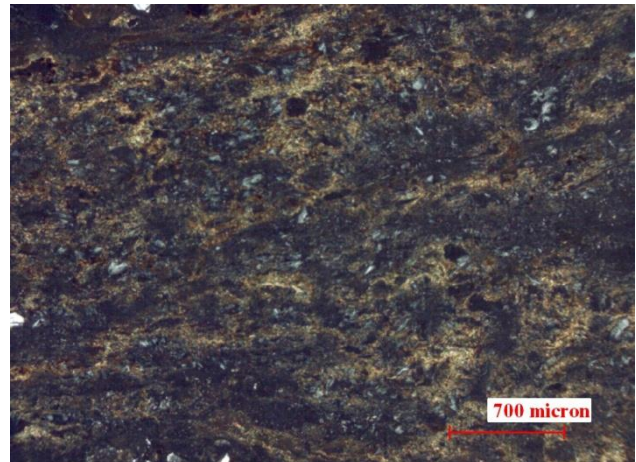
Figure 3.1.1. 12. Photomicrograph of PV FC 4 breccia sample (xpl, 4x) showing diffused zeolitization.

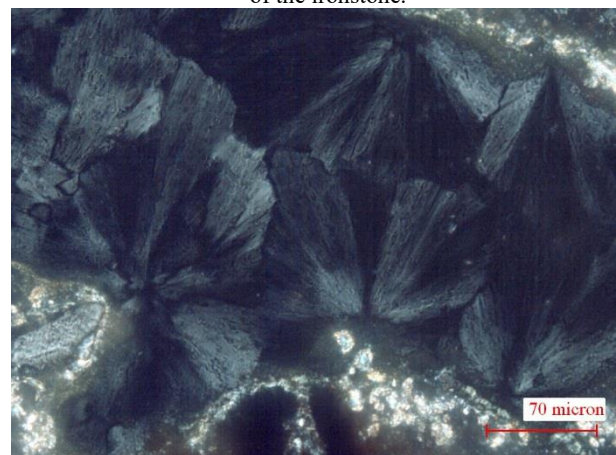
In addition, in PV FC 11 fragments of chert (Fig.3.1.1.13) and ironstone were detected; the latter one shown an alteration state (Figs. 3.1.1.14-3.1.1.15); moreover amygdales filled with zeolites have been observed (Figs. 3.1.1.15-3.1.1.16) .

Figure 3.1.1. 16. Photomicrograph of PV FC 11 breccia sample (xpl, 40x), particular of zeolites filling an amygdale.

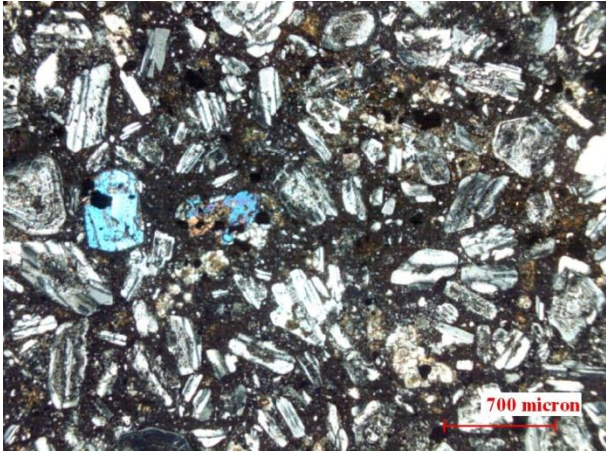
In addition, basaltic andesite have been identified at two outcrops, one near *Casas Reales*, PV vic. CR sample, and the other one near the *Convento de Santo Domingo*, PV Q 2. They show an aspect similar to the previously observed ones, with the presence of zoned plagioclase (Figs. 3.1.1.31-32) and several amygdales, traces of hydrothermal activity.

Figure 3.1.1. 31. Photomicrograph of PV vic. CR basaltic andesite sample (xpl, 4x). Presence of zoned plagioclase.

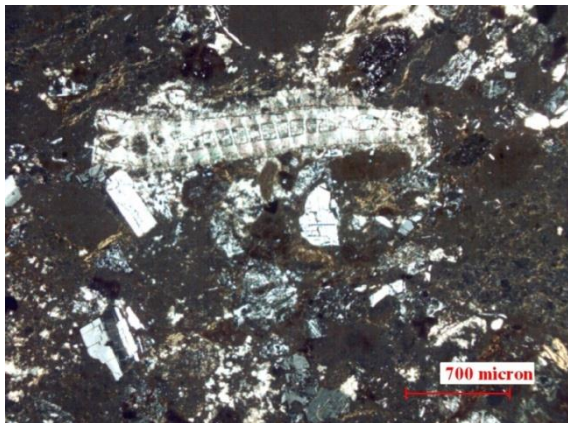
Considering the masonry of the *Torre de la Catedral*, tuffite was observed. In samples PV TC 3 and PV TC 4, presence of quartz, pomiceous/glass fragments, and also a great amount of different fossils (Fig.3.1.1.33), as foraminifera and echinoderms have been detected. It can be presumed that the rock underwent hydrothermal activity, demonstrated by the presence of zoned plagioclase and zeolitized areas (Fig.3.1.1.34).

Figure 3.1.1. 33. Photomicrograph of PV TC 4 tuffite sample (xpl, 4x), particular of foraminifera fossil.

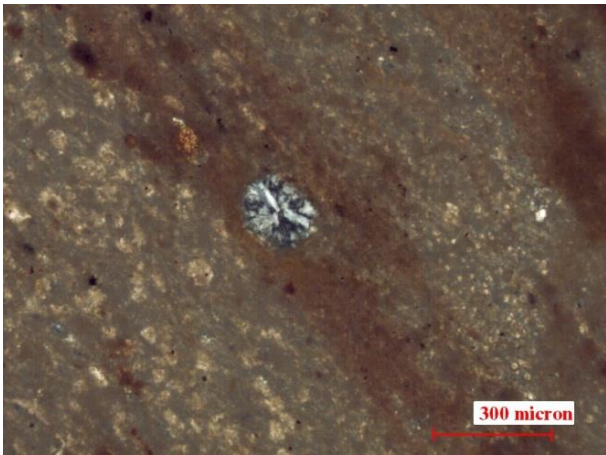
Samples PV FC 6 and PV FC 9 are altered volcanic rock, showing reddish areas due to iron oxides (Fig. 3.1.1.35). PV FC 6 present also two superficial layers: the inner one whitish and the external one, which exhibits a reddish hue, composed by iron oxides (Figs. 3.1.1.36-38). Although PV FC 9 present a coarser part ascribable to a superficial mortar layer (Fig. 3.1.1.39).

Figure 3.1.1. 35. Photomicrograph of PV FC 9 altered volcanic rock sample (xpl, 10x). Clearly evident a chalcedony crystal surrounded by iron oxides.

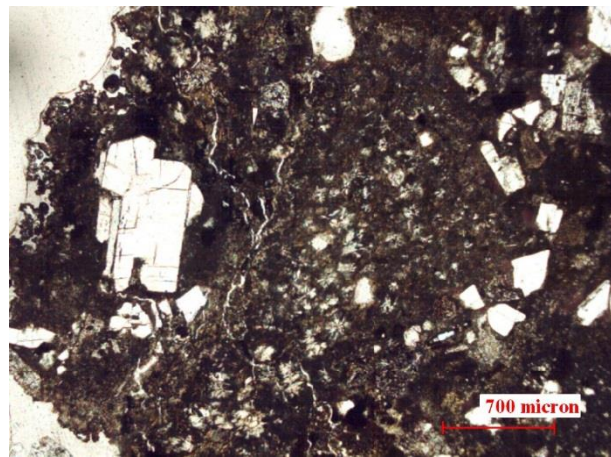
Figure 3.1.1. 47. Photomicrograph of PV TC 4 tuffite sample (ppl, 4x). Cracks presence in proximity of a zeolitized area.

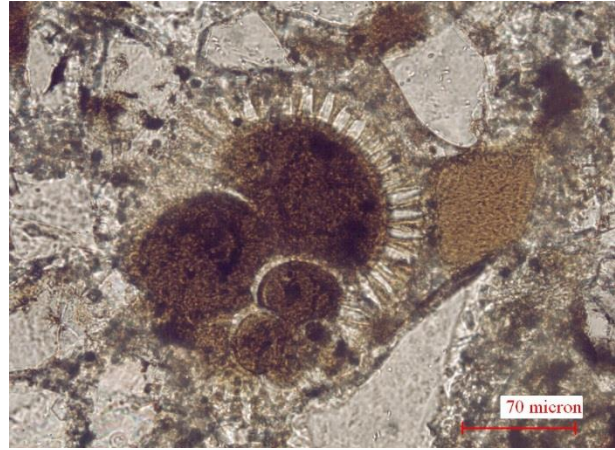
Figure 3.1.2. 2. Photomicrograph of PB SFJ 4 sandstone sample (ppl, 40x). Particular of globigerina filled by metal oxides.

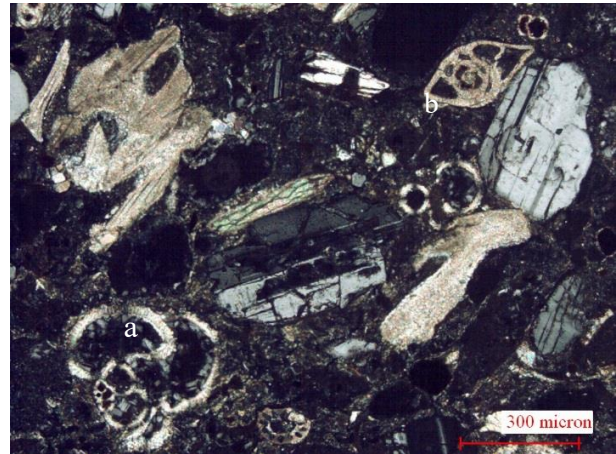
Figure 3.1.2. 12. Photomicrograph of PB FdS 10 tuffite sample (xpl, 10x), particular of the cineritic matrix and the bioclasts (a. globigerina; b. amphistegina).

Tuffites showing granulometry between sandstone until grainstone has been observed at *Fuerte de Santiago*, in PB FdS 10 sample, and also at *Fuerte San Lorenzo*, in SL 1, SL 2, SL 4, SL 6 and SL 9 samples.

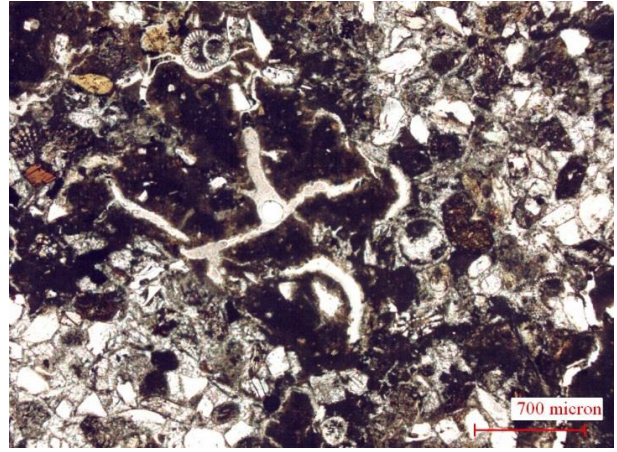
Figure 3.1.2. 16. Photomicrograph of SL 1 sandstone/tuffite sample (internal part) (ppl, 4x). Volcanic ash showing cracks.

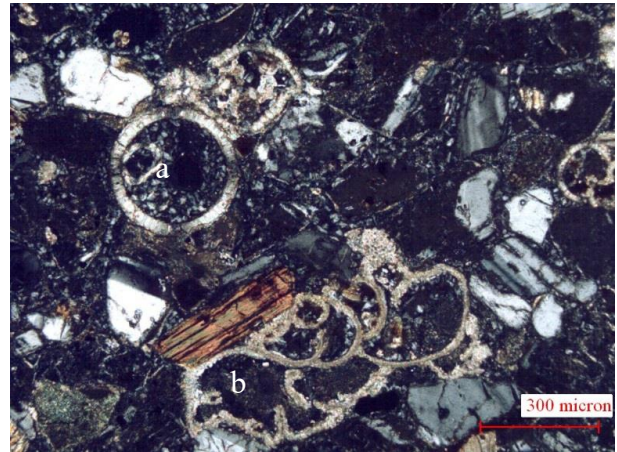
SL 2 sample is similar to the previous ones, also presenting volcanic ash with diffused cracks (Fig.3.1.2.17), but having a coarser aggregate and numerous bioclasts filled with sulphurs and metal oxides (Figs. 3.1.2.18). It also show a better preservation state than the previously observed.

Figure 3.1.2. 18. Photomicrograph of SL 2 sandstone/tuffite sample (xpl, 10x). Particular of the bioclasts present in the sample (a. brachiopod spine; b. gastropod) filled with silicates.

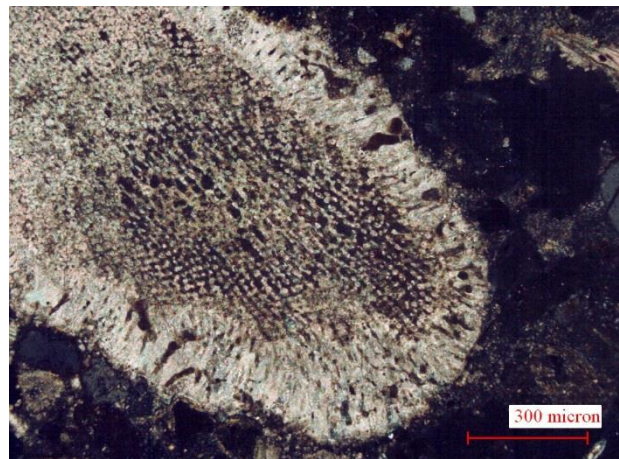
Figure 3.1.2. 22. Photomicrograph of SL 6 tuffite sample (xpl, 10x). Particular of a coral showing a re-crystallization of calcite on the external part.

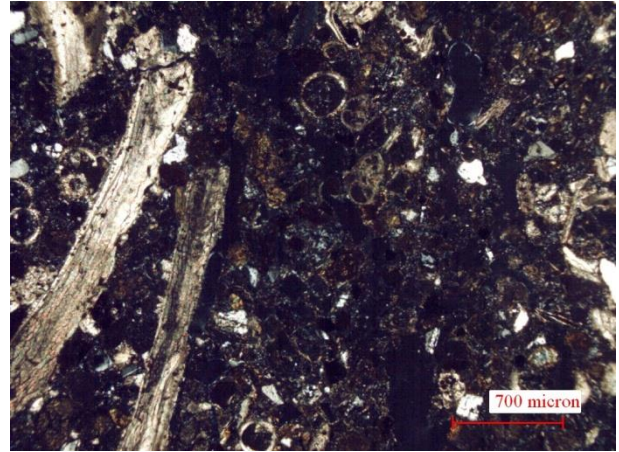
Figure 3.1.2. 24. Photomicrograph of SL 9 tuffite sample (xpl, 4x). Different granulometry between the bioclasts and the volcanic part.

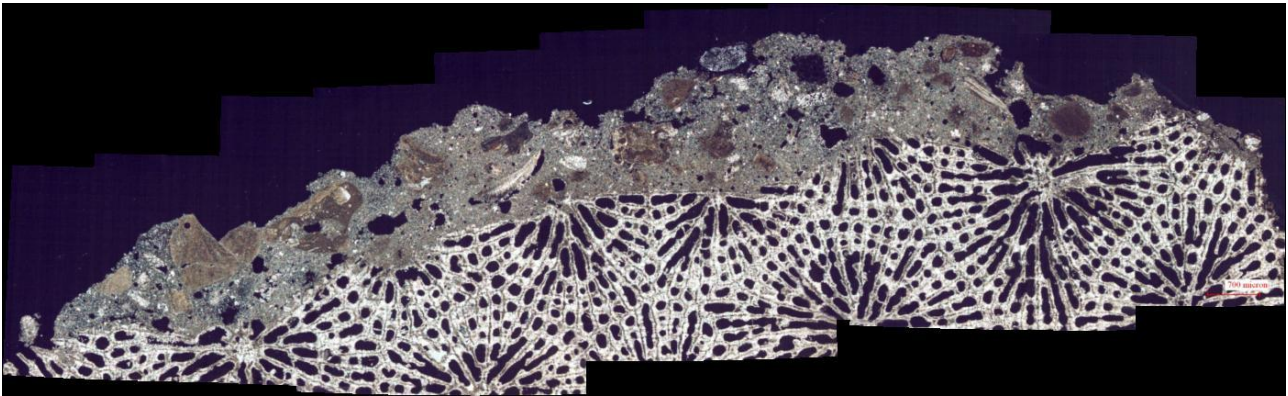
Figure 3.1.2. 28. Photomicrograph of PB FSJ 7 coral boundstone sample (xpl, 4x). Particular of the structure and the mortar layer.

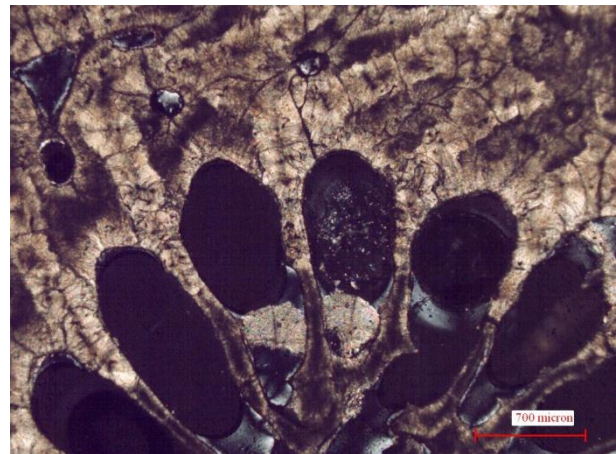
Figure 3.1.2. 34. Photomicrograph of PB SF 8 coral boundstone sample (xpl, 4x). Particular of calcite crystallization within the pores.

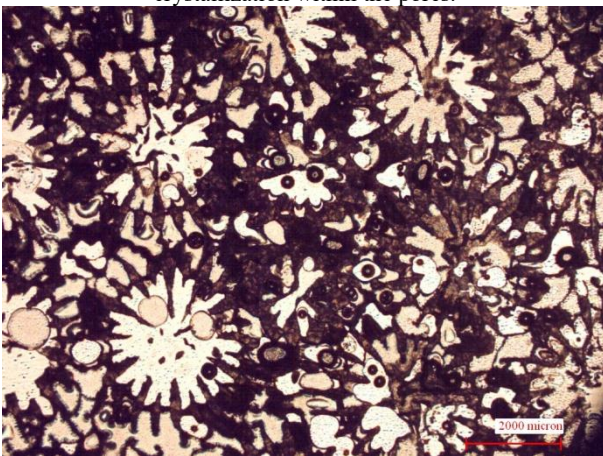
Figure 3.1.2. 35. Photomicrograph of PB SF 2 coral boundstone sample (xpl, 4x). Particular of the porosity.

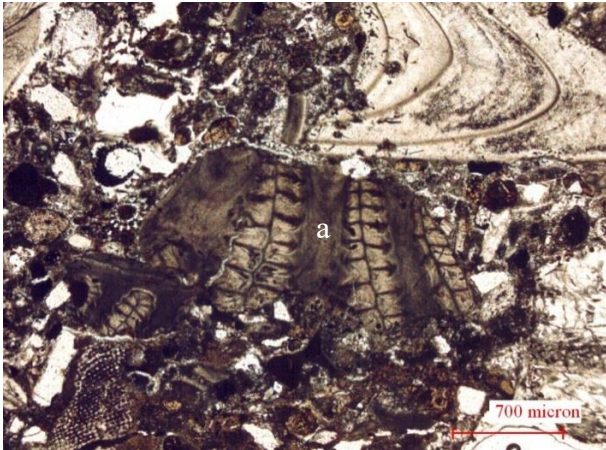
Grainstone and Packstone (Dunham, 1962) have been detected at Fuerte San Lorenzo and Fuerte San Fernando. In particular, at Fuerte San Lorenzo in SL 8 sample, belonging to the masonry. It is a grainstone, showing also a packstone part, with bryozoans, echinoderms, bivalves and plankton foraminifera (Fig.3.1.2.37). Rich in manganese oxides and presenting high intragranular and intergranular porosity. Volcanic ejecta are also identified (Fig.3.1.2.38).

Figure 3.1.2. 37. Photomicrograph of SL 8 grainstone sample (ppl, 4x). a. Bryozoan fragment.

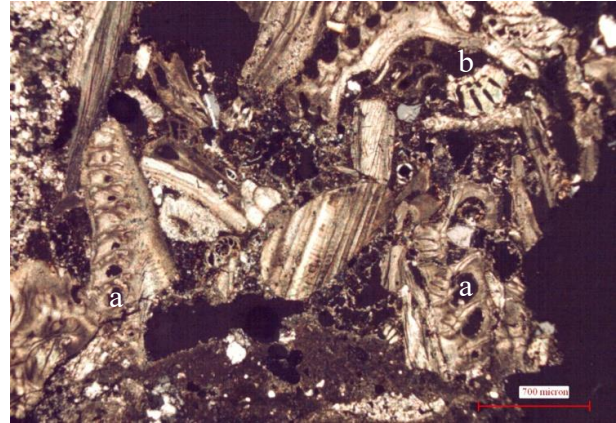
Finally, considering PB SF 1 sample, belonging to the masonry of *Fuerte San Fernando*, it shows a texture from grainstone to packstone, mainly characterized by bryozoans, bivalves echinoids, rare coral fragments and planktonic foraminifera (Figs. 3.1.2.41-42). Several manganese oxides are present and diffused porosity was observed, both intragranular and itergranular.

Figure 3.1.2. 42. Photomicrograph of PB SF 1 grainstone/packstone sample (xpl, 4x), particular of the grainstone part. a. Bryozoans; b. Echinoids.

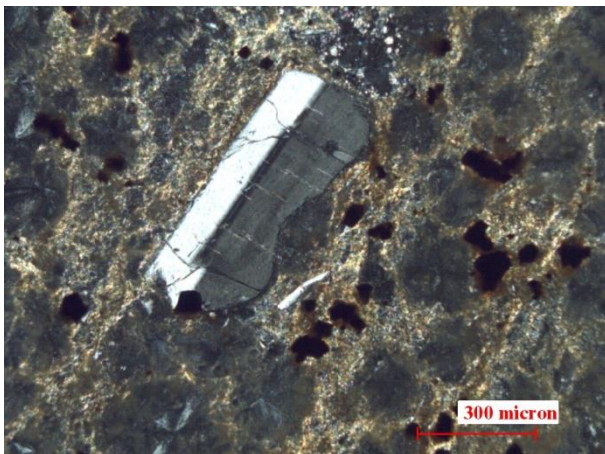
Analyses on the first one, PV FN 1 sample, have been carried out on the following points, firstly on a zeolitized part, highlighted in Figures 3.3.1.1-3.

Figure 3.3.1. 1. PLM photomicrograph of PV FN1 sample (xpl, 4x). Plagioclase crystal surrounded by zeolites; presence of brownish iron oxides.

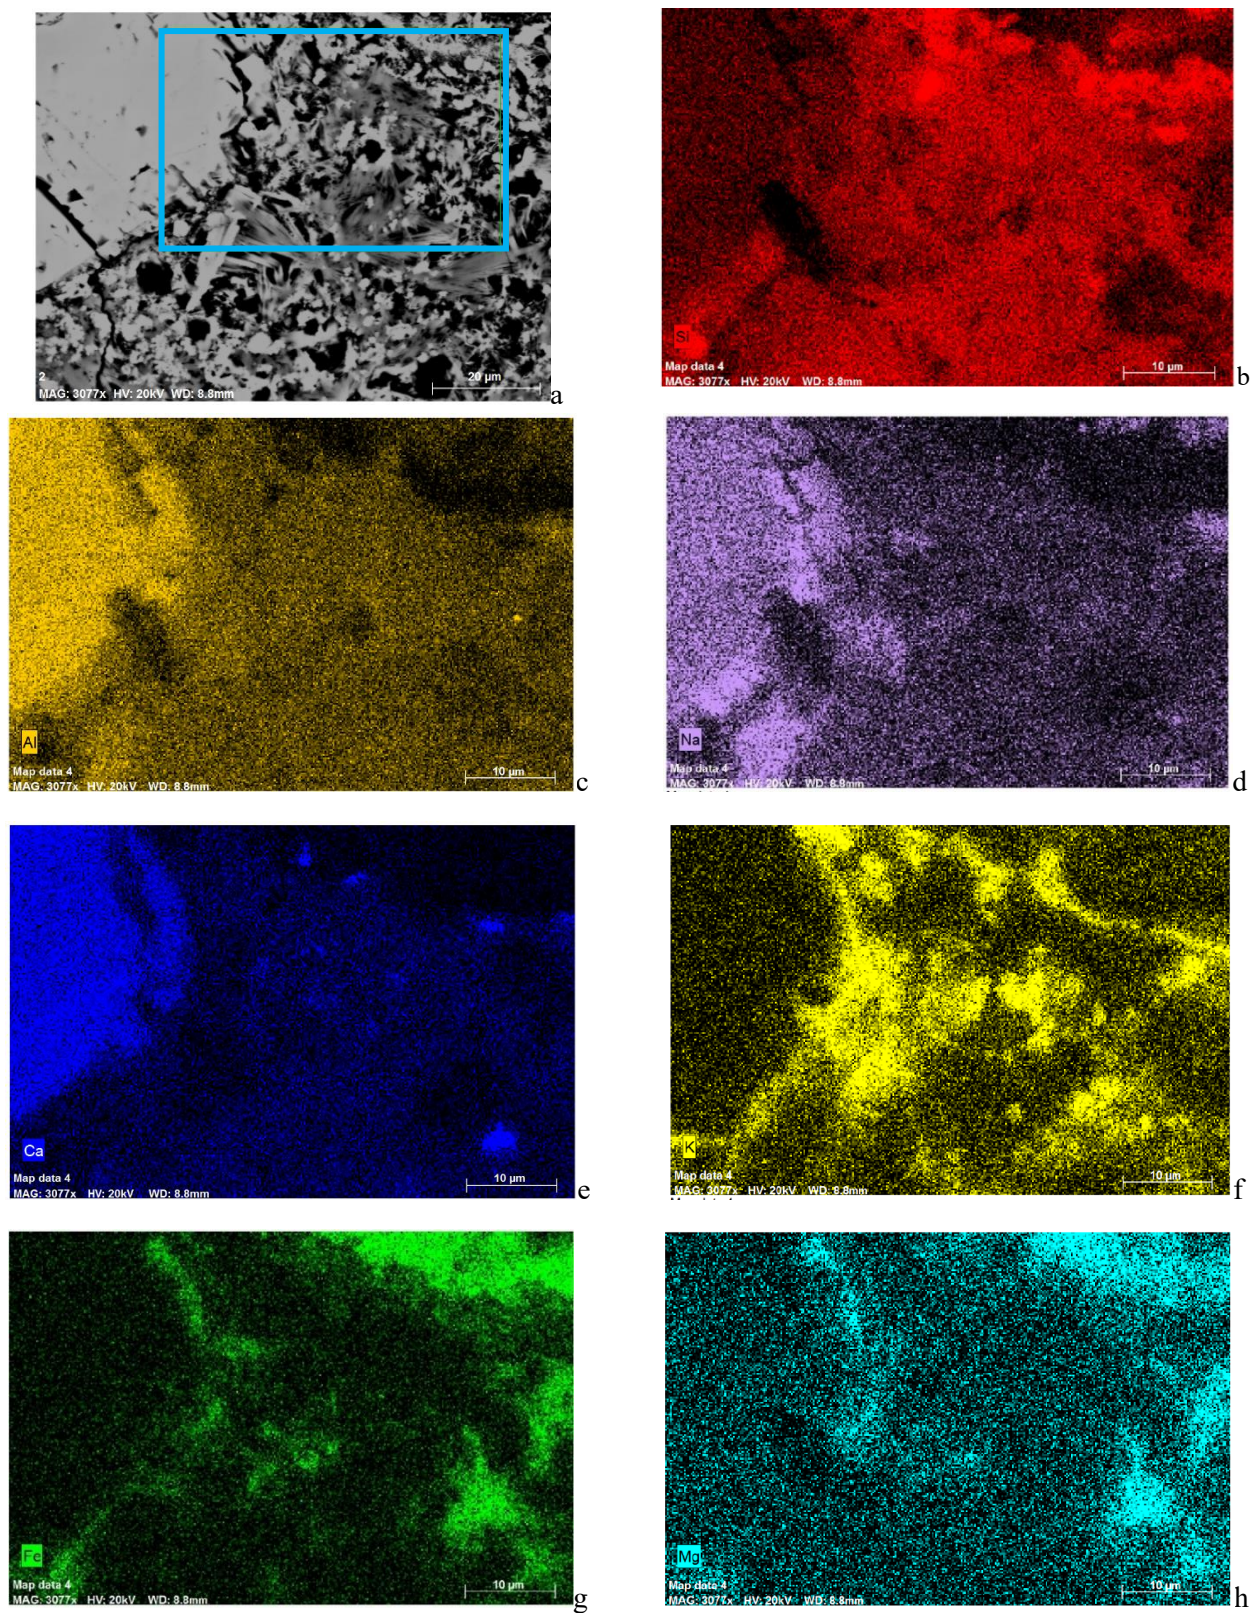
Figure 3.3.1. 20. Photomicrographs of PV FC 4 sample representing the EDS-maps analyses carried out on the area shown in a; b. EDS-map of Si; c. EDS-map of Al; d. EDS-map of Na; e. EDS-map of Ca; f. EDS-map of K; g. EDS-map of Fe; h. EDS-map of Mg.

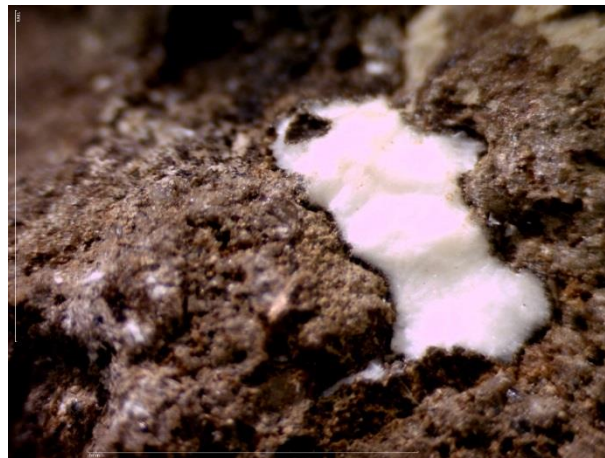
Figure 3.3.1. 24. Stereomicroscope photomicrograph of PV FN 5 sample.

Considering the basaltic andesites at Panama Viejo, amygdales filled with secondary minerals have been observed under stereomicroscope (Fig. 3.3.1.24) and PLM (Figs. 3.3.1.25-26). Therefore, ESEM-EDS investigation was performed on PV FN 4 sample (Figs. 3.3.1.27-28), showing several of these structures.

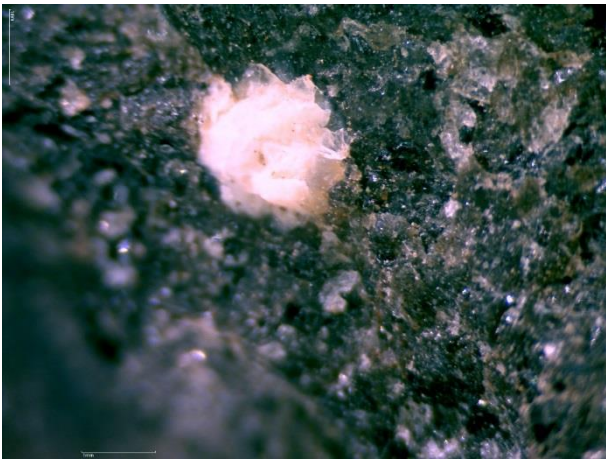
Figure 3.3.1. 37. Stereomicroscope photomicrograph of PB SF 6 sample showing an amygdale.

Regarding Portobelo, even in the basaltic andesites detected at Fuerte San Fernando, amygdaloidal structures have been observed also under stereomicroscope, as shown in Figures 3.3.1.33-38 for PB SF 6 sample.

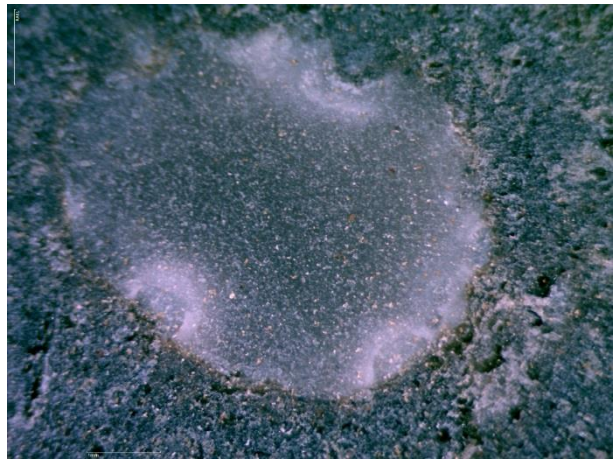
Figure 3.3.1. 38. Stereomicroscope photomicrograph of PB SF 6 sample showing an amygdale.

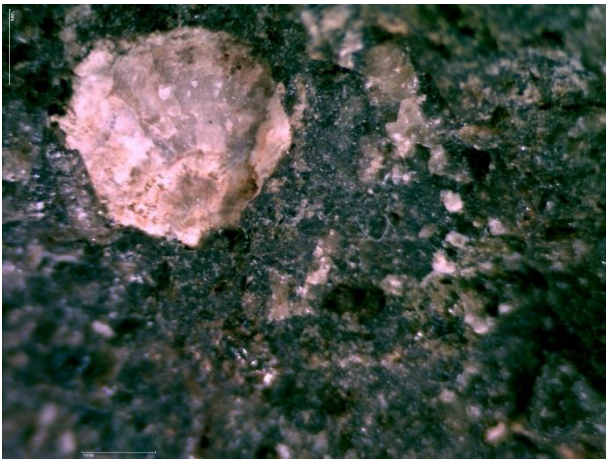
Figure 3.3.1. 50. Stereo photomicrograph of PB SF 11 bulk sample showing an amygdale.

Finally, on PB SF 11 sample EDS investigation has been carried out on the bulk specimen (Figs. 3.3.1.51). As clearly visible in the spectrum shown in Fig. 3.3.1.52, in this case calcite minerals fill the amygdale structure.

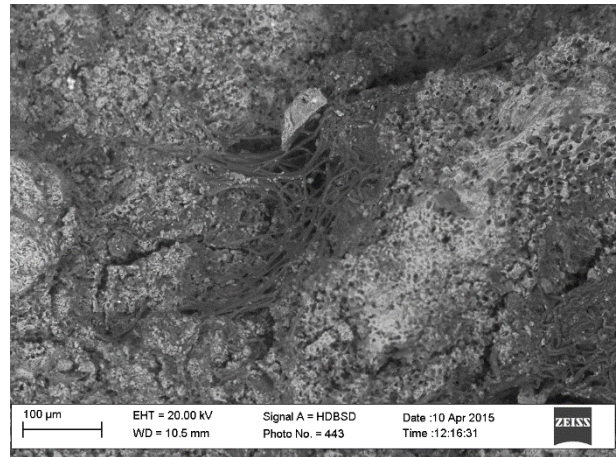
Figure 3.3.2. 12. BSD-ESEM photomicrograph of PB SF 1 showing moss filaments on grainstone/packstone.

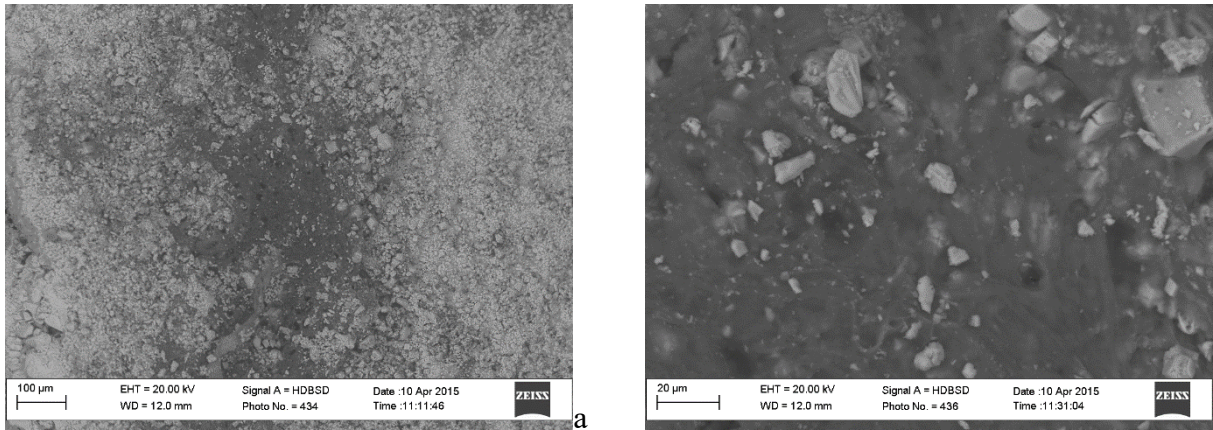
Figure 3.3.2. 19. BSD-ESEM photomicrographs of PB SF 5 calcite encrustation, showing a biological patina (a,b different zoom).

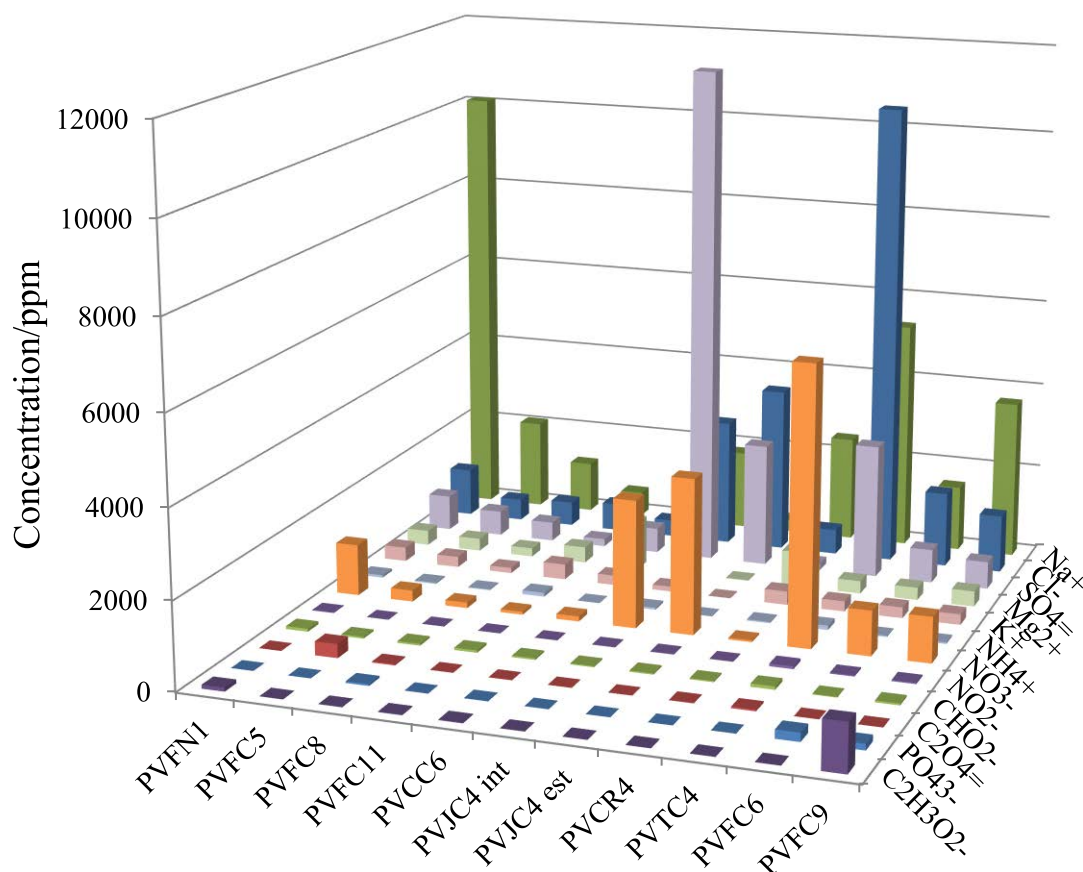
Figure 3.6. 1. Ion concentration in Panama Viejo samples, calcium is excluded in order to have a clearer visualization of the other ions.

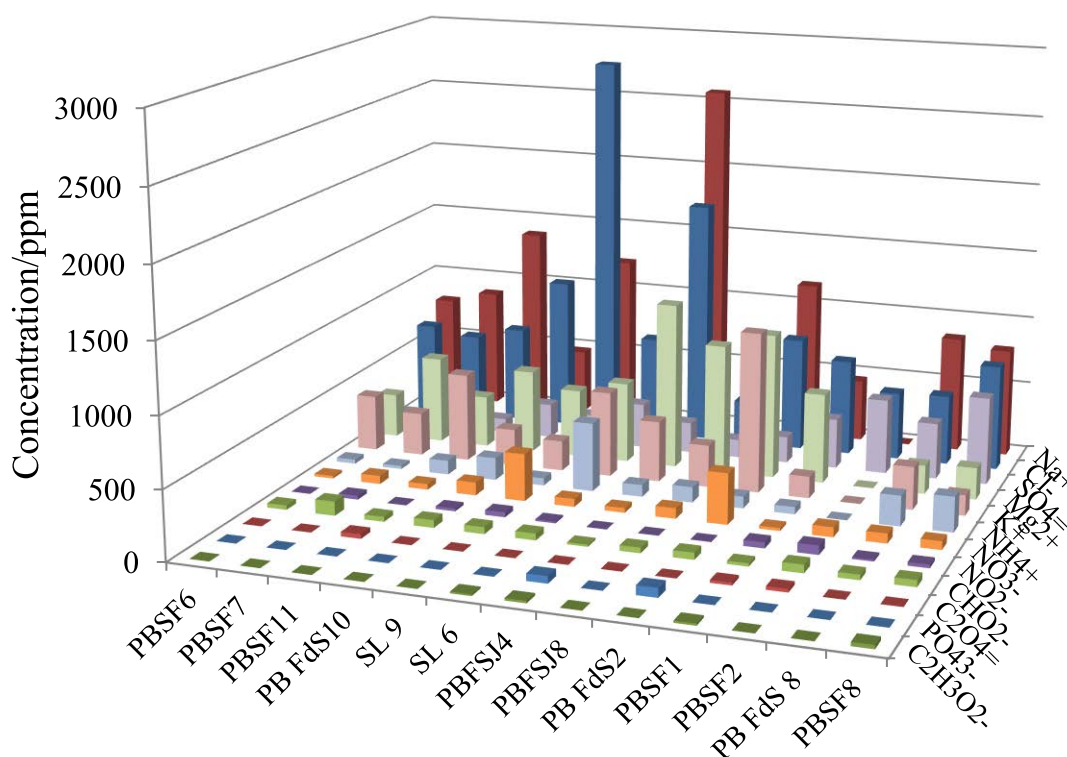
Figure 3.6. 2. Ion concentration in Portobelo and San Lorenzo samples, calcium is excluded in order to have a clearer visualization of the other ions.

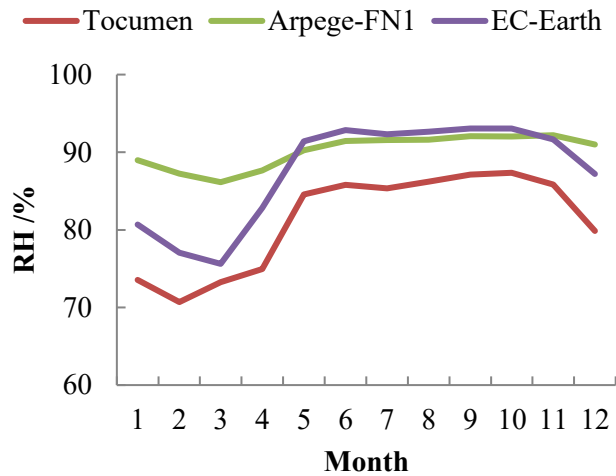
Figure 4.1.1. 9. Comparison of monthly average of relative humidity of Tocumen monitoring station and Arpege-FN1 and EC-Earth experiments, over 30 years (1979-2008).

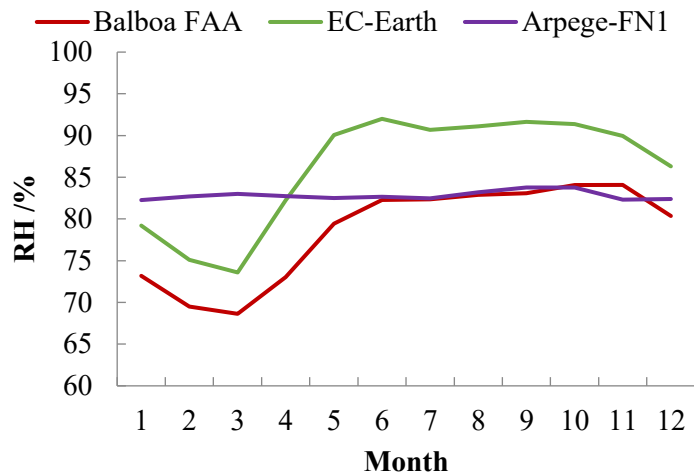
Figure 4.1.2. 9. Comparison of monthly average of relative humidity of Balboa FAA monitoring station and models data, over 30 years (1979-2008).
