Hygrothermal performance of an internally insulated masonry wall: Experimentations without a vapour barrier in a historic Italian Palazzo

This paper presents the newly developed study, methodology and assessment of the hygrothermal performance of a historic building wall retrofitted with three different internal insulation technologies, without a vapour barrier. It aims at assessing any possible condensation problems at the most critical point of the tested stratigraphy (namely, in between the wall and the insulation material) and to limit the modification of the original hygrothermal behaviour of the original wall's materials with the addition of a vapour layer, as would commonly be used. This evaluation was performed through in situ measurements and dynamic software simulations. In situ data was used for calibrating the 2D simulation model conducted with Delphin software 6.0.20.

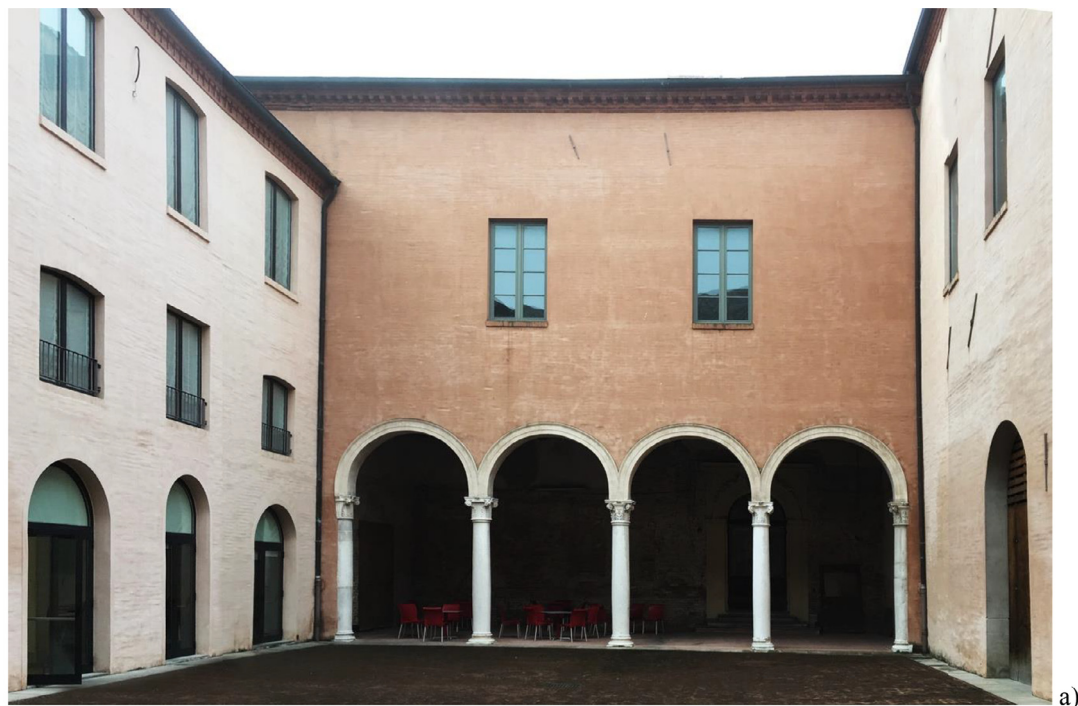
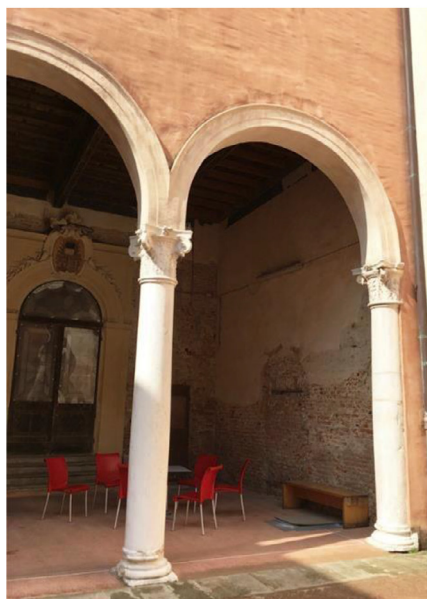
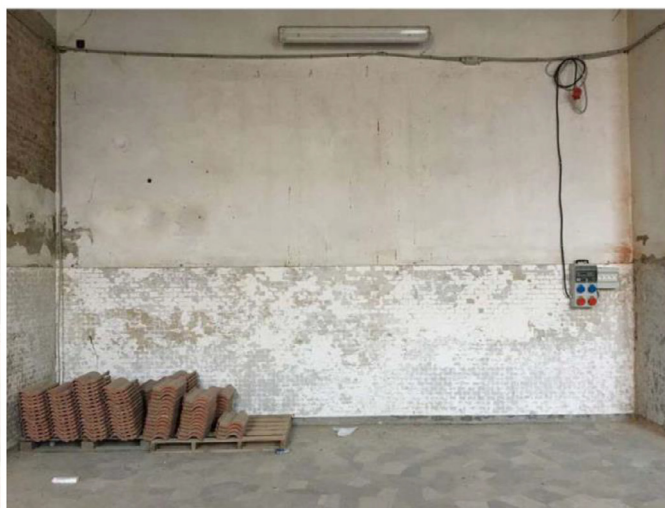
Fig. 1. Palazzo Tassoni Estense: the selected wall for the hygrothermal in situ analysis is located under a porch, in the courtyard of the building: a) Courtyard view, b) external view; c) internal view.

The selected wall in which the tests were conducted is E/SE oriented, located under a porch (Fig. 1). As declared in [30] (p3), although this factor restrict the extrapolation of the study's results, it also presents a unique feature of walls alike in historic buildings: these walls do not get wet unlike most walls exposed to rainwater, neither do such walls dry as easily, since they do not receive direct sunlight. In other words, the phenomenon is studied in its purest state, as it depends solely on the vapour transport phenomena.

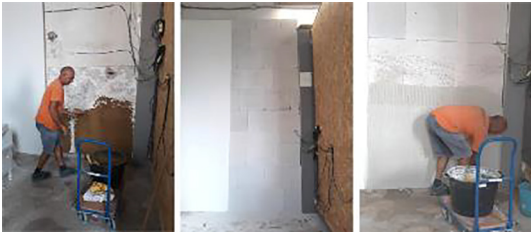
Insulation material	Technology description	Total thickness (mm)	Image
Calcium silicate (mineral foam) blocks (CaSi) <i>Wall estimated U-value 0,33 Wm²K (-77%)</i>	1 panel (100 mm) glued to the historic wall with a reversible adhesive mortar (8 mm thick), provided of a 10 mm finishing mortar layer	118

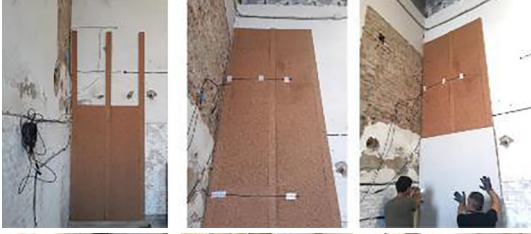
Cork boards (CB) <i>Wall estimated U-value 0,44 Wm²K (-69%)</i>	1 board (50 mm) panel supported by its own timber structure (covered on the two faces with a thin layer of cork) punctually fixed to the historic wall, finished with 1 gypsum fibre board	62.5

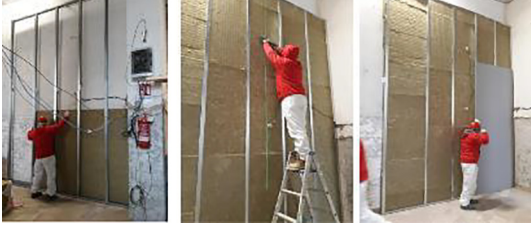
Stone wool panels (SW) <i>Wall estimated U-value 0,26 Wm²K (-82%)</i>	2 panels (40 + 60 mm) with their own steel frame (separated from the wall by the 40 mm panel to avoid the thermal bridge), and finished with one gypsum board	112.5

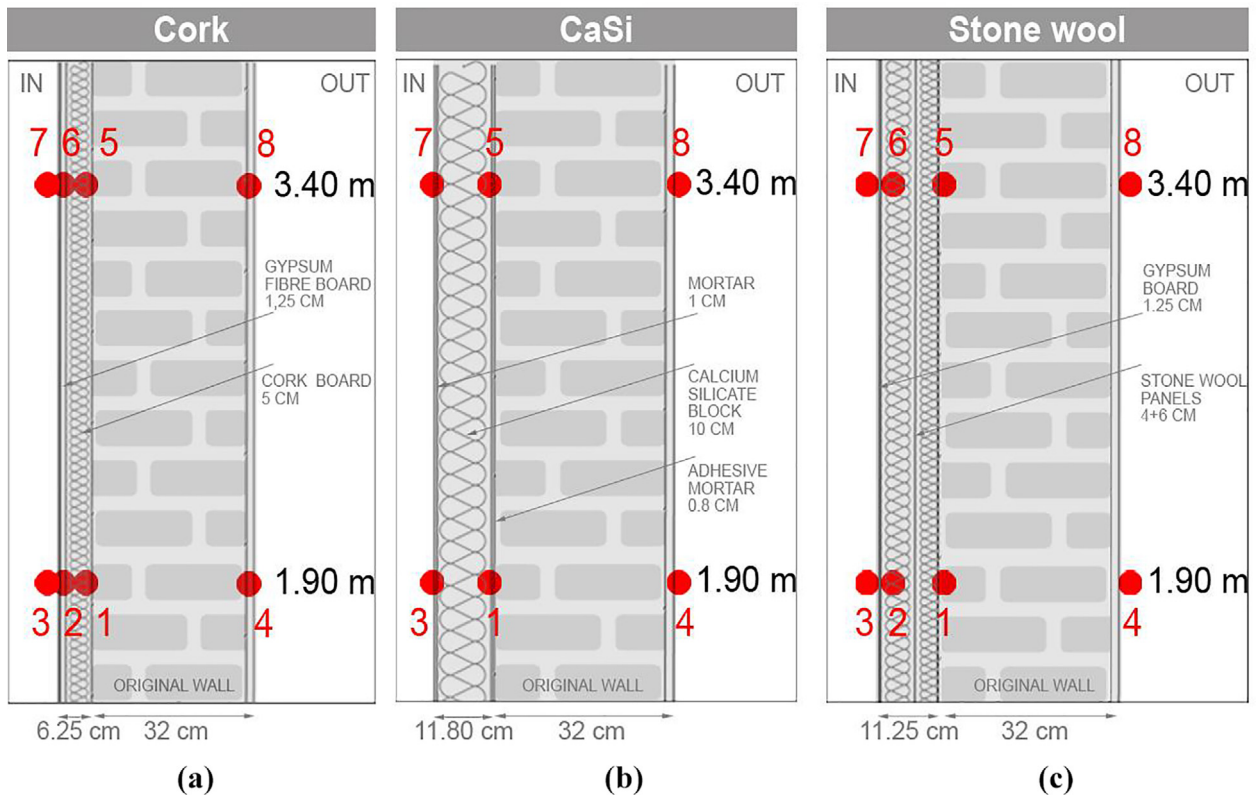
Fig. 3. Vertical section schemes of the position of the sensors: (i) sensors 8 and 4 - external surface of the original historic wall (HW); (ii) sensors 7 and 3 - internal surface of the insulation materials (placed on the internal face of the HW); (iii) The remaining sensors are placed in between the stratigraphy layers of the insulation technologies. Materials: (a) Cork boards panels (CB); (b) Calcium silicate blocks (CaSi); (c) Stone wool boards (SW).

The hygrothermal models were designed according to the stratigraphy sections presented in Fig. 3 (a to c). The indoor climate files (T and RH values measured inside each box) result from a combination of monitored data - between 15th November 2019 and 30th September 2020 -, with EN 15,026 [39], for the period between 1st October and 14th November (signalled by the light

i) between all the survey's analysed points, it was decided to show only the one relating to probable interstitial condensation, being the most significant point (points 1 and 5 in Fig. 3);

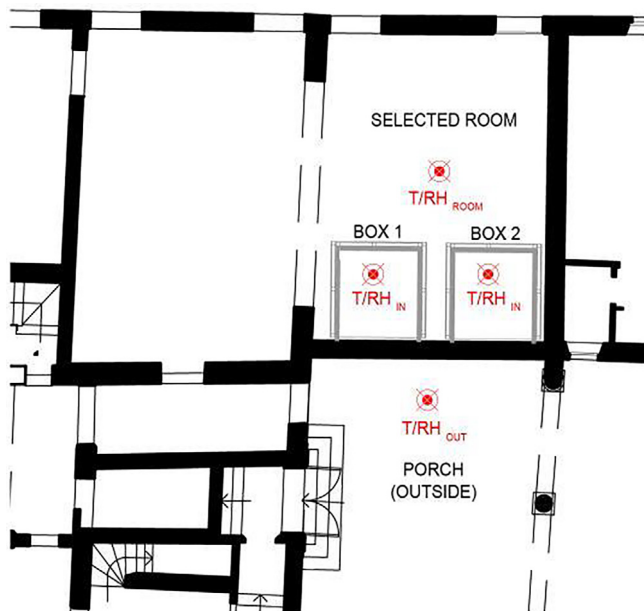
Fig. 4. Selected room (plan view) for tests and the location of the two monitoring boxes. Relative positioning of the T/RH sensors of the monitoring system (in red) of the environmental conditions (Outside - under the porch; selected room - a non-climatized indoor environment; inside - climate chambers: box 1 and box 2).

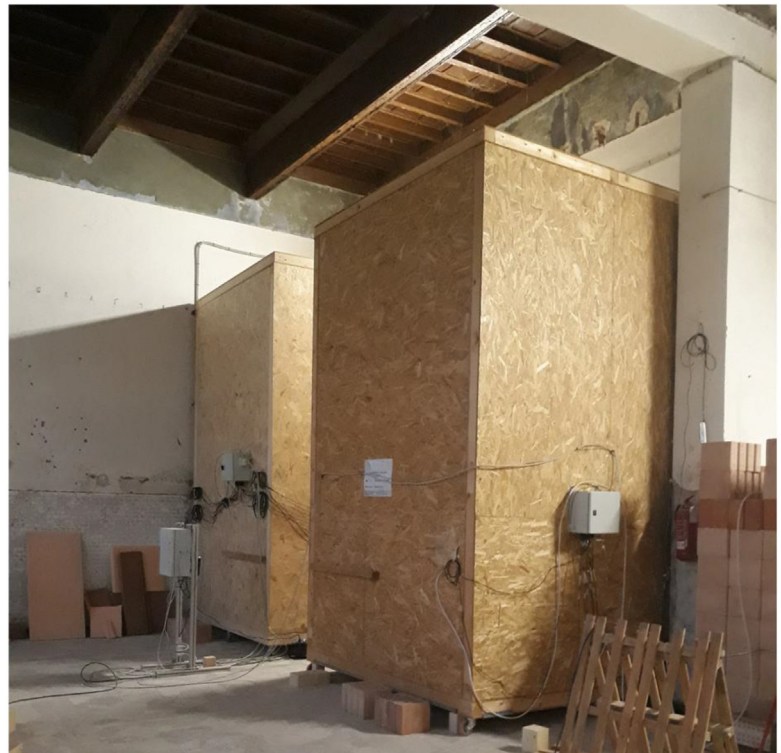
Fig. 5. a) Positions of the two metering hot boxes and the insulation technologies, b) The two metering boxes in the test room.

The full design and construction descriptions of these boxes (2.50 × 2.50 × 4.01 m gross), allowed the studying of up to two insulation systems in parallel, which can be found in [28]. To create the microclimate inside each box, a 2000 W heating convector and two ultrasonic humidifiers were provided (this equipment is also fully described in [28]). The relation between the room and the hot boxes is synthesized in Fig. 4. The box’s dimensions were determined also by the want to install, in parallel, two insulation systems, as depicted in Fig. 5, alike to the experimental study developed by Kloseiko et al. [20]. This study was taken as a point of reference, where different insulation systems, measuring 1.00 m width each, were studied by placing sensors in the middle (a 0.50 m distance from each material border was assured, ensuring sensors safety distance from the borders. In other words, the extension of the insulation surface is enough to minimize the impact of the influence of the material’s boundaries).

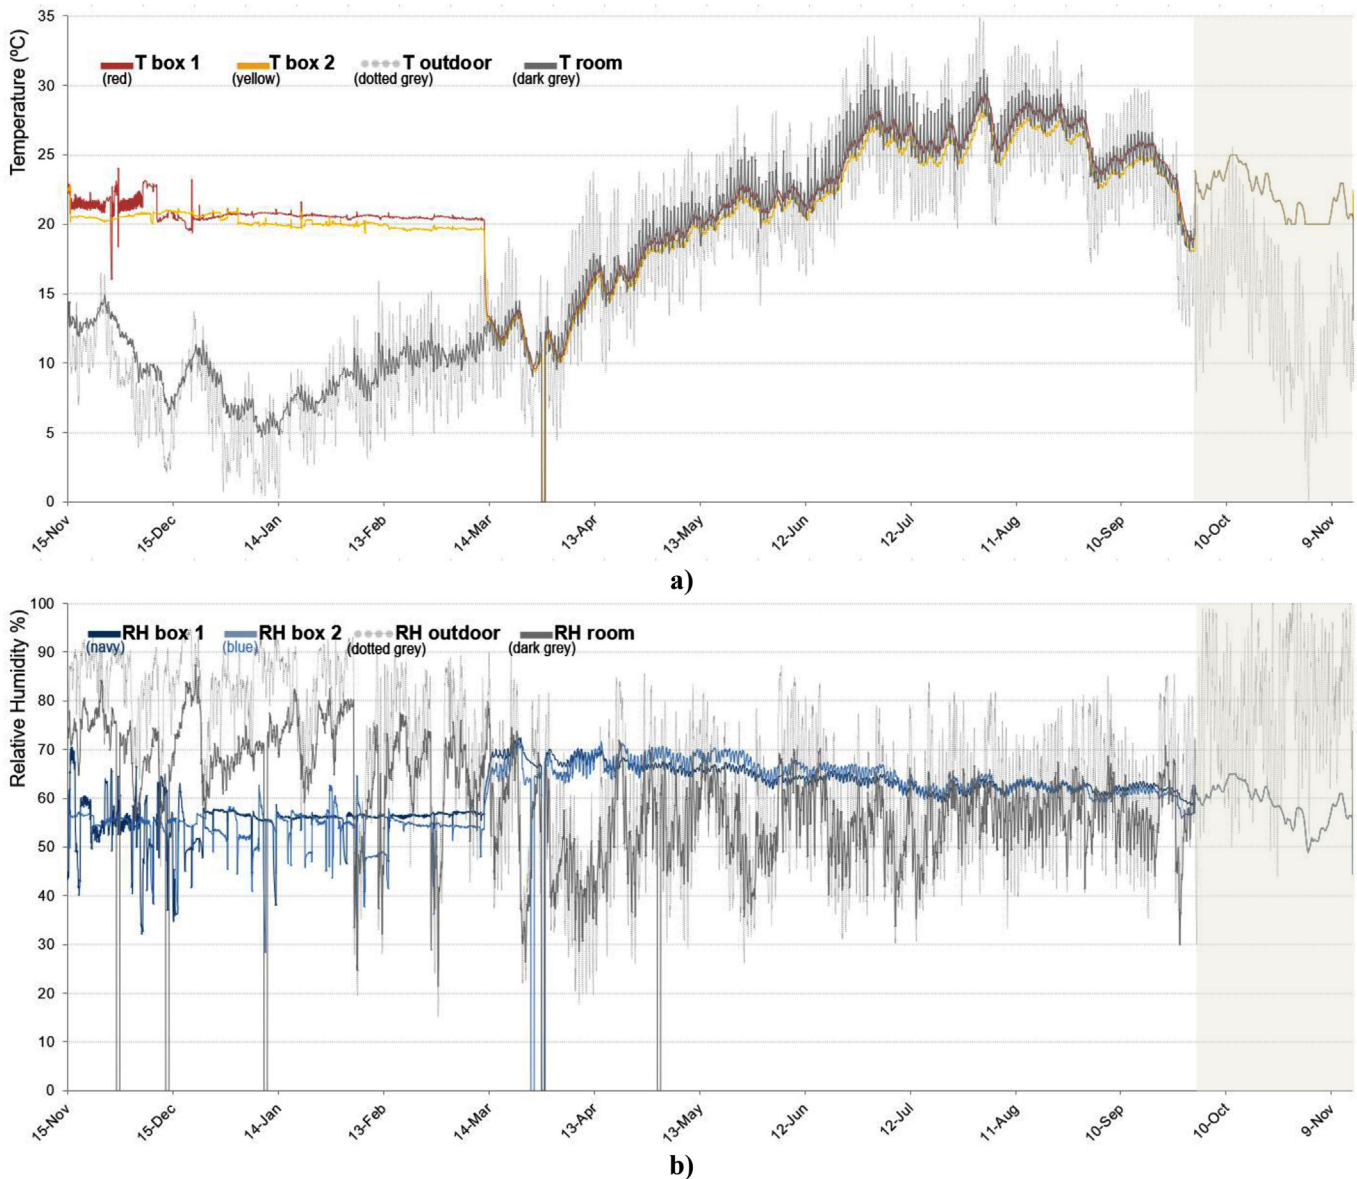
Fig. 6. Hourly annual data of external and internal climates: (a) Temperature (°C); (b) Relative Humidity (%). The light grey rectangle refers to the climate file created with EN 15,026 [39] values (period between 1st October and 14th November).

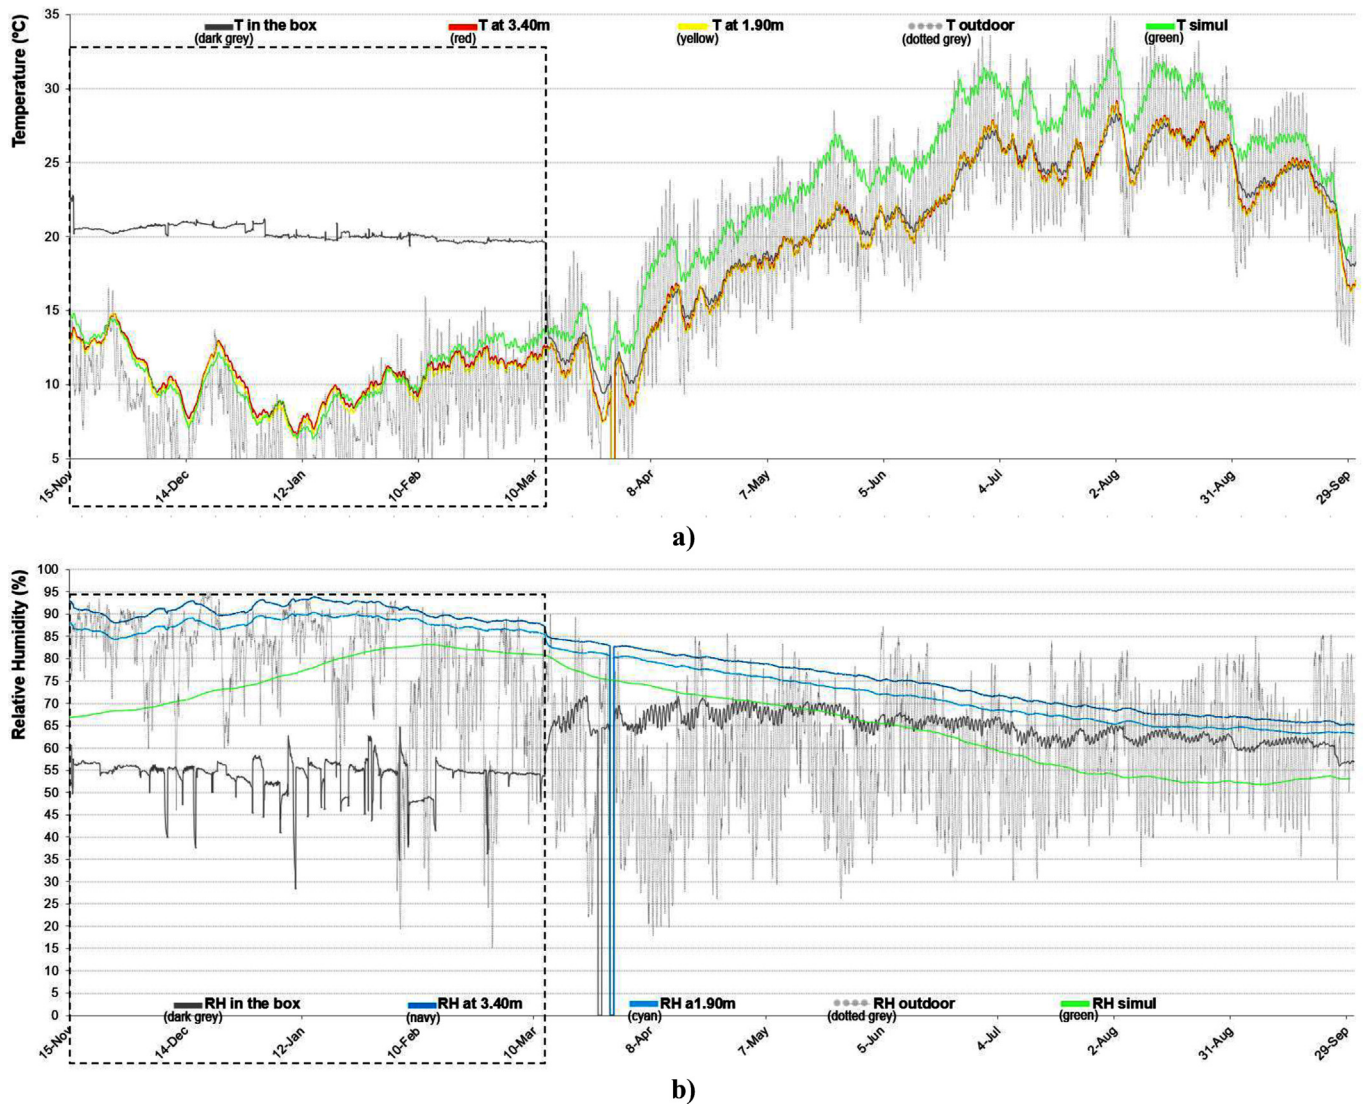
Fig. 8. Hourly monitored and simulated hygrothermal conditions, between 15th November and 30th September with CaSi insulation technology (118 mm), at the probable condensation point: a) T (°C); b) RH (%).

In the case of the RH (%), at both measurement points, it was always below 95%. Nonetheless, it is worth mentioning that the sensor accuracy over 80% decreases and therefore the 95% threshold for condensation might have been achieved. For the same reasoning, RH (%) monitored differences at both levels should not be considered significant: RH (min ÷ max) values, varied between 65.08%÷93.86% at 3.40 m, and 63.19%÷90.40% at 1.90 m, respectively. Nonetheless, the initial building moisture and successive drying out period was visible: RH (%) between the insulation and the historic wall decreased until 1st October 2020, reaching values below 65%.

On the contrary, the RH (%) simulated values were underestimated. The field data showed higher RH (%) values than those suggested in the simulation. It is likely that the underestimation of RH (%) by the software is caused by the overestimation of inter-seasonal drying. Both the field and the simulation data showed

Concerning [i]), the temperature of the simulated data of the first year, when compared to the last year of the simulation (Fig. 8.a), did not differ significantly and therefore it is not shown (max $\Delta T = 0.1$ °C). RH (%) values, instead, were quite different (max $\Delta RH = 15$ %) and, therefore, this data is presented in Fig. 11. As exhibited by the pink broken line, the RH simulation of the first year is closer to the in-situ data, considering that this corresponds to the initial months after the installation. Nonetheless, the simulation data underestimates the field measurements almost throughout the entire monitoring period.

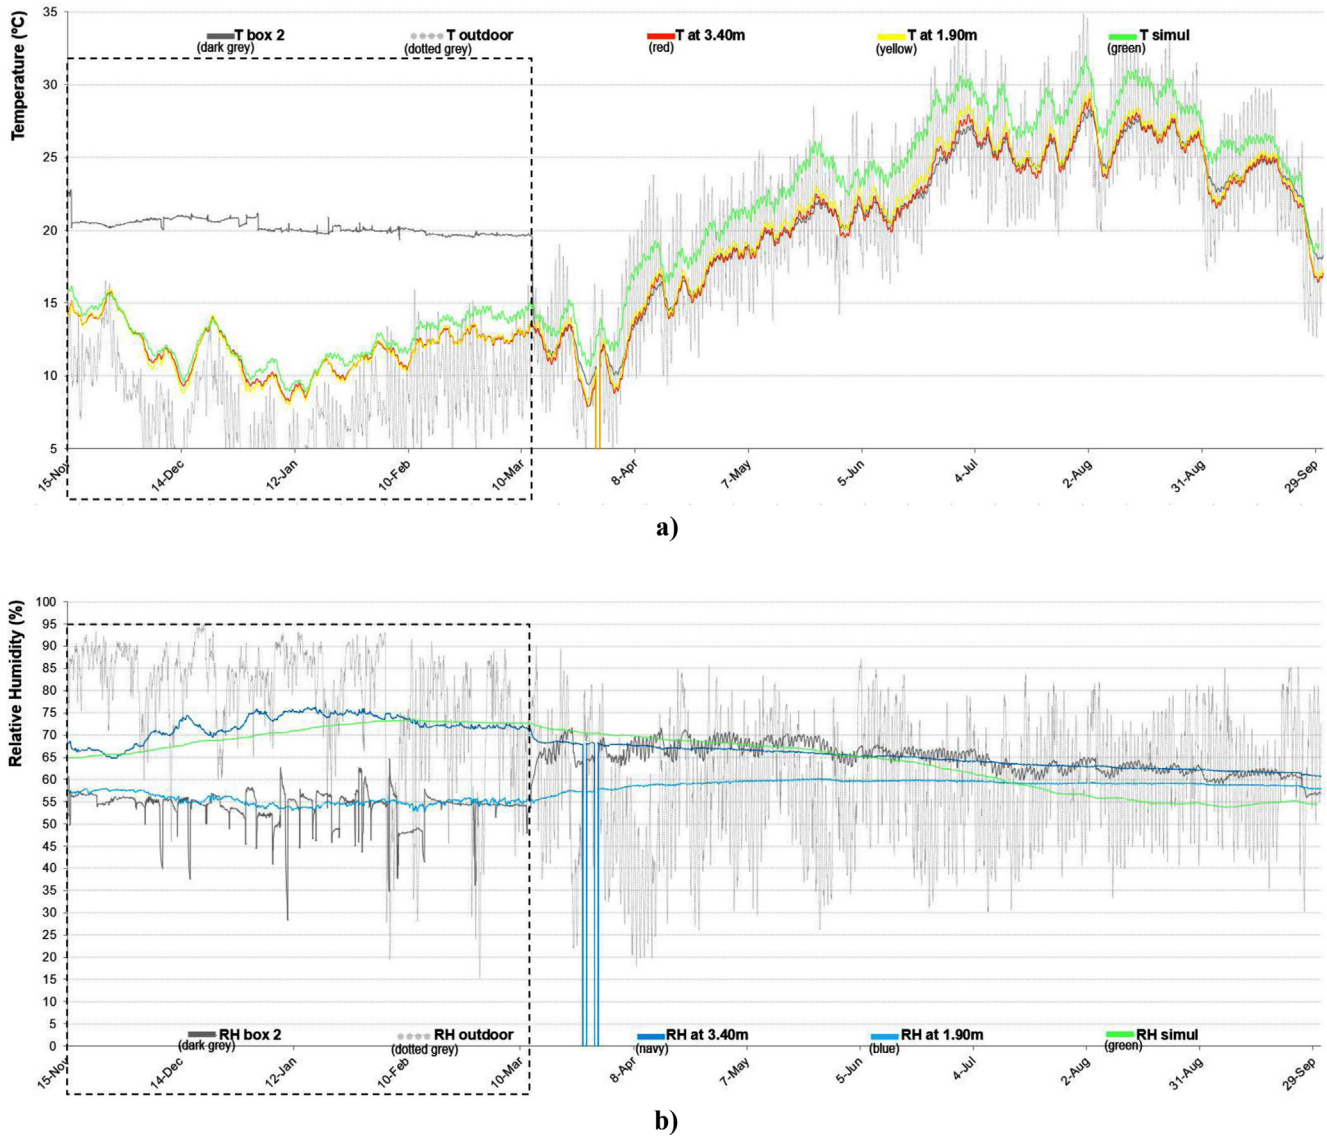
Fig. 9. Hourly monitored and simulated hygrothermal conditions, between 15th November and 30th September with Co insulation technology (62.5 mm), at the probable condensation point: a) T (°C); b) RH (%).

measured at both heights was observed, RH (min ÷ max) values, varied between 60.67% ÷ 76.30% at 3.40 m, and 53.77% ÷ 60.20% at 1.90 m, respectively. In other words, the maximum RH (%) value registered at the lower sensor equalled the minimum value registered at 3.40 m.

The simulation overestimated the T (°C) values: the global difference between the measured (average of the two sensors) and the simulated values varied between 0.00 ÷ 3.73 and, RMSE = 2.01. During the “active-phase”, RMSE = 0.87, which is lower than the instrumental error. In some moments the simulation overestimated the onsite RH (%) behaviour, in others it underestimated it. This difference was re-emphasized by the end of July. Statistically: the difference between the RH (%) measured (average of the two sensors) and the simulated values varied between 0.00 % ÷ 10.38 % and RMSE = 5.92 % – this value is higher than the sensors accuracy. As visible in Fig. 9.b), the RH (%) simulation curve better fitted the data registered by the sensor placed at 3.40 m during most of the time. If data had been collected solely at 3.40 m, and the same analysis was performed, the difference would be lower 0.00 % ÷ 8.10 %, and RMSE = 3.96 %, fitting the instrumental error ± 2 % when $20 \leq RH (\%) \leq 80$.

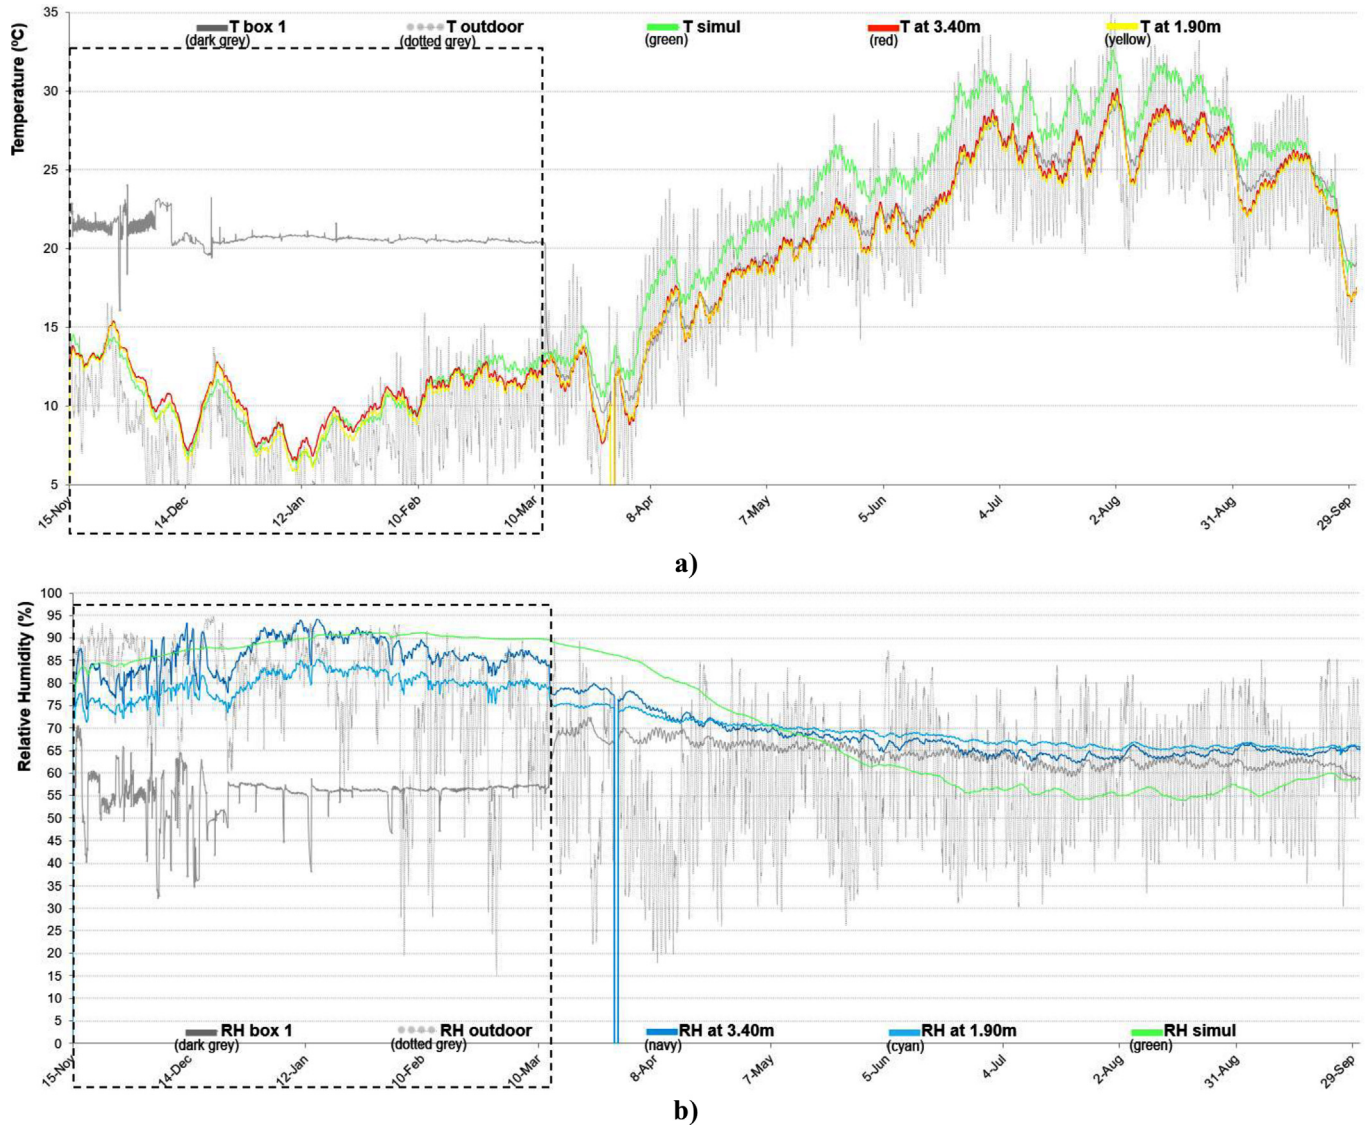
Fig. 10. Hourly monitored and simulated hygrothermal conditions, between 15th November and 30th September with SW insulation technology (112.5 mm), at the probable condensation point: a) T (°C); b) RH (%).

The T (°C) profile of the monitored data was not very different from the other materials, i.e., no significant difference was found between T (°C) measured at 3.40 m or at 1.90 m, at the likely condensation point. At these points, the T (min ÷ max) values, varied between 6.53 °C ÷ 30.18 °C at 3.40 m and 5.78 °C ÷ 29.76 °C at 1.90 m.

RH (%) was not so “homogeneous”. A visible difference was found between the RH (min ÷ max) measured at 1.90 m, 64.12%÷85.24% and 3.40 m, 62.15%÷94.19%, respectively. Although the condensation limit (95%) was never reached, much like with the CaSi, a reasonable doubt can be noted, due to sensors accuracy over 80%.

Concerning the simulation, much like in the previous technologies, when it comes to the T (°C), the simulation overestimated the T (°C) values, especially after the springtime: the global difference between the measured (average of the two sensors) and the simulated varied between 0.00 °C ÷ 4.49 °C and RMSE = 2.06 °C. During the “active-phase”, the RMSE = 0.56, which is comparable with the instrumental error (± 1 °C when $0 \leq T$ (°C) ≤ 20). In this case, the RMSE is even lower than the sensors accuracy.

During a considerable part of the year, the RH (%) simulation curve either overestimated or underestimated the field data. Statistically, the global difference between the measured (average of the two sensors) and the simulated values varied between 0.00 % ÷ 12.87 % and RMSE = 7.50 %. If only the “active-phase” was observed, RMSE = 5.93 %, approaching the instrumental error (up to ± 4 % when RH ≥ 80 %). From the observation of Fig. 10.b), it is visible that the simulation curve (RH, %) better fitted the monitored values at 3.40 m. If data had been measured solely at 3.40 m, the difference between the simulation and the monitored data would

be less significant: 0.00 % ÷ 11.68 % and RMSE = 6.32 %. If only the “active-phase” was observed, RMSE = 4.12 %, fitting the instrumental error ± 2 % when 20 ≤ RH (%) ≤ 80.

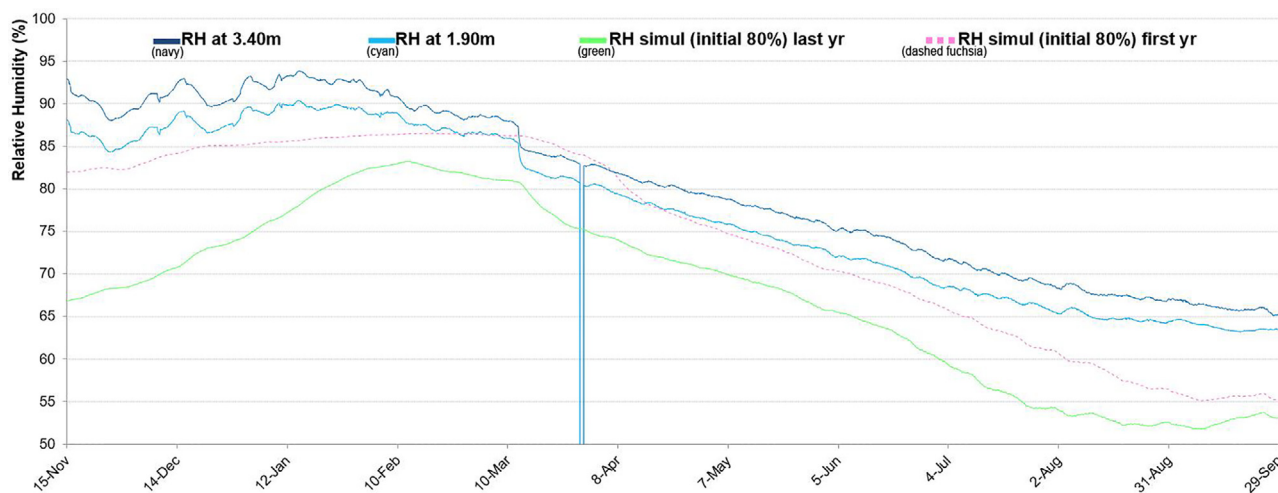
Fig. 11. Monitored and simulated RH (%) conditions, between 15th November and 30th September with CaSi insulation technology, at the probable condensation point [original simulation and scenario i]).

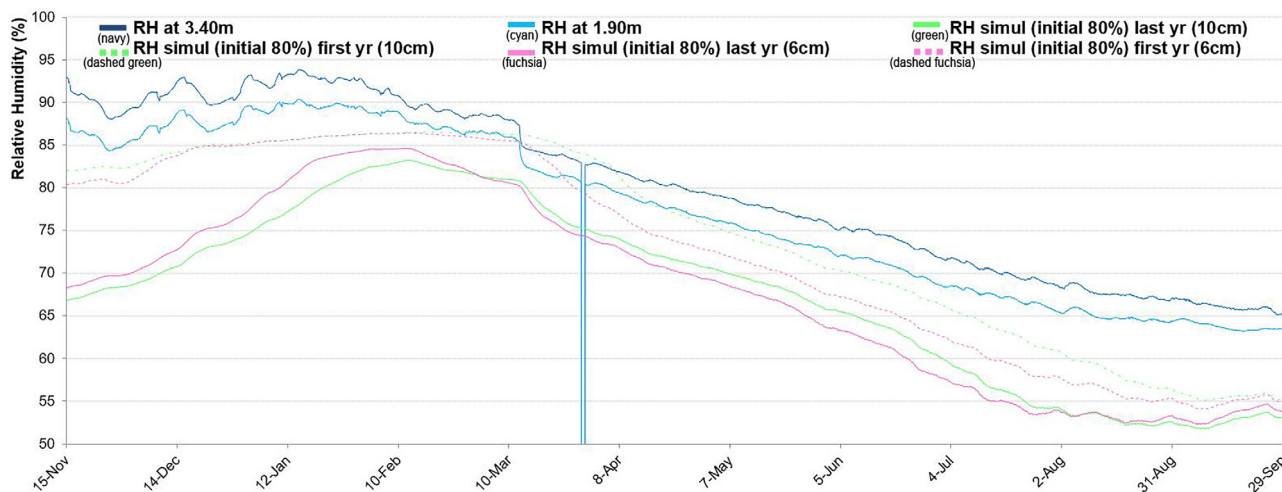
Fig. 12. Monitored and simulated RH (%) conditions, between 15th November and 30th September with CaSi insulation technology, at the probable condensation point [original simulation and scenario iv), with initial RH value equal to 80%].

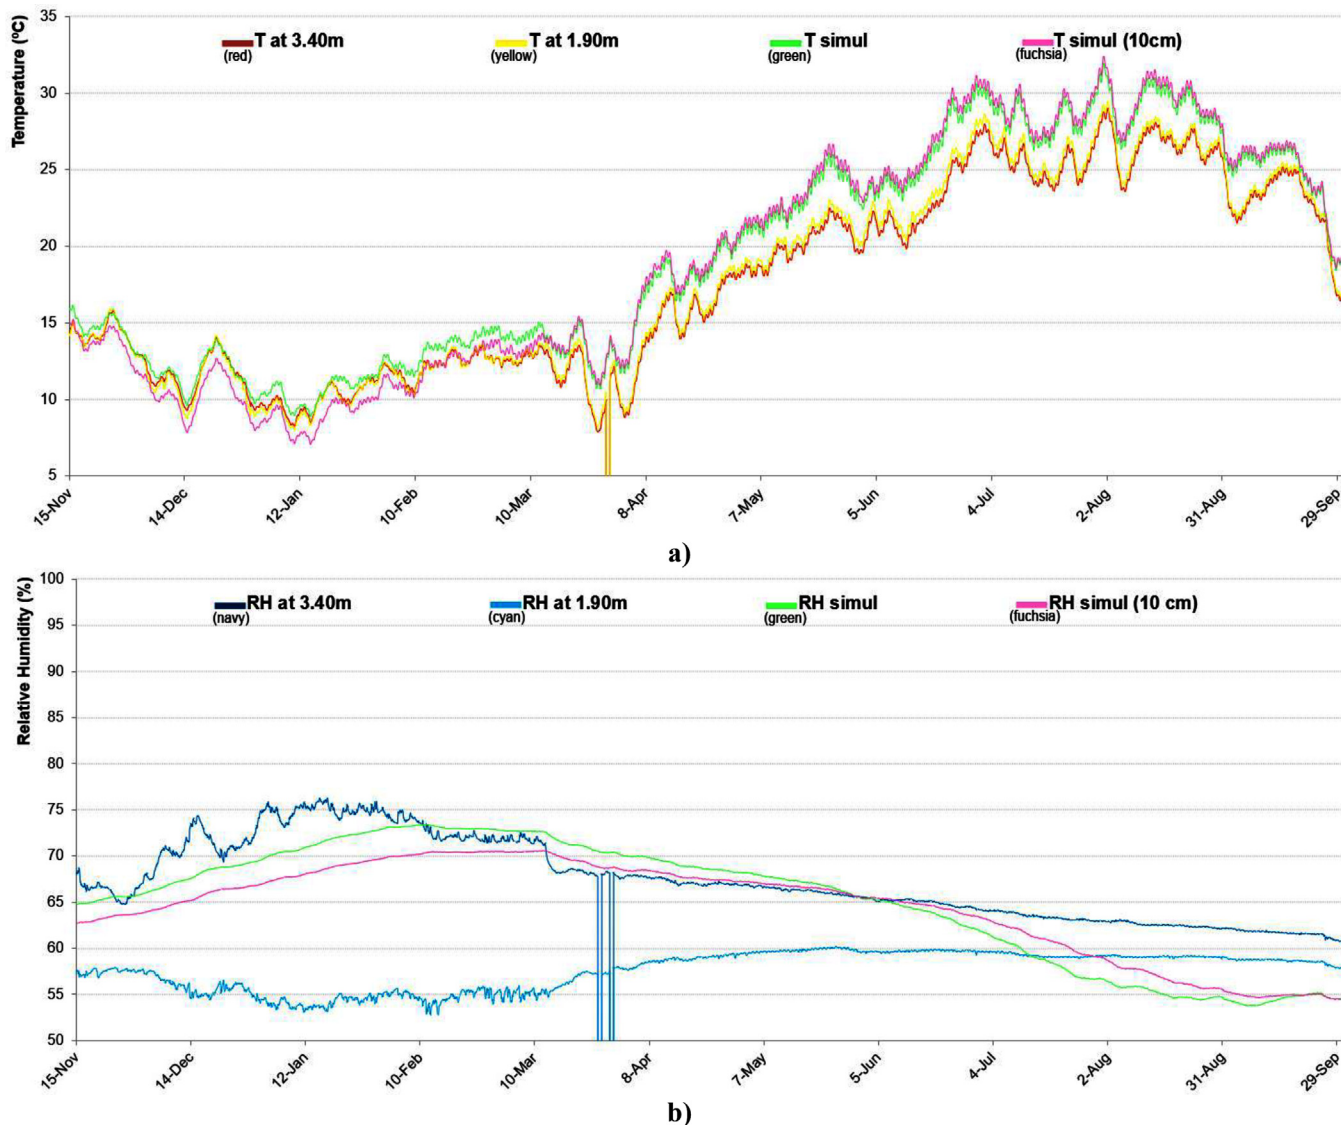
Fig. 13. Monitored and simulated hygrothermal conditions, between 15th November and 30th September with Co insulation technology, at the probable condensation point [original simulation and scenario i)].

The results of the first variation [i]) are presented in Fig. 13. As expected, augmenting the material's width, would lower the T (°C)

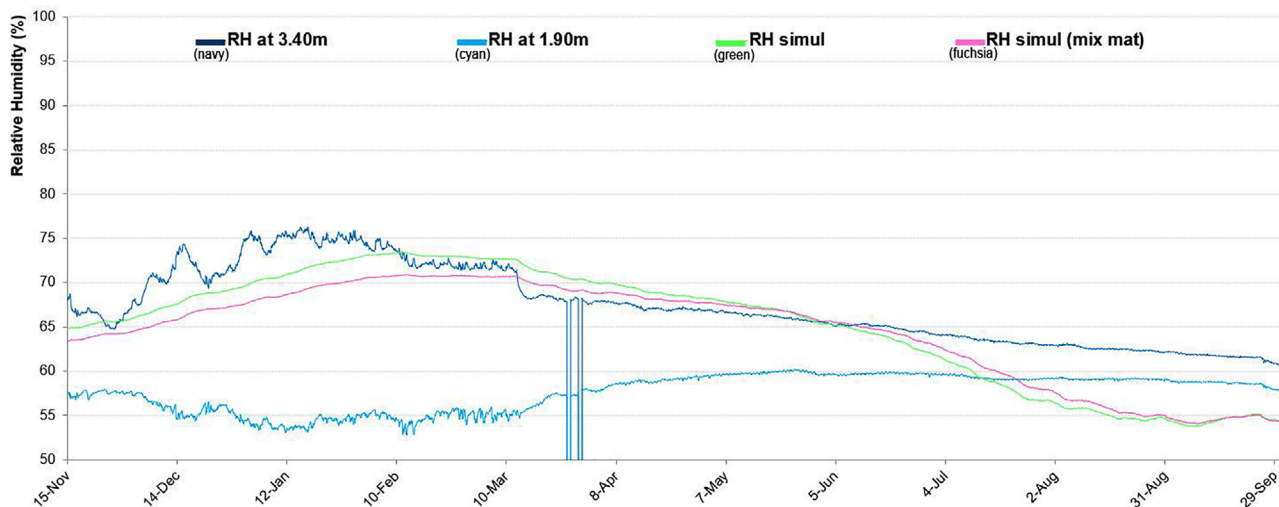
Fig. 14. Monitored and simulated hygrothermal conditions, between 15th November and 30th September with Co insulation technology, at the probable condensation point [original simulation and scenario iii)].

Finally, concerning [iii], no significant differences were observed in terms of T (°C), therefore no data is shown, but smoother RH (%) values were obtained, as evidenced in Fig. 14, when compared with the original simulation.

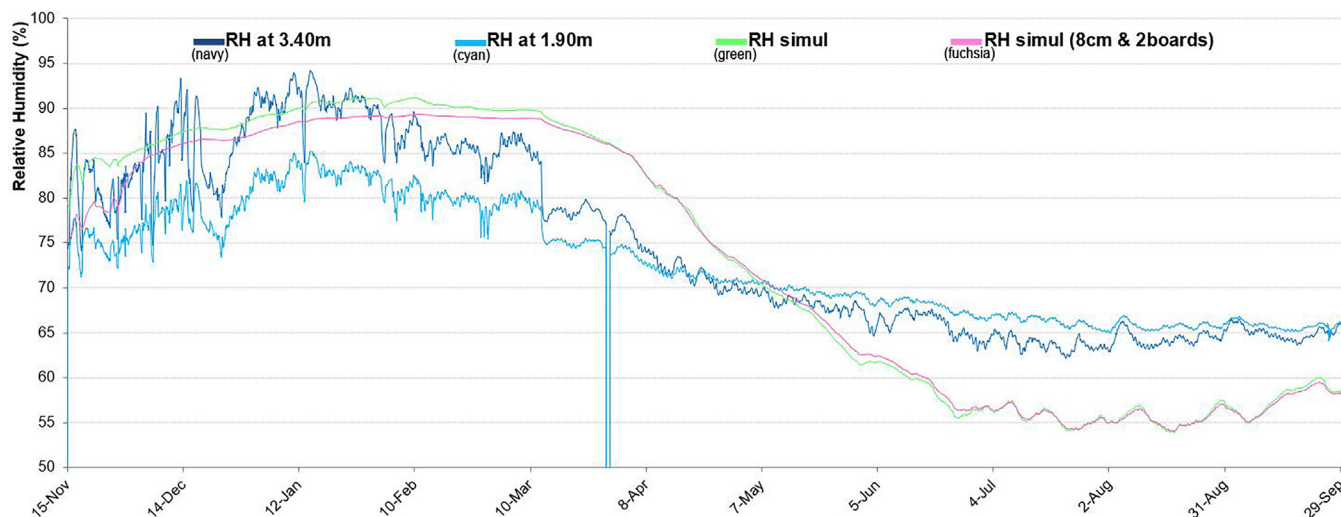
Fig. 15. Hourly monitored and simulated RH (%) values, between 15th November and 30th September with the SW insulation technology, at the probable condensation point [points 1 and 5, Fig. 3b)].
