Optimisation of survey procedures and application of integrated digital tools for seismic risk mitigation of cultural heritage: The Emilia-Romagna damaged theatres.

APPEDIX B: DAMAGE SURVEY

B PD form - Social Theatre of Novi (Modena)

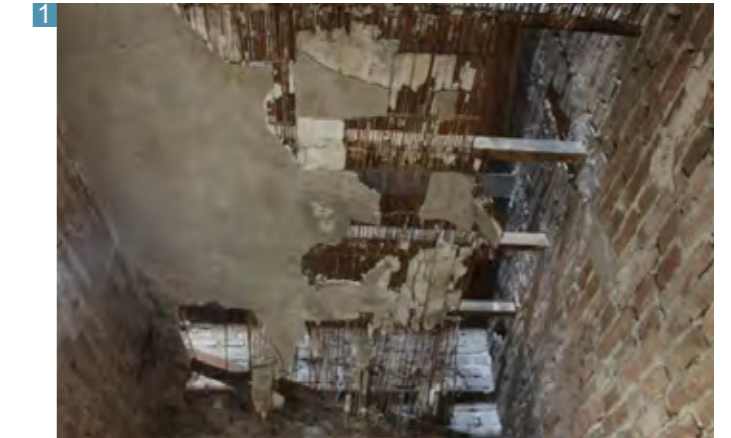
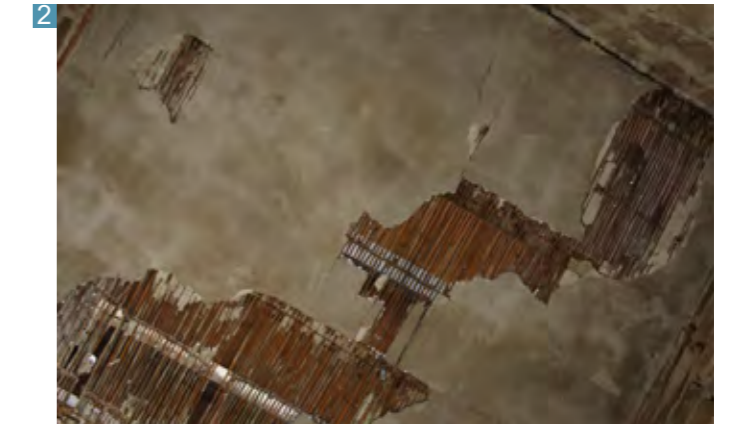
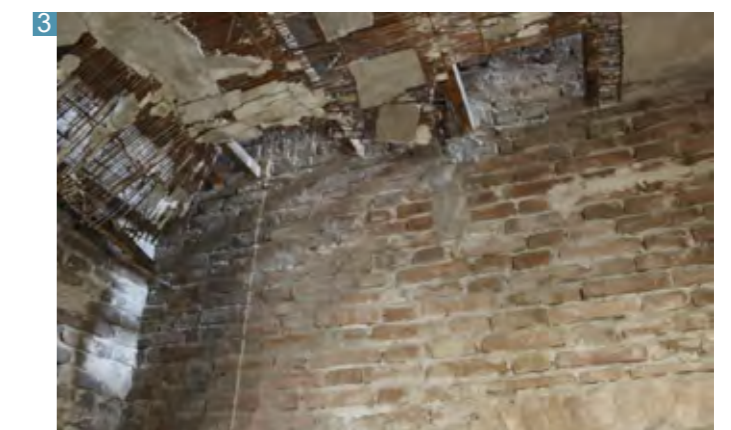
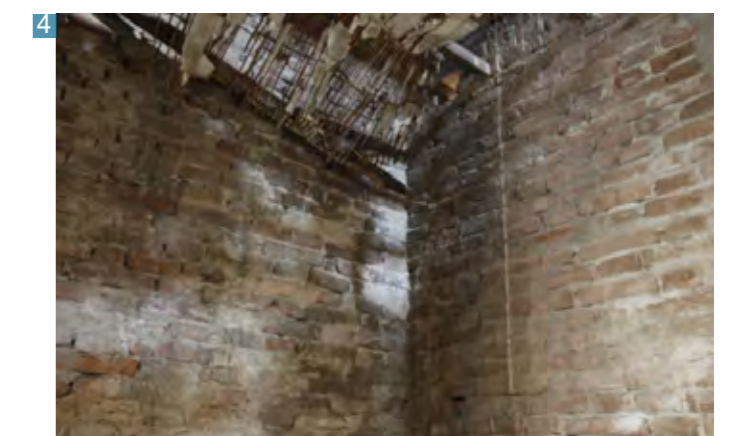
Note: A comparable cracking pattern is found in the diametrically opposite space 03_0.3.004

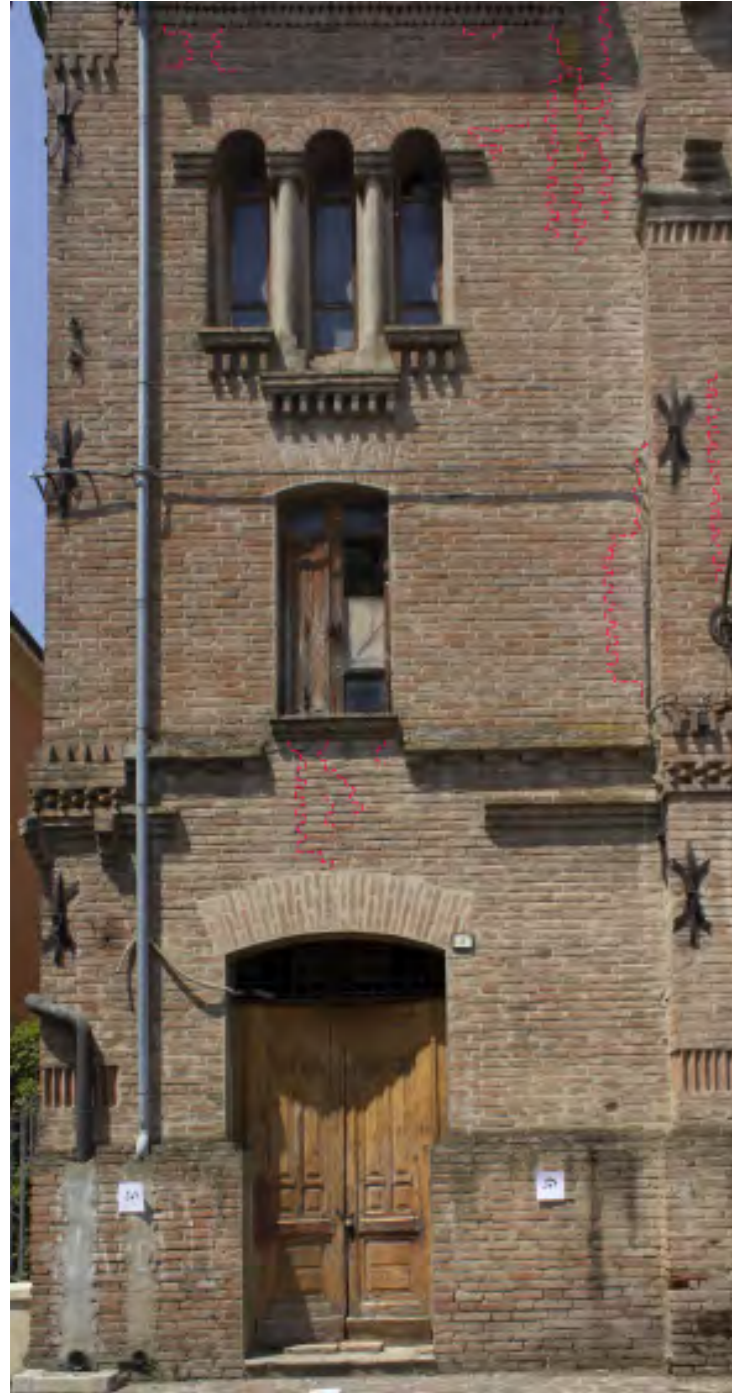
east elevation

M3

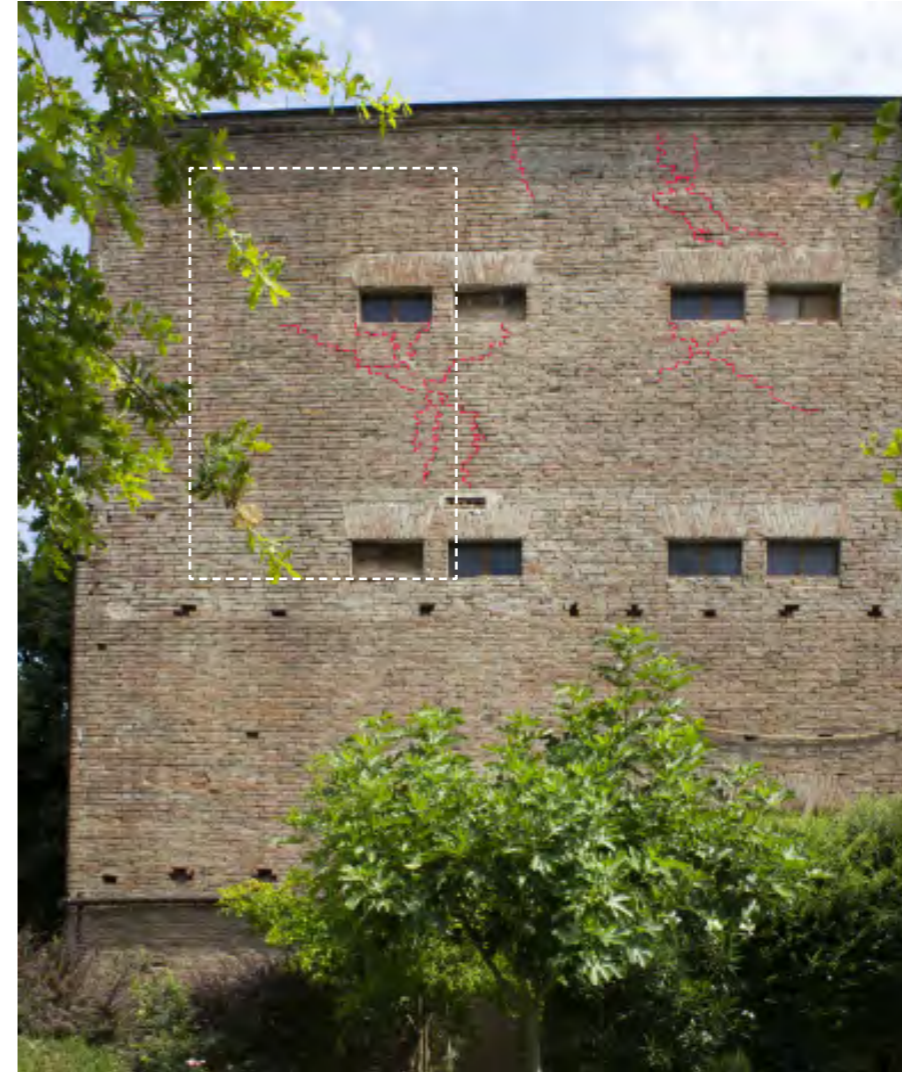
south elevation

M3

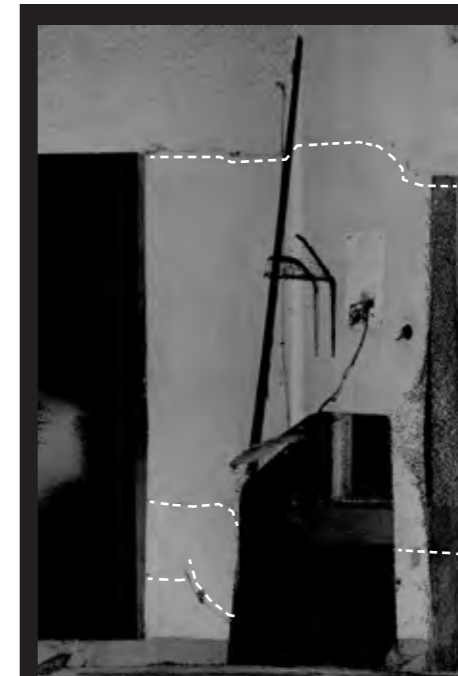
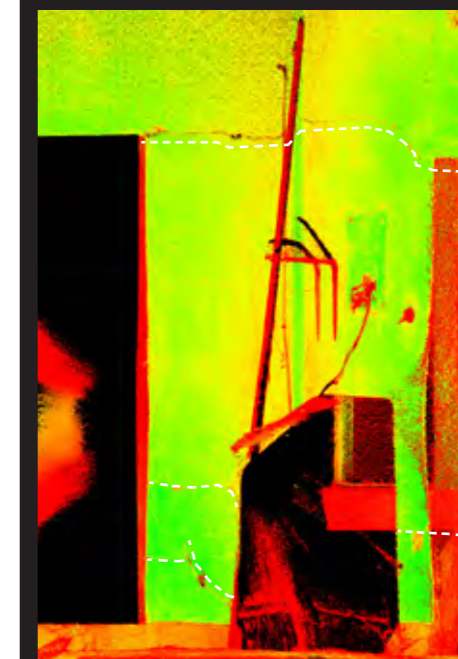
M20
US 0.1
02_01_003

Significant damage and excessive deformability of the horizon affected the rooms of the ridotto (unit 02; second-order; rooms 003, 004, 005), which were affected by partial collapses of the ceiling and a significant cracking framework. Since these rooms were subject to alterations to adapt the theatre's functions to the cinema, significant cracks are visible along the partition walls, indicating that they are not well bonded to the load-bearing masonry. In addition, partial collapse of the roof affected Body A, which occurred in correspondence with the rooms described above.

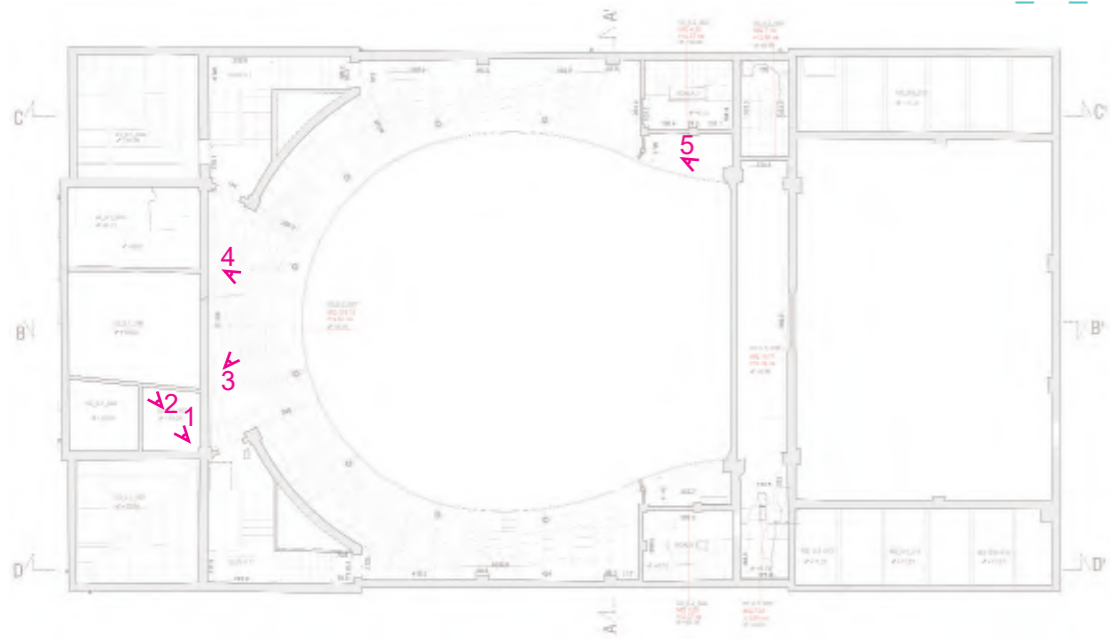
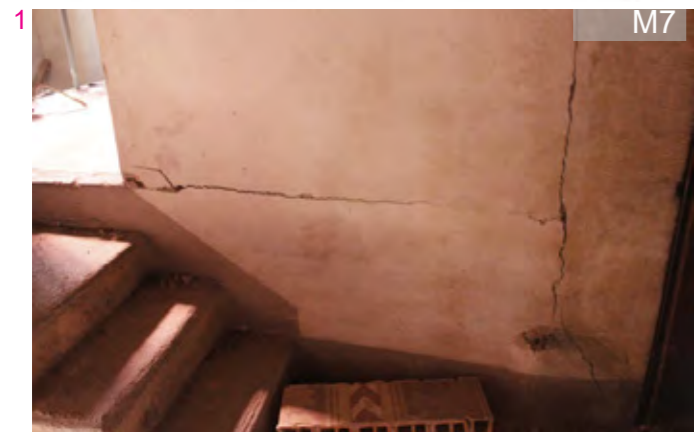
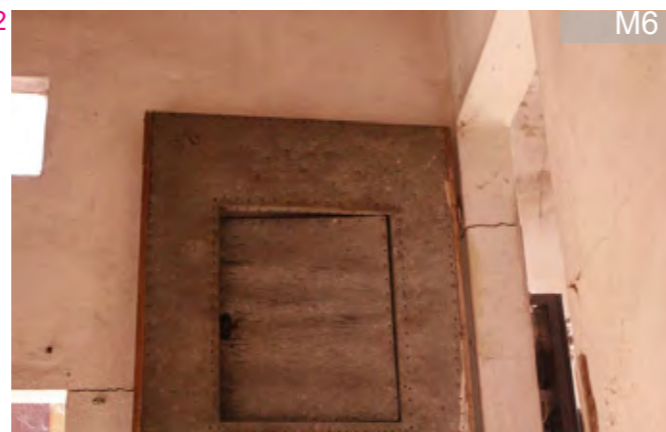
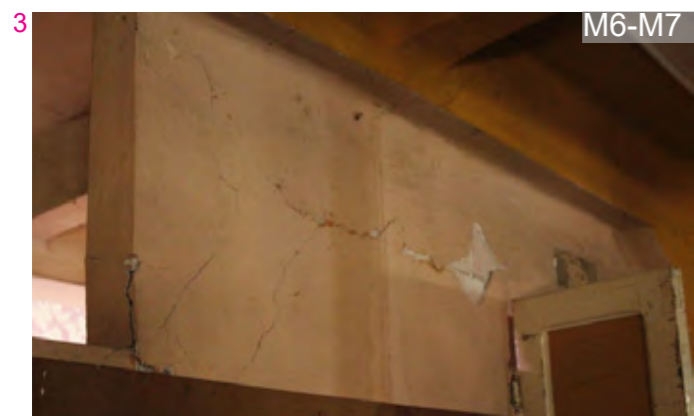
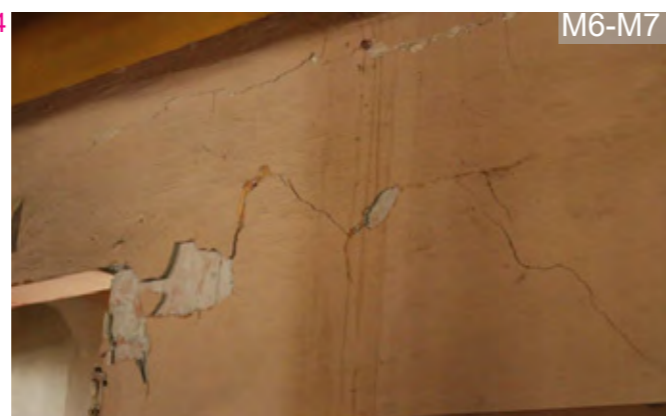
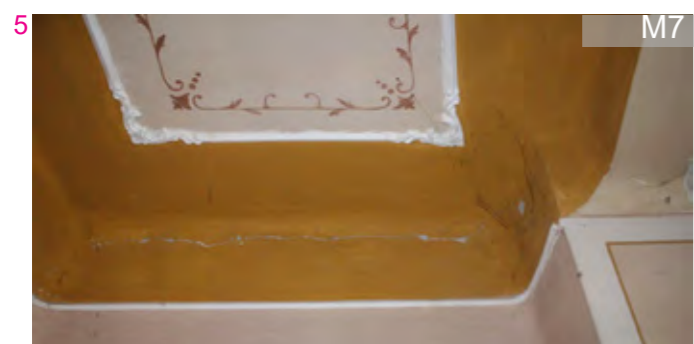
M12
US 0.1
02_01_001/003

Detail views of the cracking framework of the space intra-slab 02_01_003

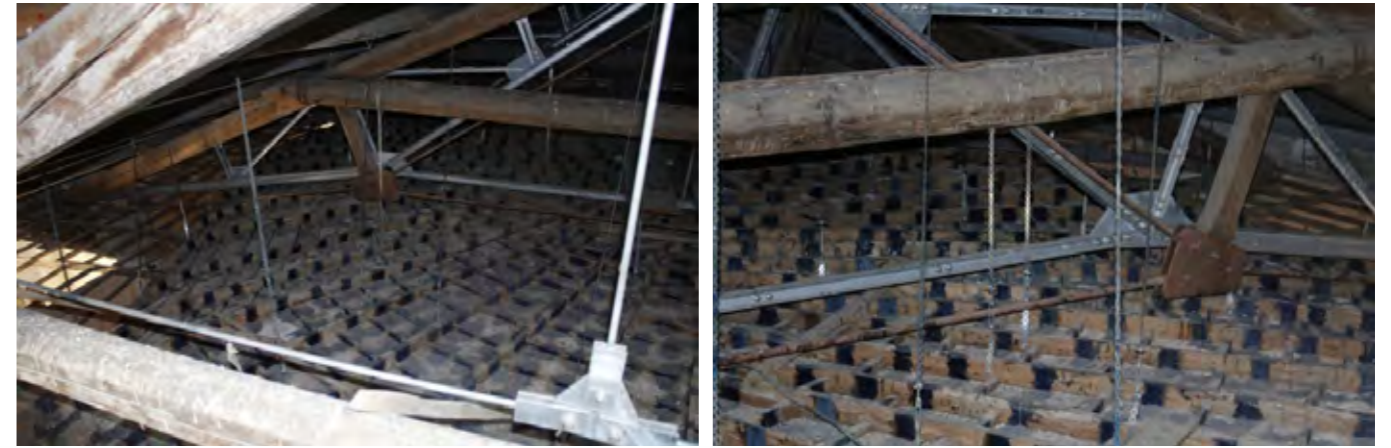
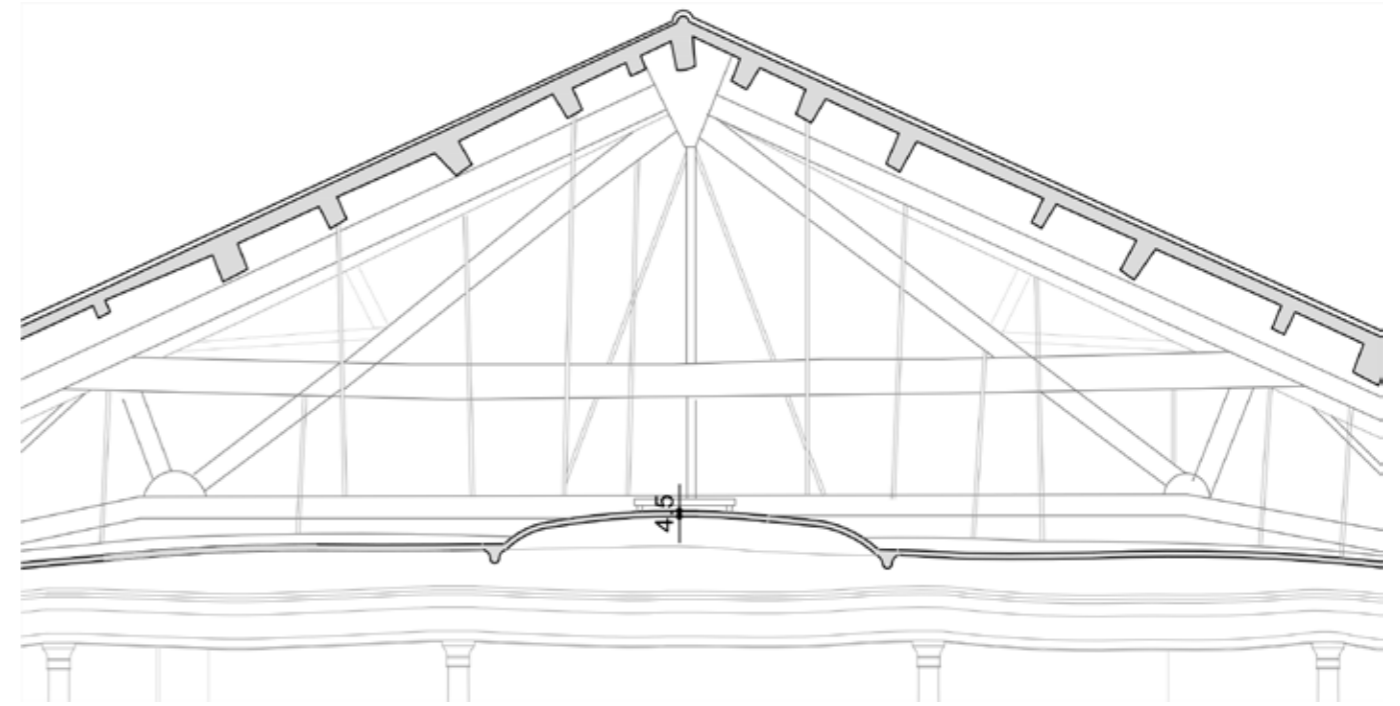
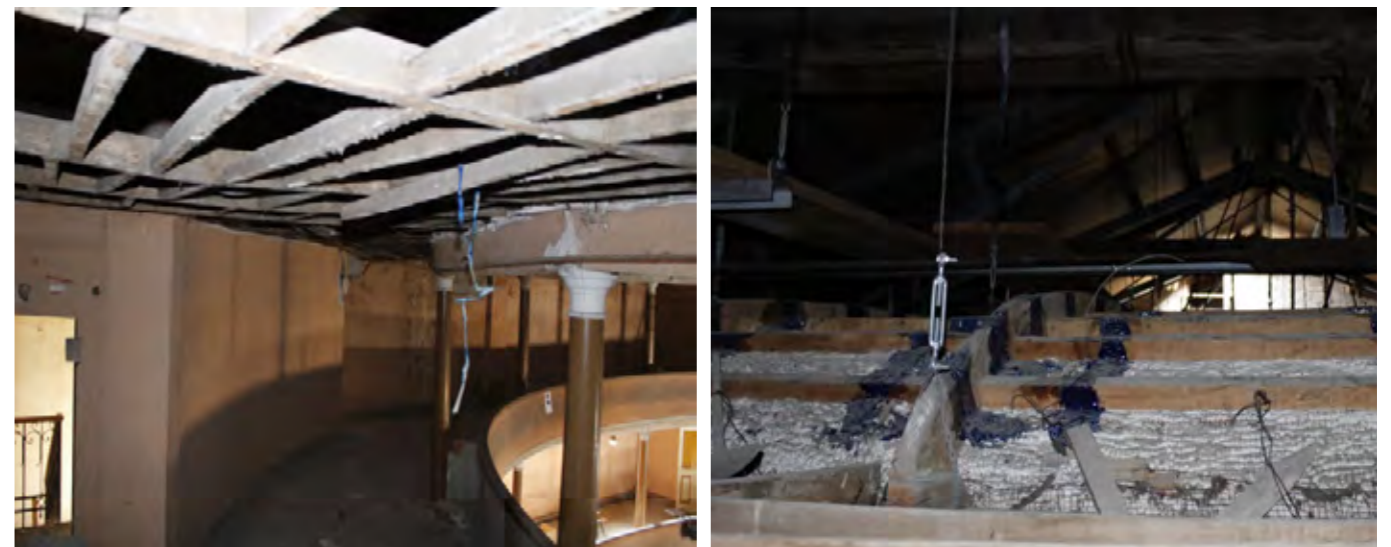
M18-M22
US 0.2
03_0.2_001

Detailed plafond system views

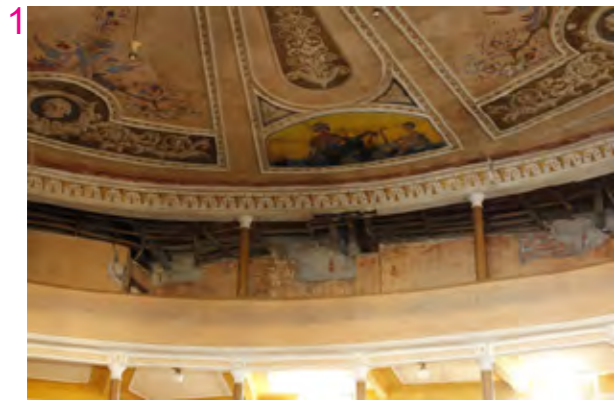
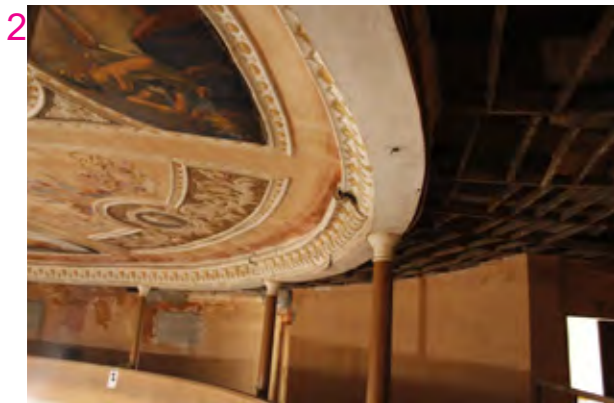
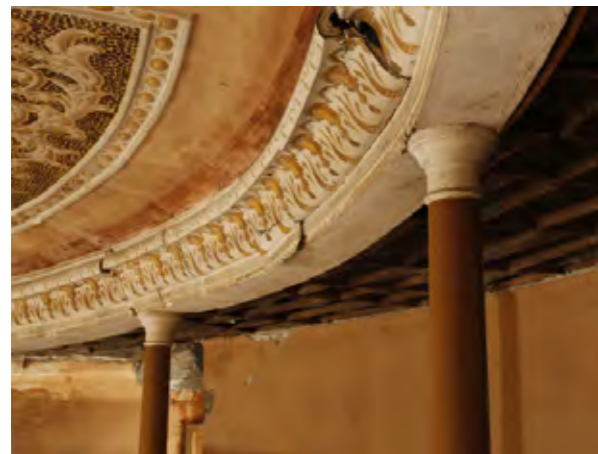
M18-M22
US 0.2
03_0.2_001

Detailed views of the damage found across the gallery border

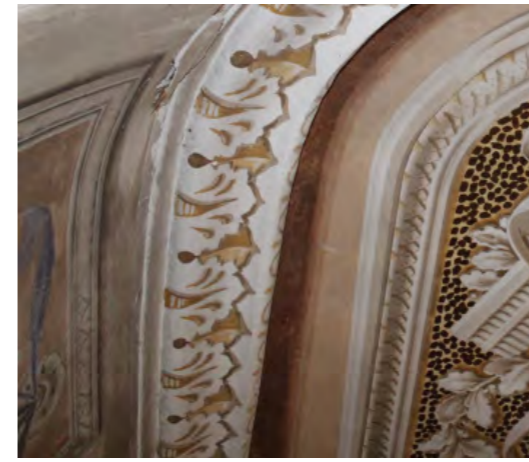
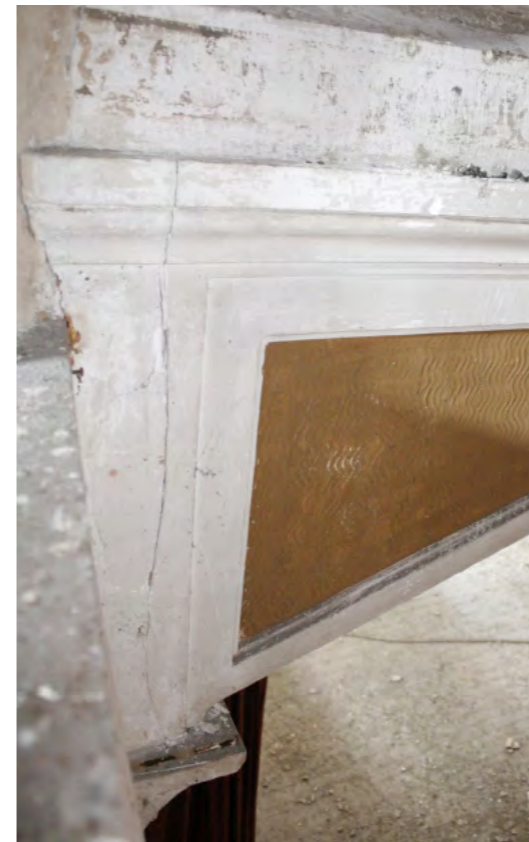
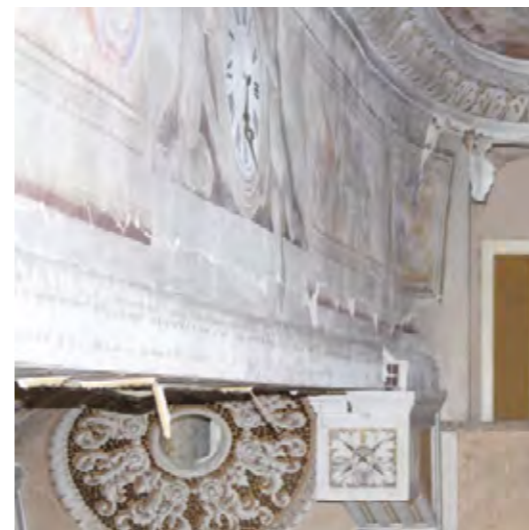
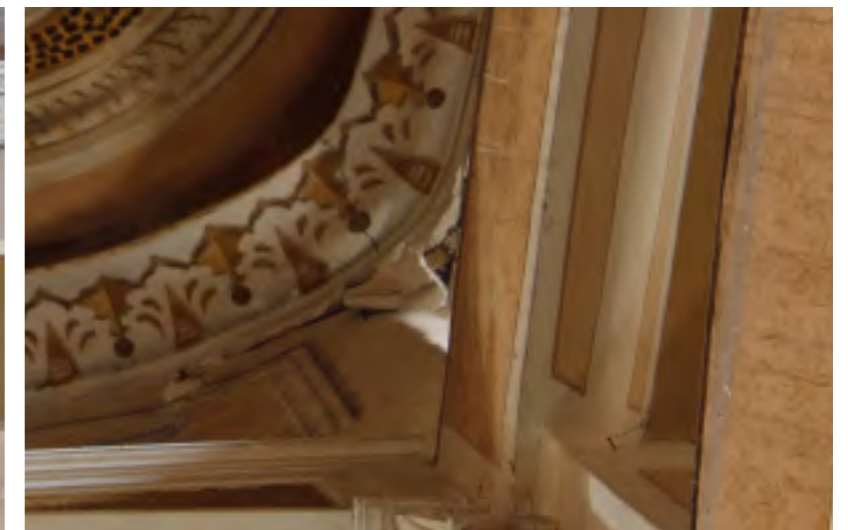
M18-M22
US 0.2
03_0.2_001

Detail views showing beam and scenic arch injuries

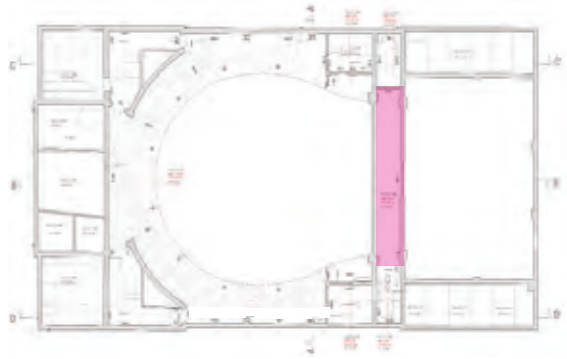
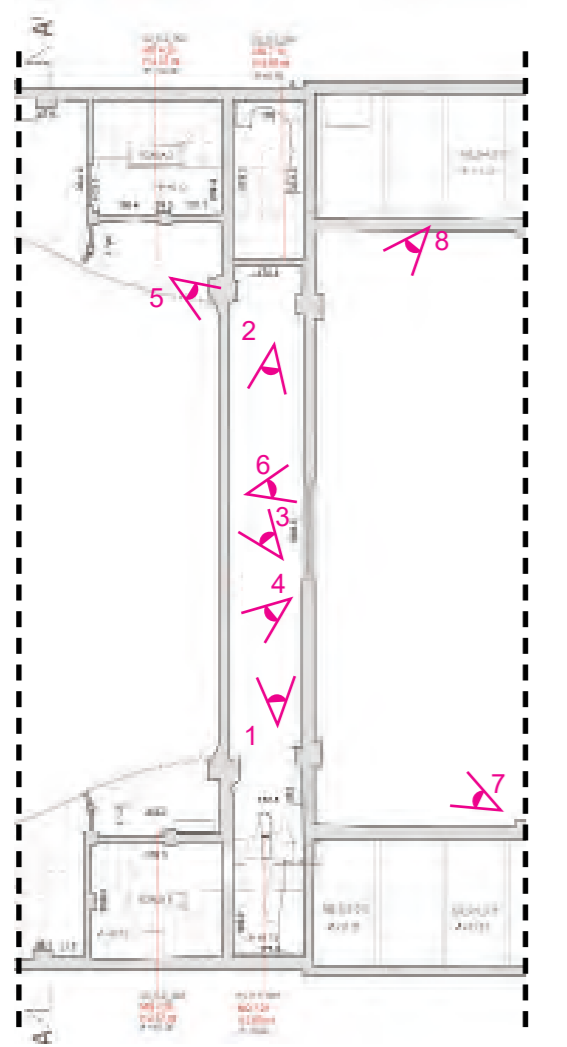
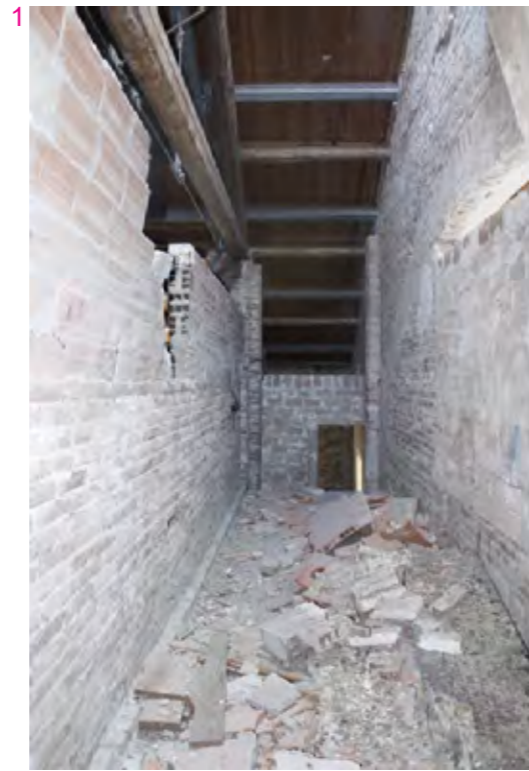
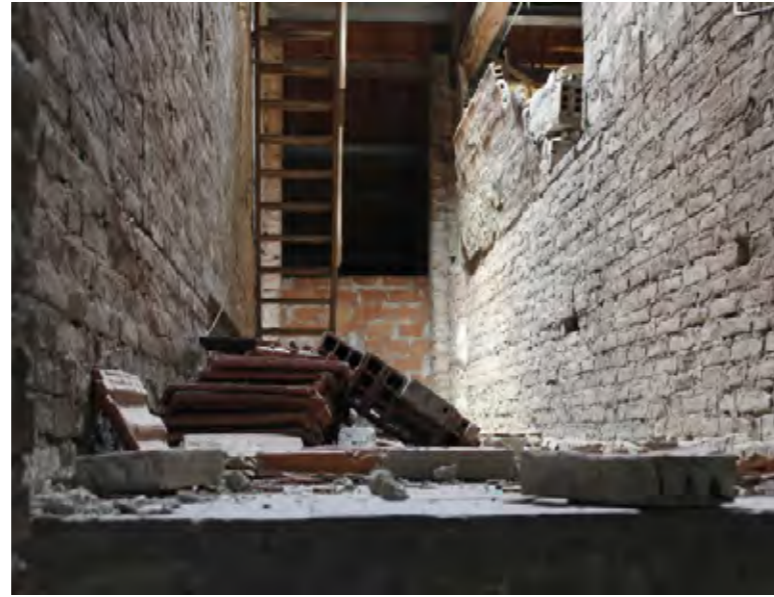
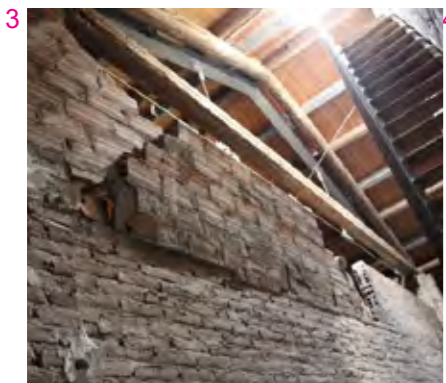
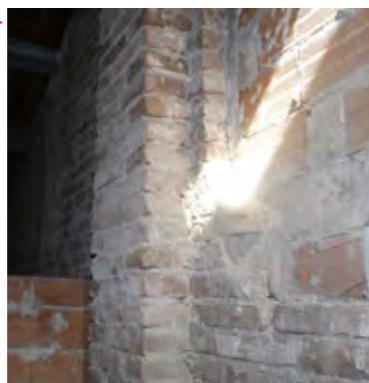
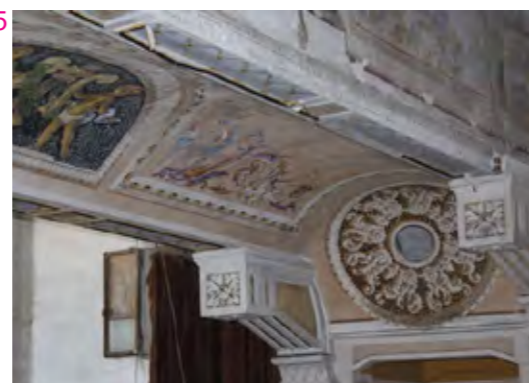
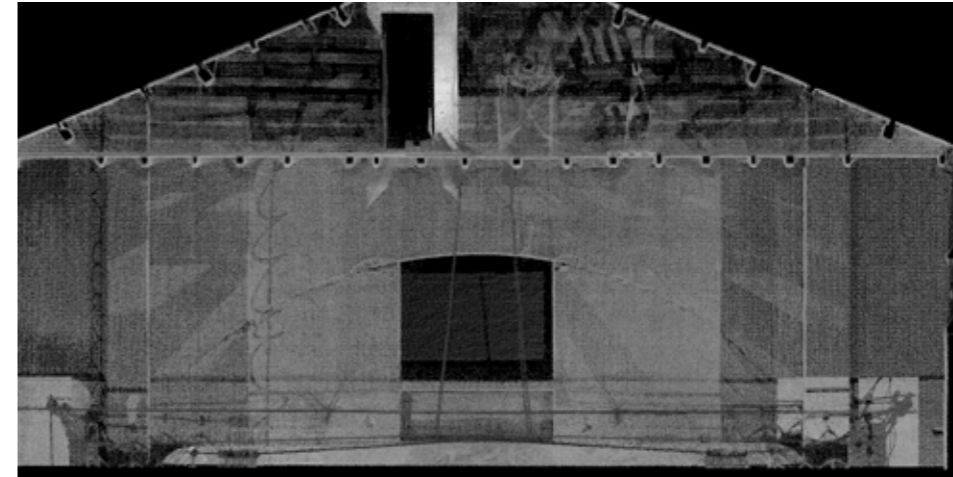
M23/25
US 0.3
03_0.3_006

Detailed views of the damage found across the gallery border

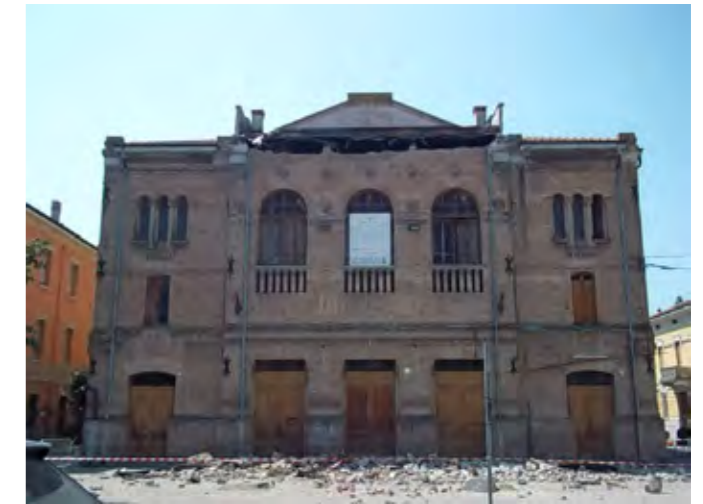
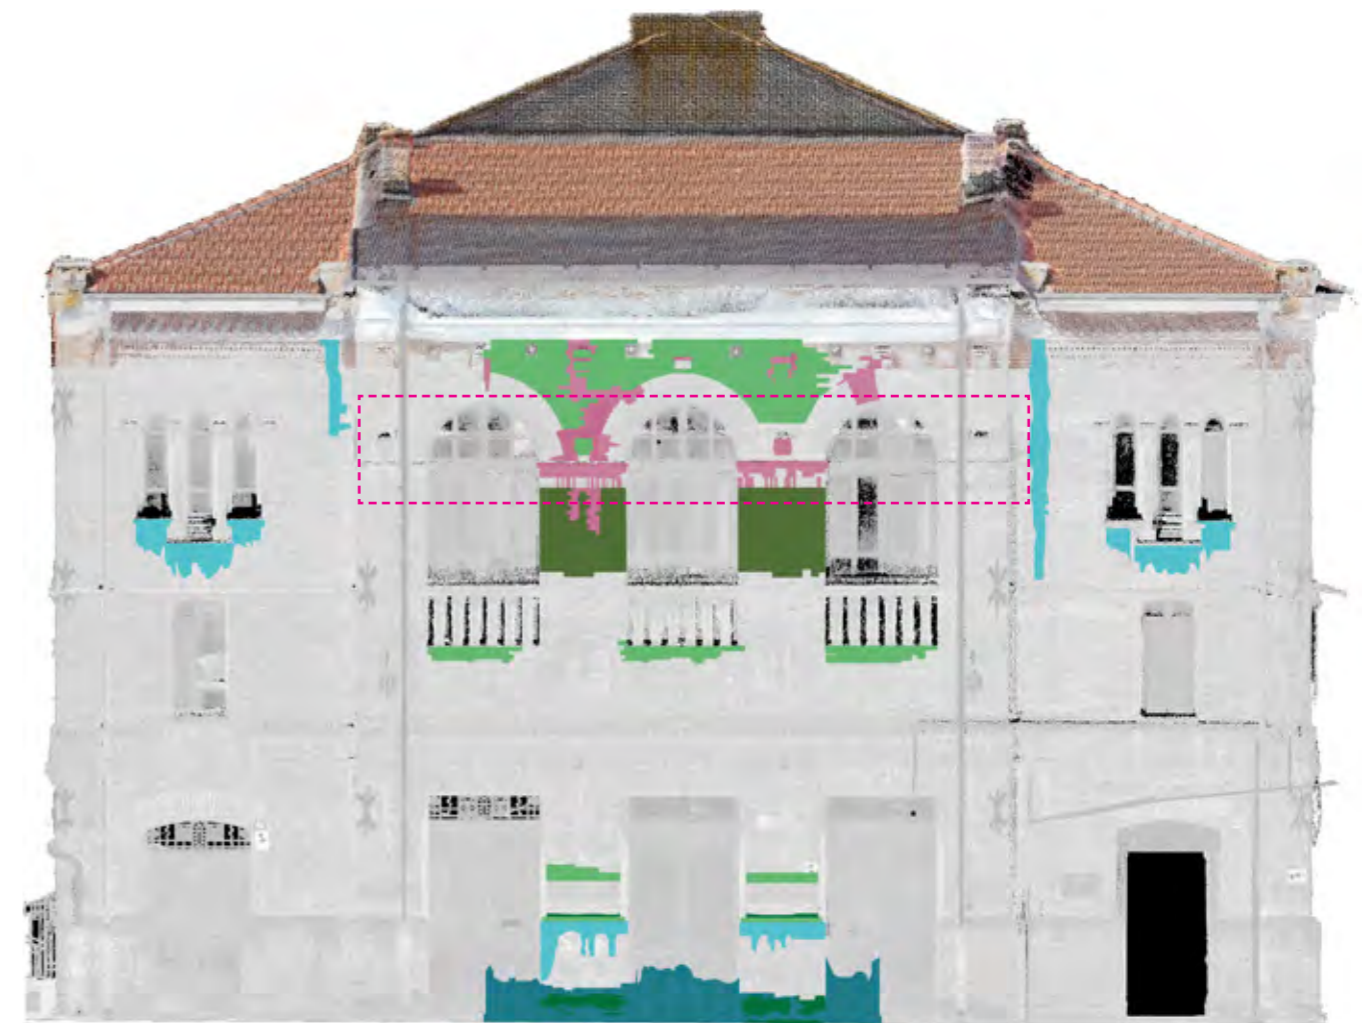
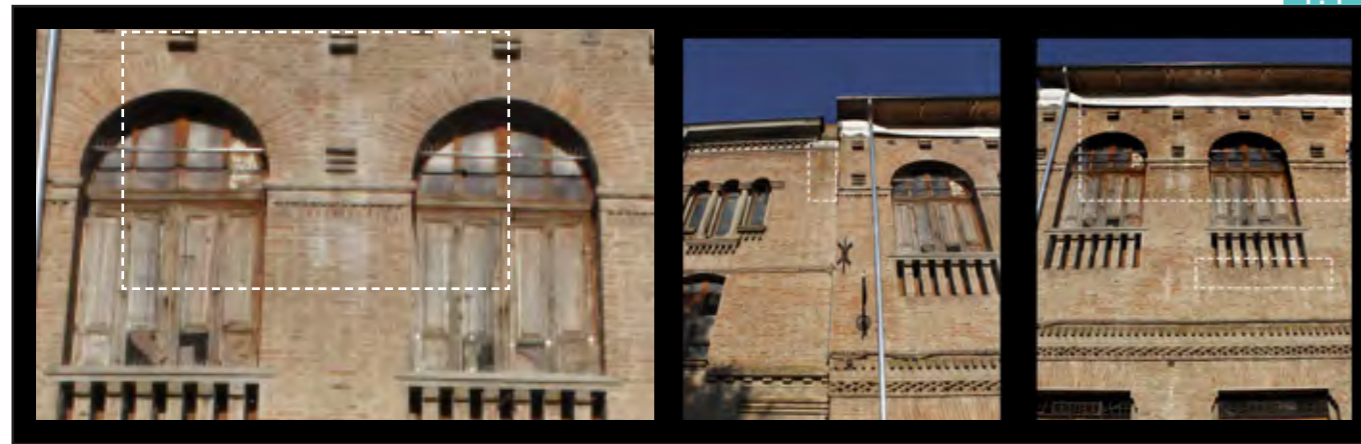
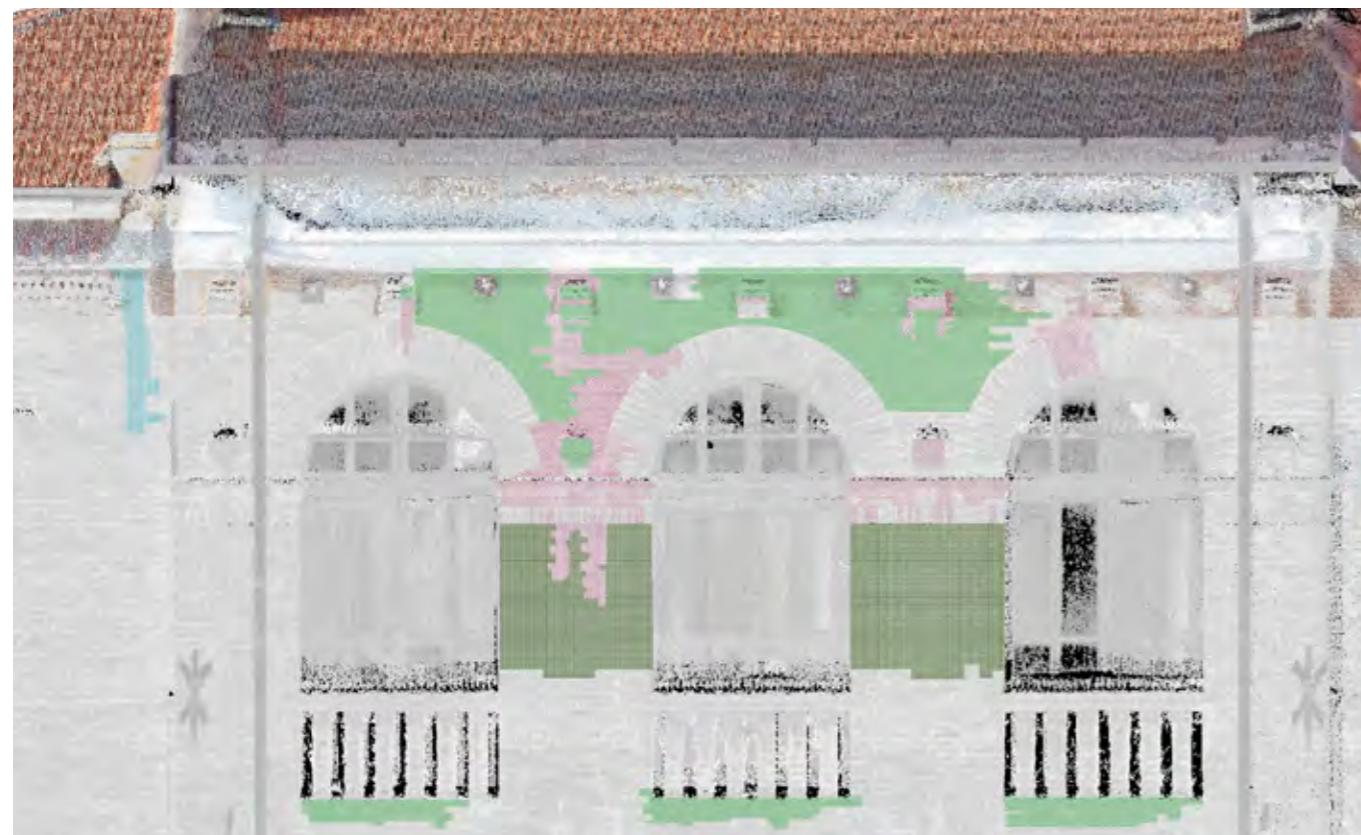
Degradation morphology survey: east elevation (viale dei Martiri della Libertà)

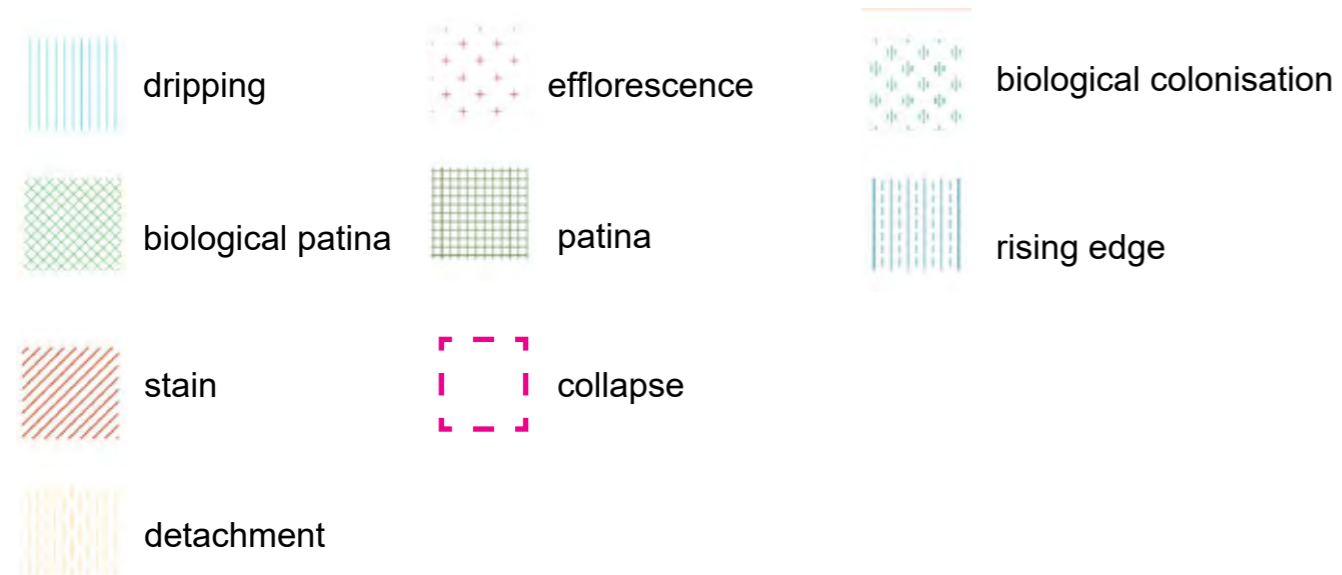
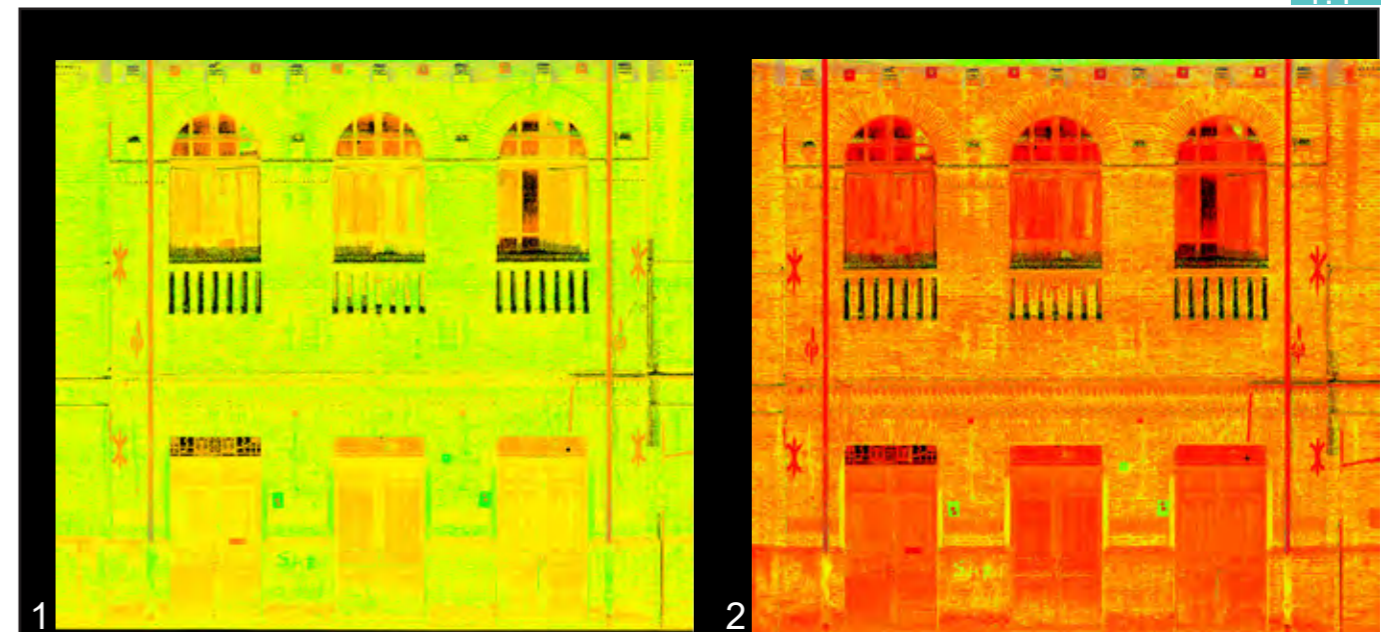
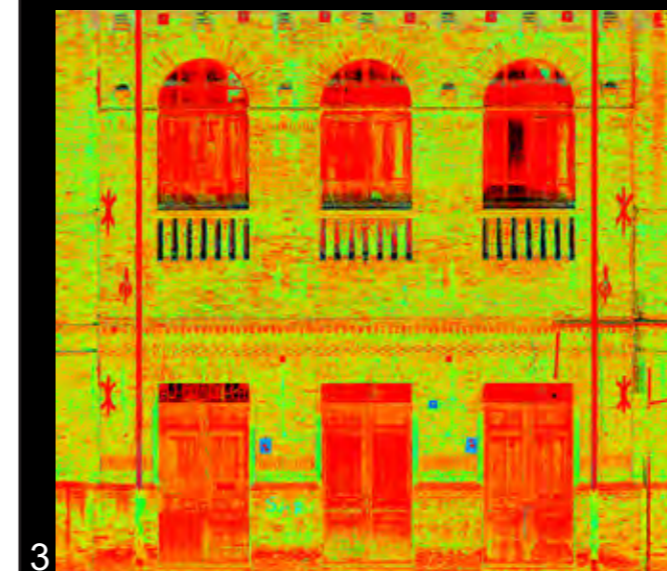
Map of degradation morphologies

Interpretation data of reflection values.

- 1) green: brick surface
 yellow: biological patina
 orange: biological colonisation
- 2) yellow: efflorescence
 dense orange: efflorescence
 red: biological patina
 dense red: rising front
- 3) dense green: efflorescence
 orange: run-off; biological patina
 red: biological colonisation
 dense red: rising front
- 4) dense blue: efflorescence
 cyan: efflorescence, biological patina
 green: biological colonisation
- 5) blue: brick surface
 cyan: biological patina, dripping
 green: biological colonisation
