Optimisation of survey procedures and application of integrated digital tools for seismic risk mitigation of cultural heritage: The Emilia-Romagna damaged theatres.

APPEDIX B: DAMAGE SURVEY

B PD form - Social Theatre of Novi (Modena)

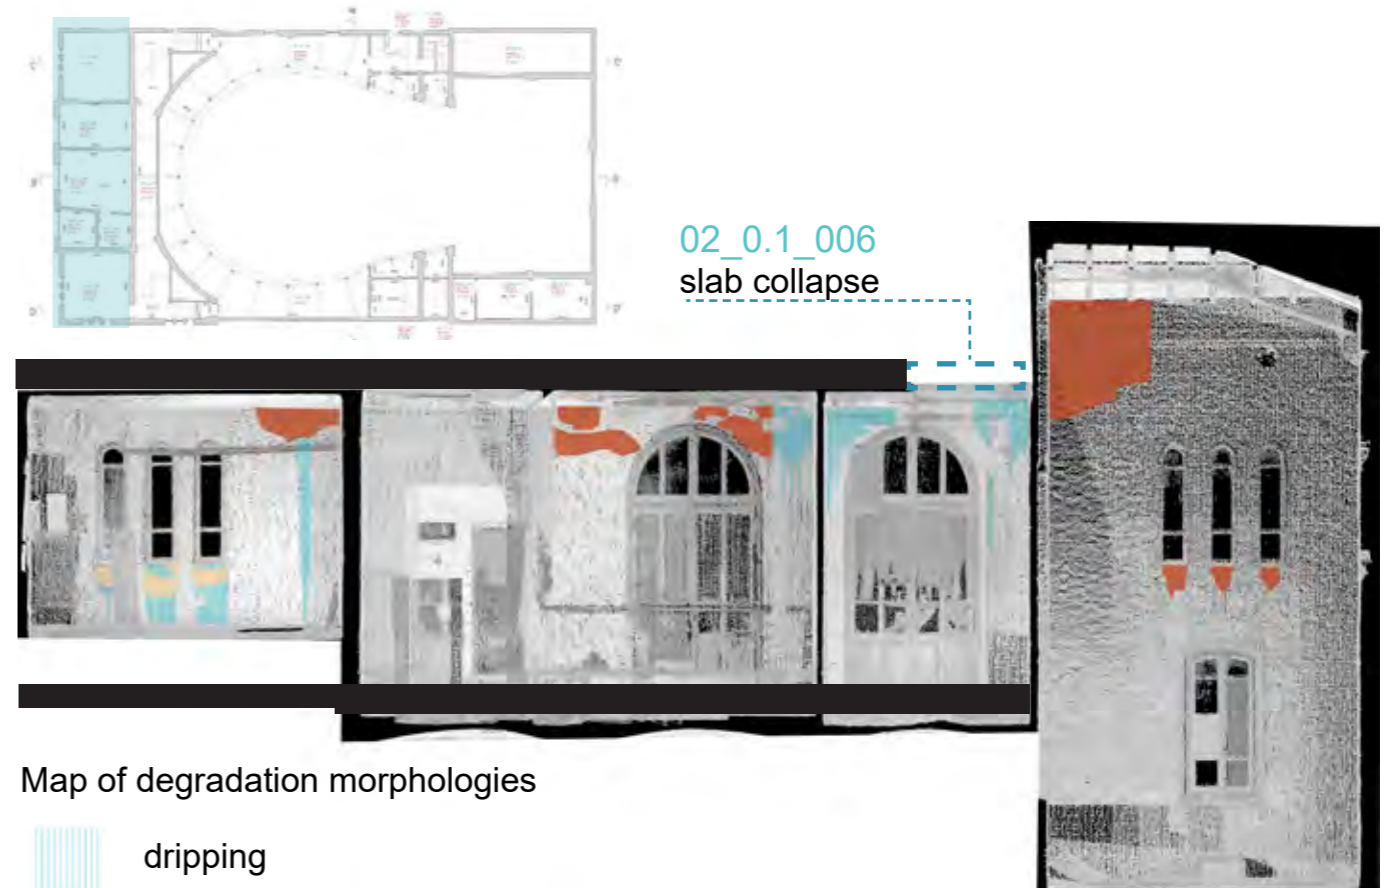
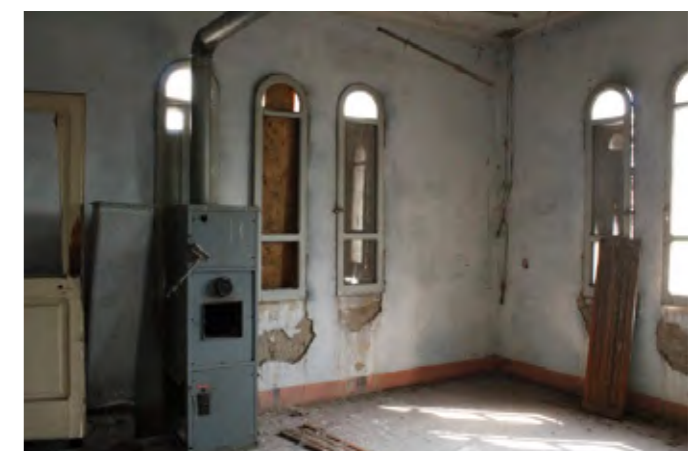
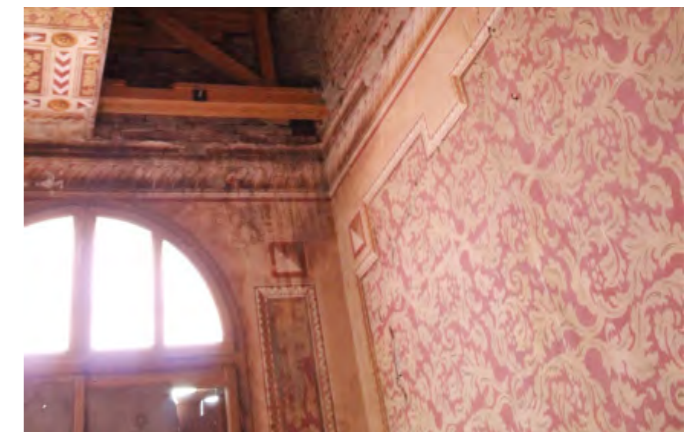
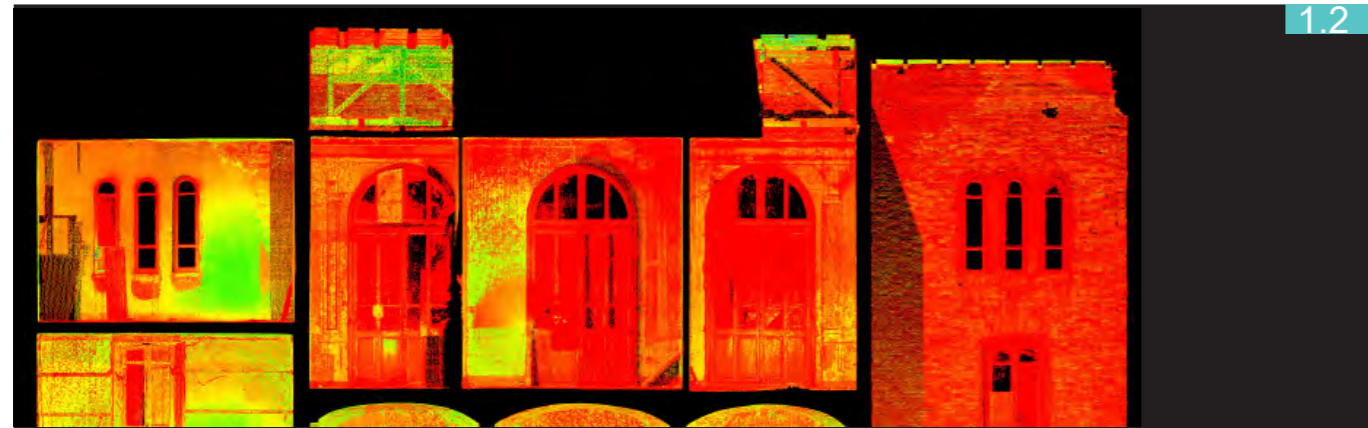
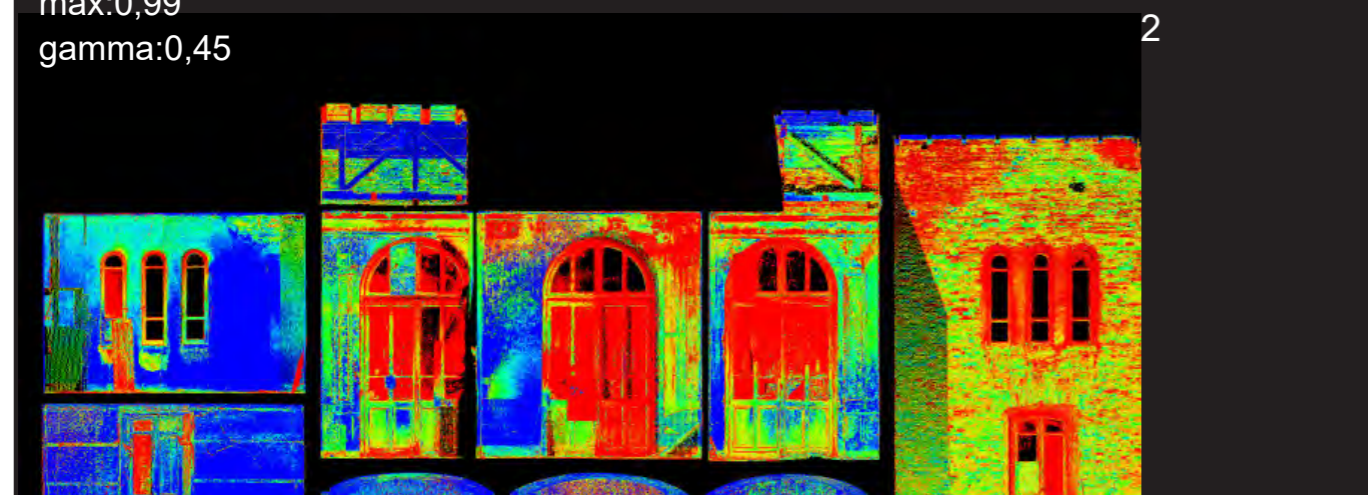
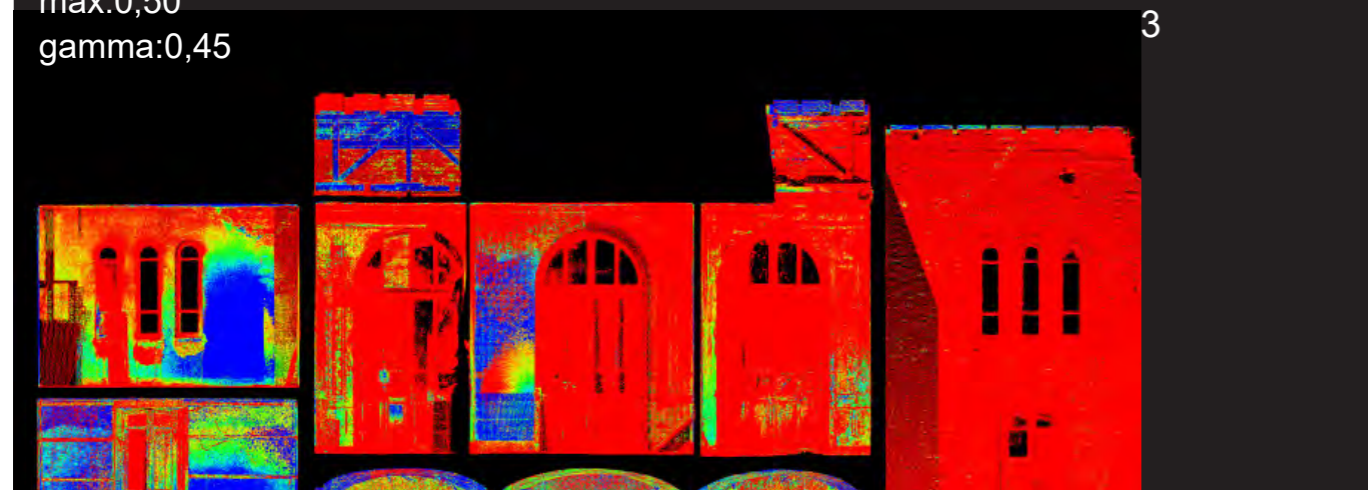
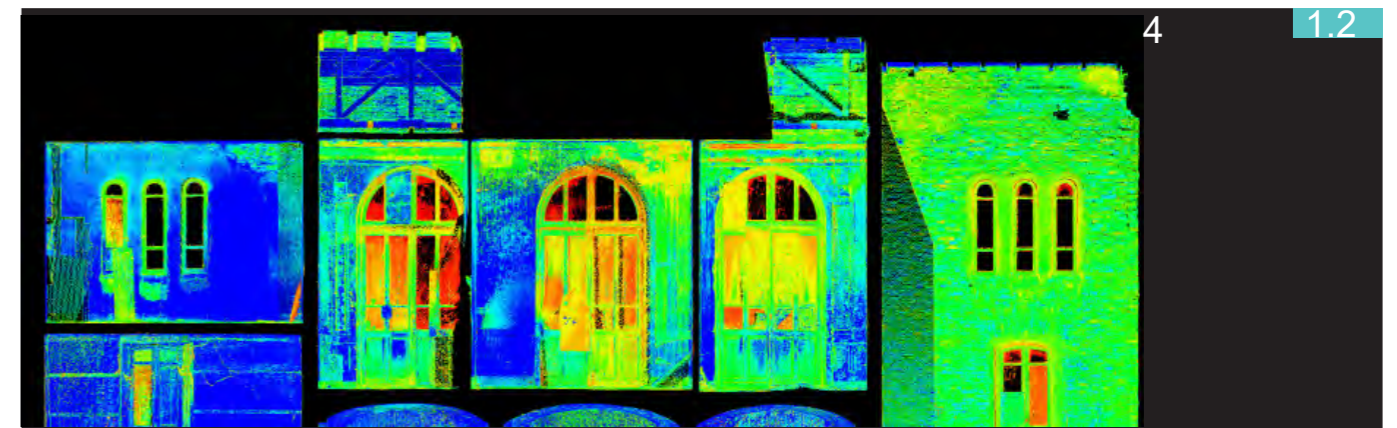
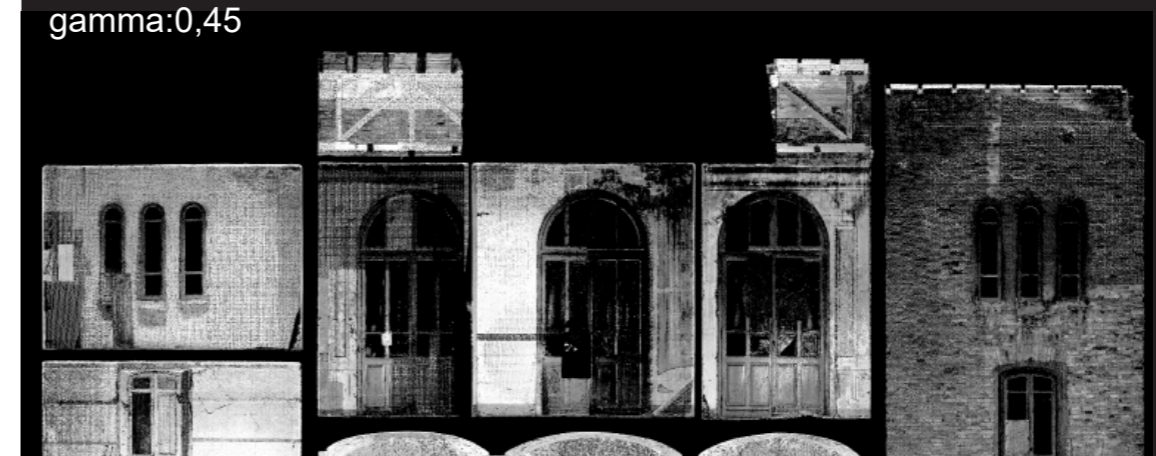
02_0.1.002-03-04-05-06

Interior surface degradation related closely to seismic damage (east view)

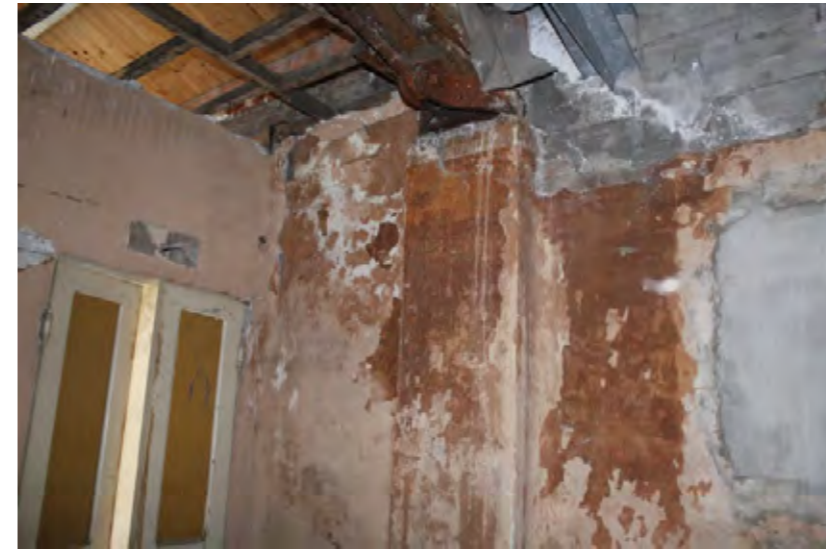
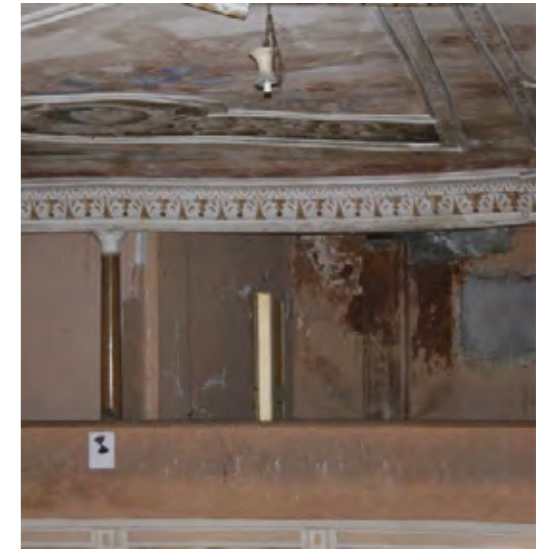
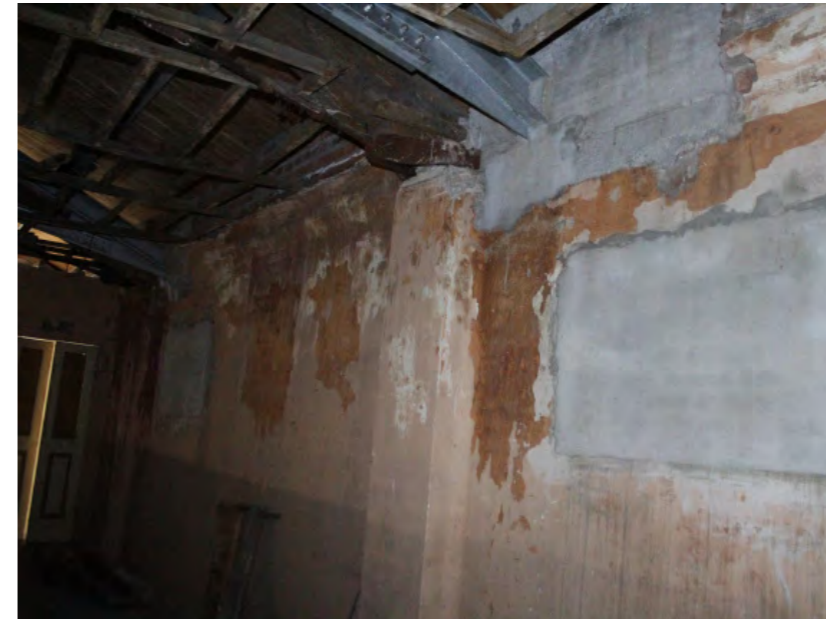
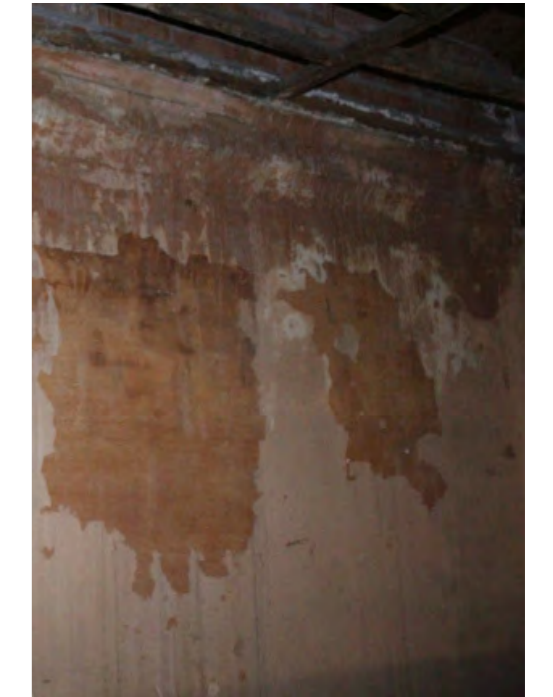
1.2

Analysis of decay morphologies of the ceiling vault.

Causes of decay: the presence of water.

Phenomenon: "darkening" of the vault due to thermo-hygrometric conditions of the vault.

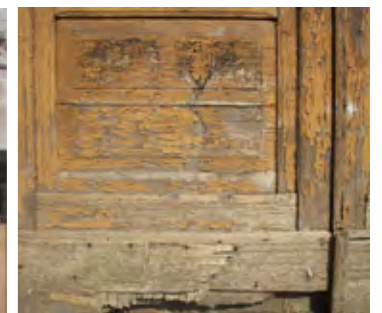
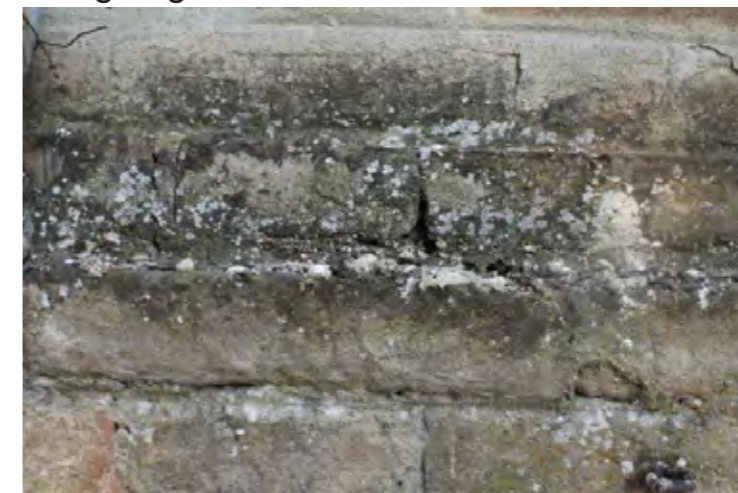
exfoliation: present along the wooden frames (the phenomenon is most present along the lower bar of the theatre entrance doors, especially on the east and north fronts)

rising edge

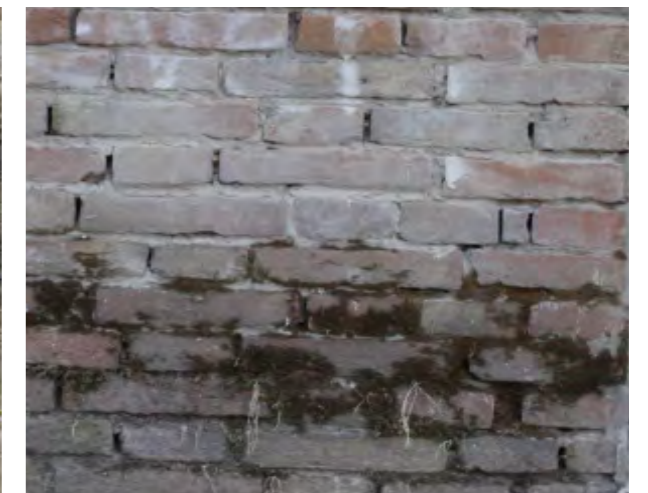
biological colonisation

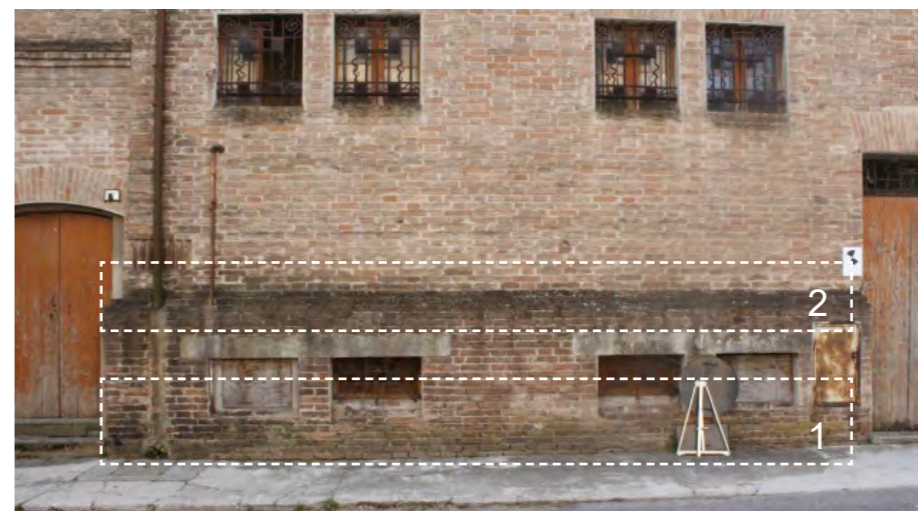
photographic survey basement strip

1-rise; biological colonisation
 2-dripping; biological patina: the phenomenon is linked to inadequate water disposal..

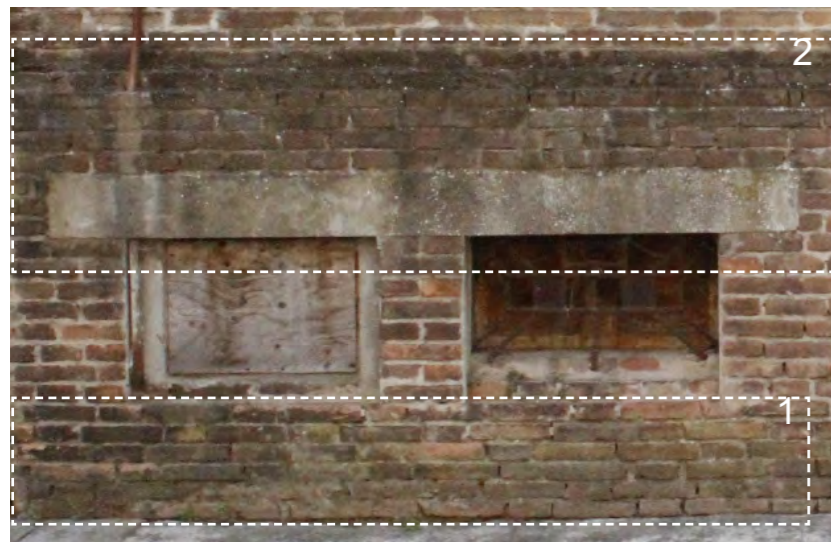
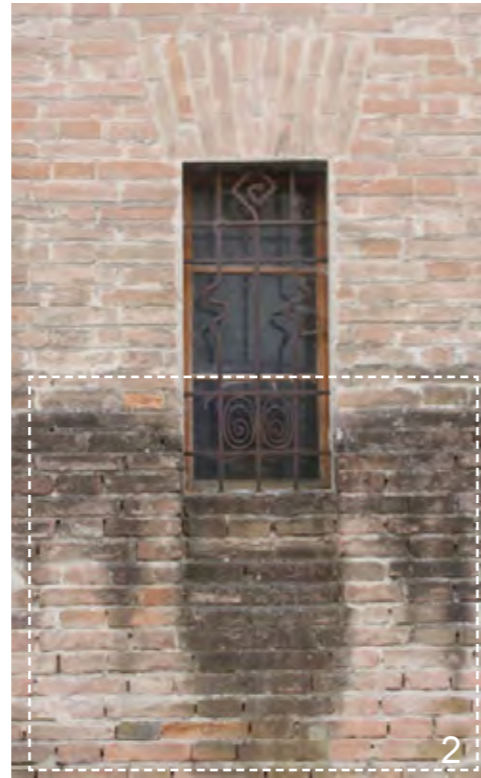
1-rise; biological colonisation

2-dripping; biological patina: the phenomenon is linked to inadequate water disposal..

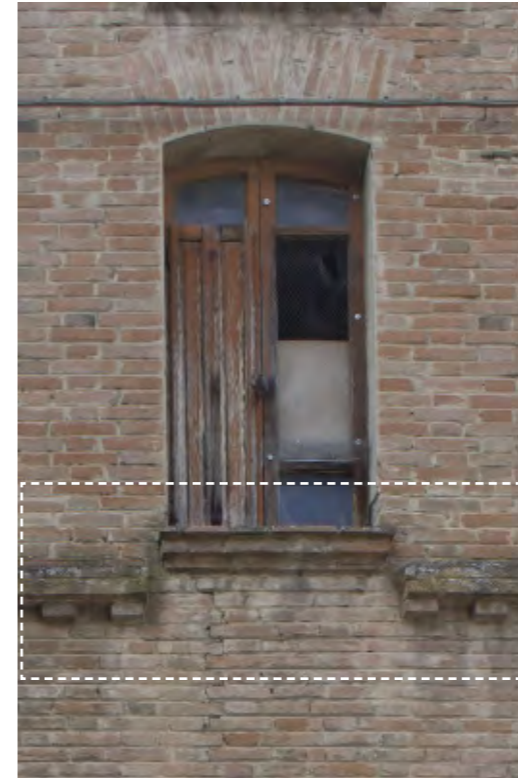
2-Colouring; biological patina: the phenomenon is linked to inadequate water drainage, often caused by the absence of pavement markers.

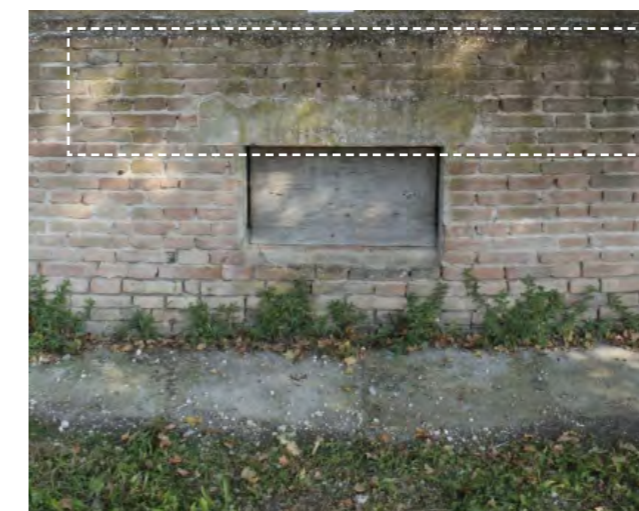
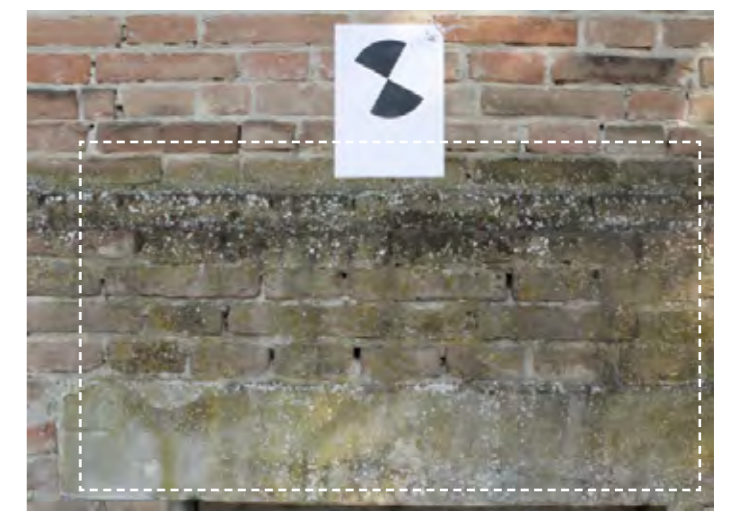
1-rise; biological colonisation; the presence of vegetation

2-colouration; biological patina: the phenomenon is linked to inadequate water disposal.

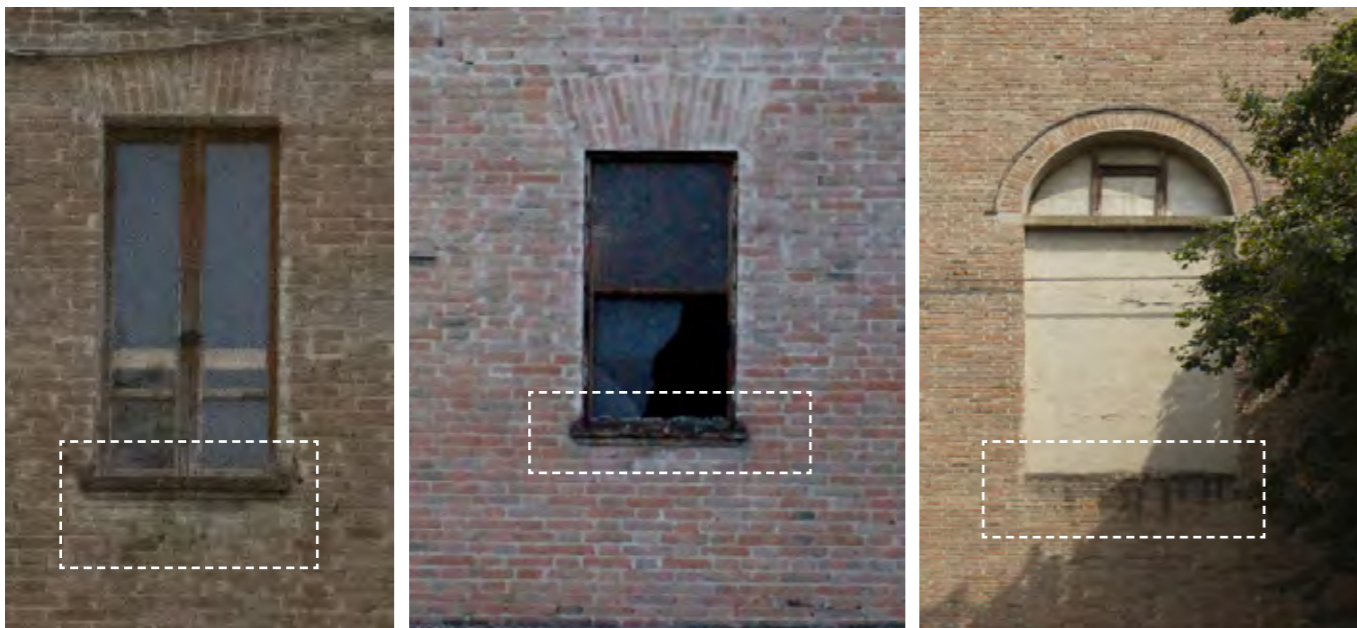
2-Colouring; biological patina: the phenomenon is linked to inadequate water drainage, often caused by the absence of surface markers.

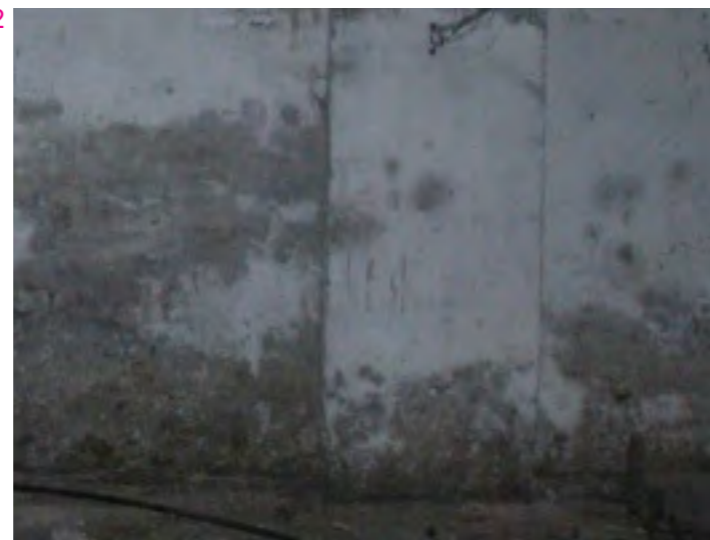
US 0.4
LG_0.4.001

1-2 rising edge

1-2 stain: localised colour change of the surface, related to the presence of water

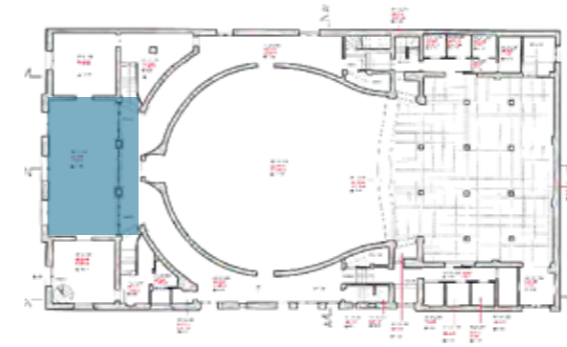
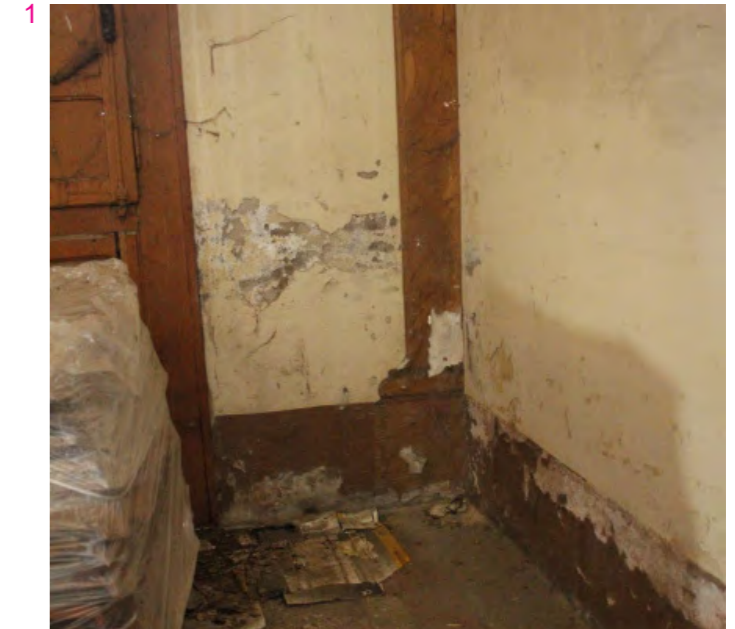
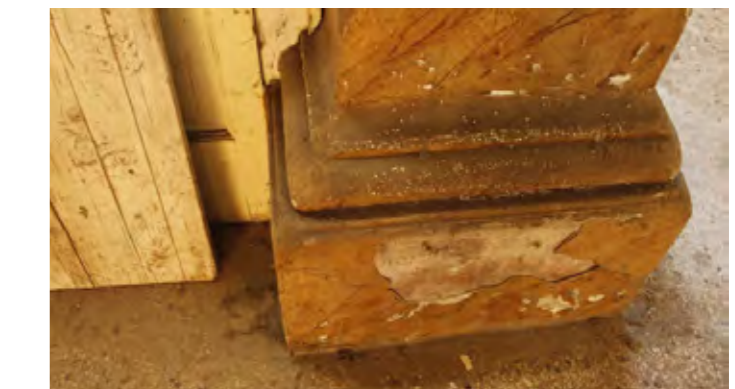
US 0.1
GF_0.1.002

1 -detachment is a phenomenon present on plasterwork, with the layers falling off.

2 -detachment of the decorative film

2 - 3 superficial deposit

3 - biological colonisation

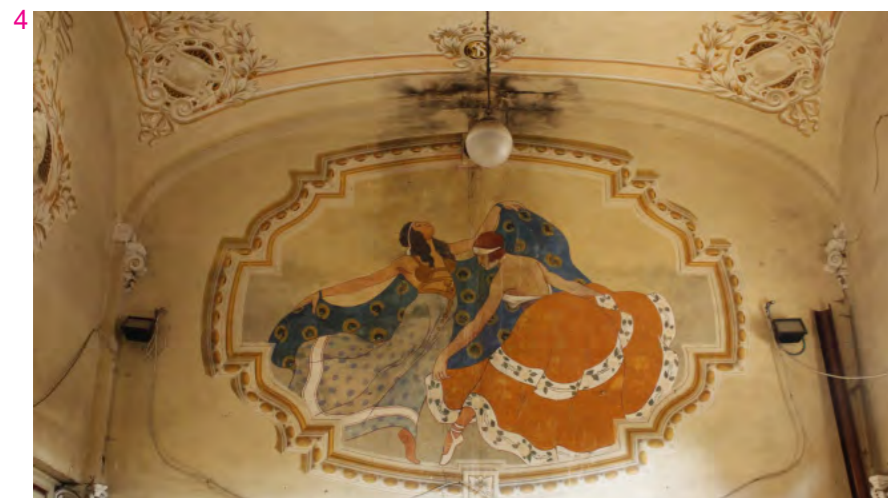
detail of the vaulted ceiling GF_0.1.002

3-4-5 staining: localised colour variation of the plaster surface

3-5 differential plaster degradation

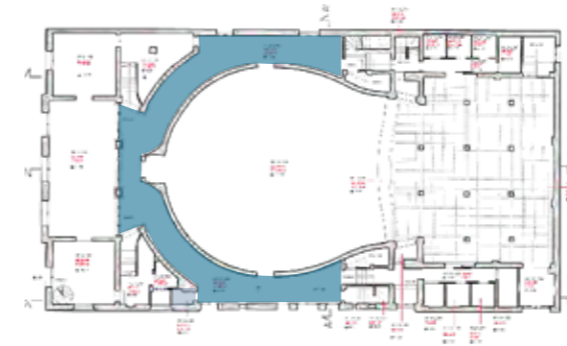
US 0.2
GF_0.2.005

1-2-3 stain: localised colour change on the plaster surface

1-2-3 differential plaster degradation

4- detachment: a phenomenon present on plaster, with falling layers.

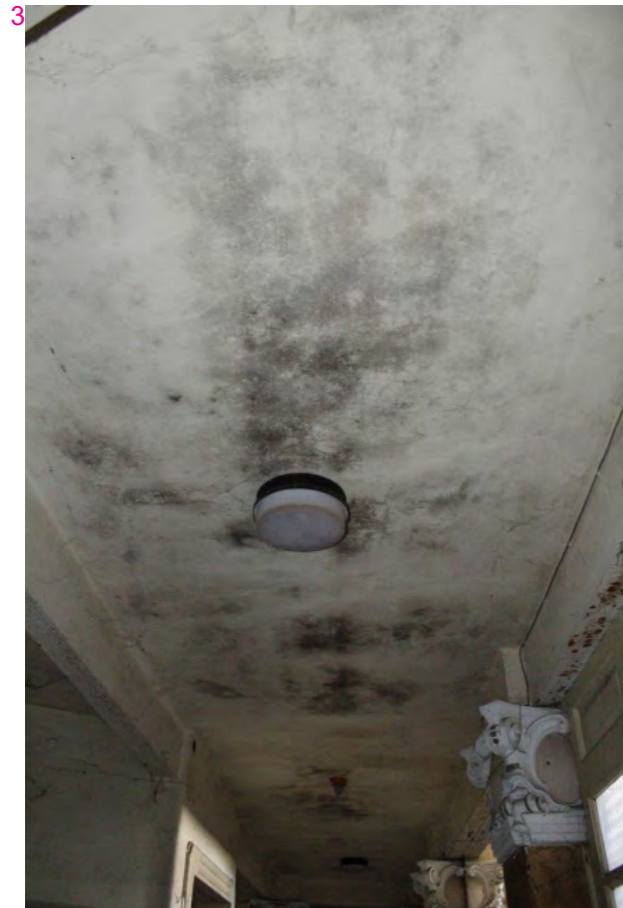
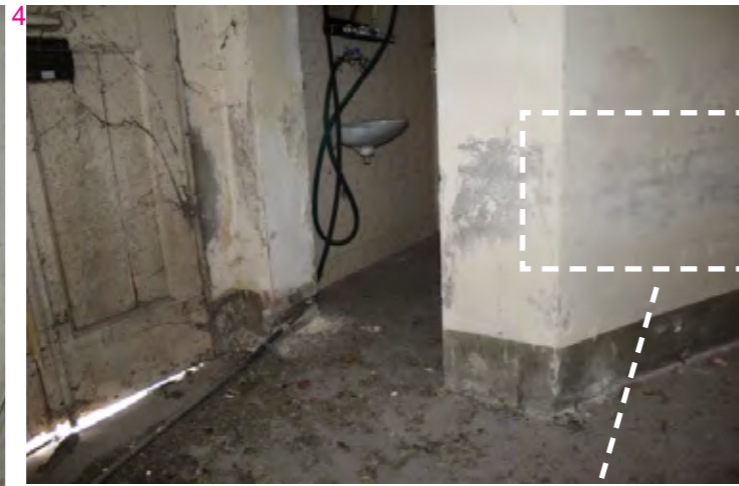
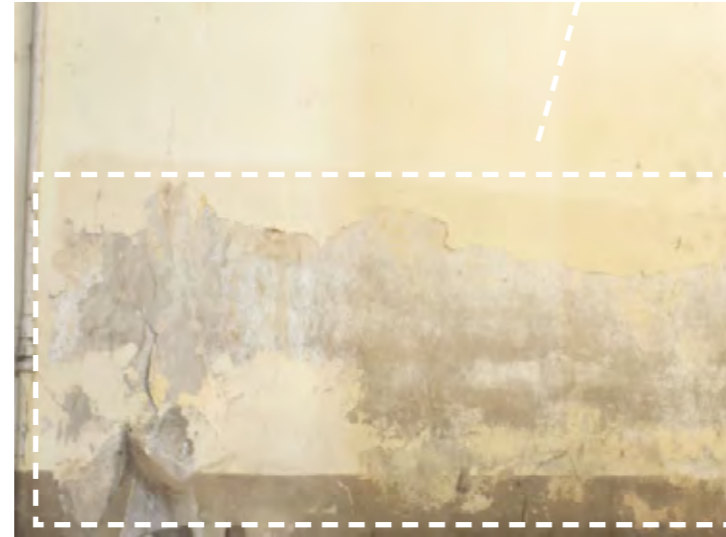
detail of the ceiling GF_0.2.005

macro detail of the plaster detachment partially visible in photo 4

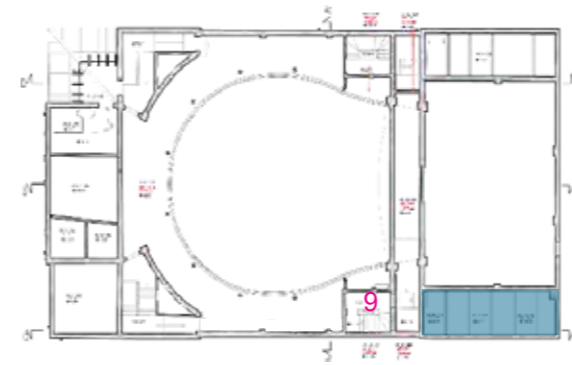
03_0.3.013-14-15

1-2 staining: localised colour change on plaster surface

1-2 dripping

1-2 differential plaster degradation

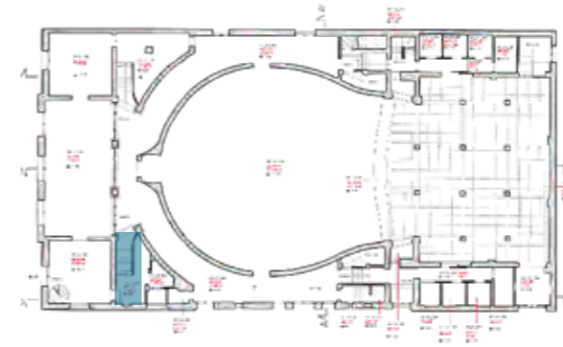
staircase 2

- 1-2 detachment: phenomenon present on plaster, with falling layers.
- 1-2 surface deposit
- 1- vandalistic murals(corridor wall)

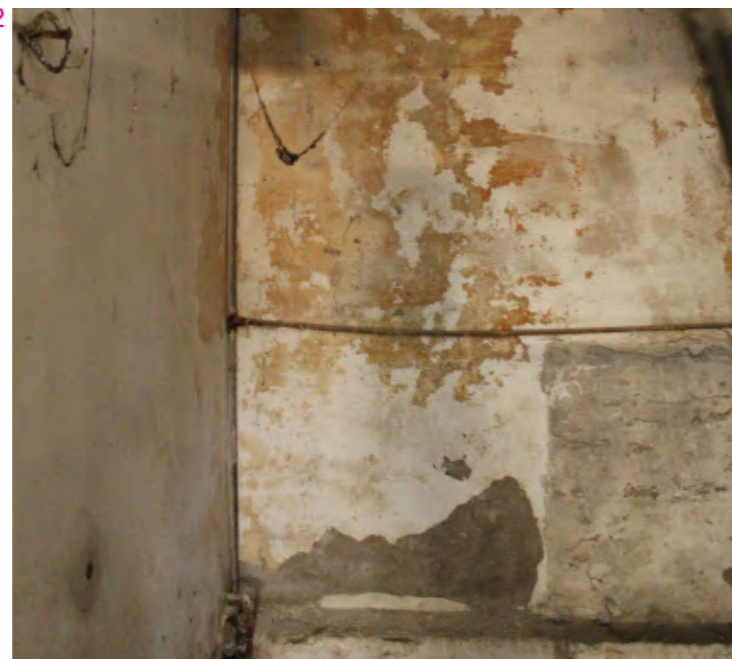
staircase 9

1-2 staining: a localised colour variation on the surface, related to the presence of water

1-2 detachment: a phenomenon present on plaster, with the layers falling off

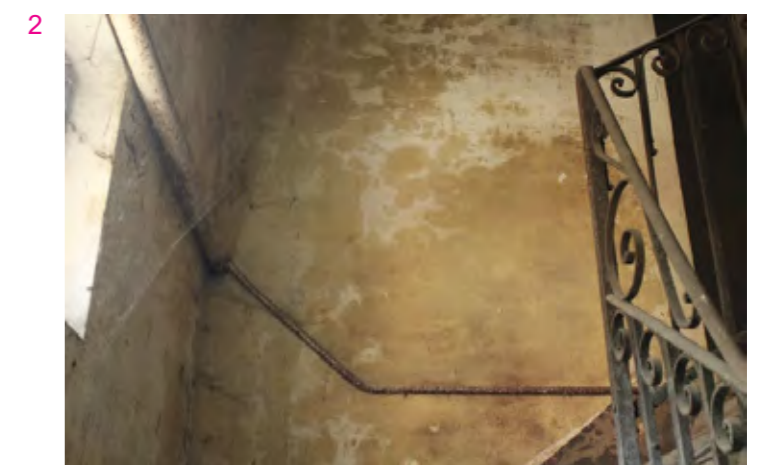
staircase 7

1-2 staining: localised colour variation on the surface, related to the presence of water

1-2 detachment: a phenomenon present on plaster, with the layers themselves falling off

1-2 differential plaster degradation

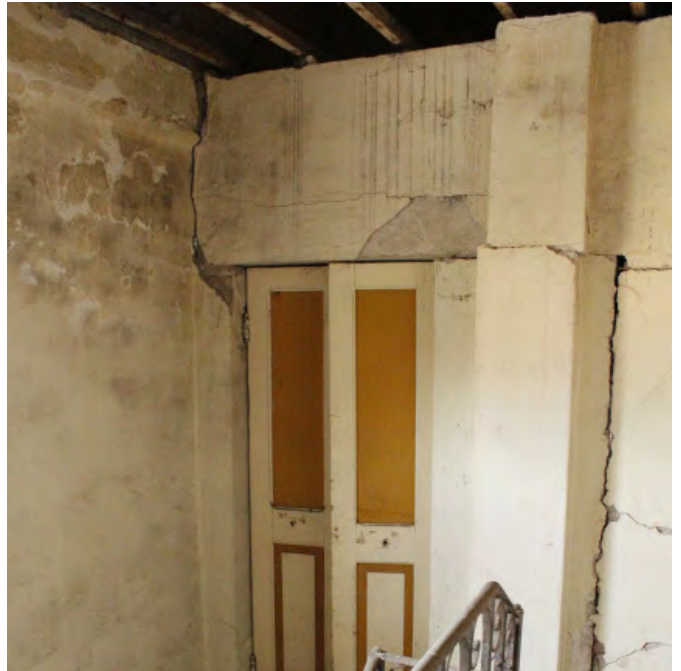
1

1-2-3 staining: localised colour change on the plaster surface

1-2-3 dripping

1-2-3 differential plaster degradation
