Evaluation of the Wear-Resistant Plate Performance on Different Locations over the Flow Path of a Large-Sized Heavy-Duty Centrifugal Fan

Fan Noise, Aerodynamics, Applications and Systems

Keywords: large-size centrifugal fan; erosion; wear-resistant plate; dust-laden flow

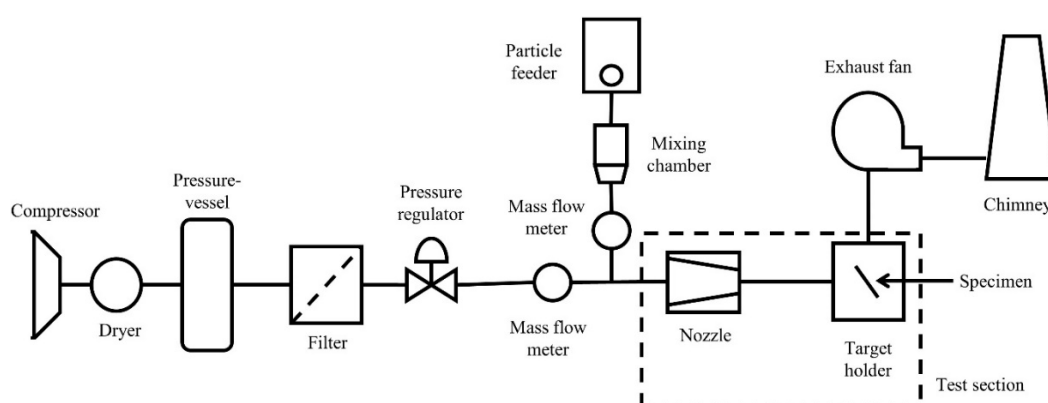
Figure 1. Schematic layout of the experimental test bench.

The present section describes a jet-impingement test bench designed and built at the Fluid Machinery Laboratory of the Department of Engineering of the University of Ferrara. The schematic view of the whole erosion facility and the main components is depicted in Figure 1. The test bench employs dry and clean shop air provided by a screw compressor. The air is mixed with a dosed amount of powder and then accelerated in a sand-blast nozzle toward a square specimen in the test chamber. The nozzle outlet section has a diameter of 4 mm. An exhaust fan linked to a chimney recirculates the air inside the test chamber. The air mass flow rate is controlled by a pressure regulator upstream of the nozzle. The specimen is placed on a target holder, which allows an accurate regulation of tilt angle and distance from the nozzle outlet section. For the present application, a distance of 10 mm between the nozzle and the specimen surface is chosen. Preliminary tests were carried out employing alumina particles (Al_2O_3) (with 50 μm diameter) against 20MnB4 specimens (according to UNI EN 10269 [9]) with an elemental content as weight fraction (wt %): 0.228% C, 0.943% Mn, 0.068% Si, 0.010% S, 0.009% P, 0.025% Al, 0.003% B, 0.042% Ti, 0.070% Cr, 0.033% Ni, 0.039% Cu, 0.0001% Pb, and iron (balance). Through the preliminary tests, the reliability of the test bench was validated, since the results were in line with those provided by the ASTM G76 [10]. A detailed description of the test bench performance and usage are provided in [6,7].

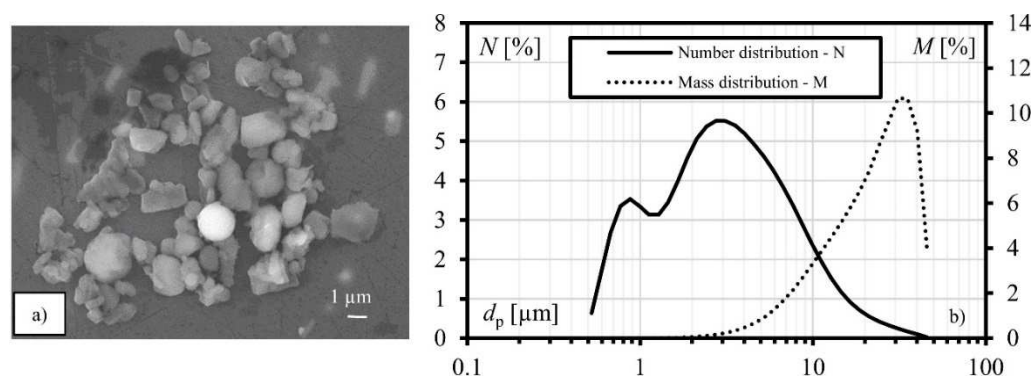
Figure 2. Characteristics of the powder employed: (a) SEM observation, and (b) number and mass distribution.

It was made by sintering limestone and aluminosilicate materials, such as clay, during the cement kiln stage. The powder used in the present experimental campaign was collected directly from the plant where the fan operates. The powder morphology is depicted in Figure 2a, while its number and mass distribution are shown in Figure 2b. The particle density is 2.717 kg/m^3 , and its mean diameter is $4.34 \mu\text{m}$. The Malvern Mastersizer 3000 (Malvern Panalytical, Malvern, UK) and the AccuPyc II 1340 pycnometer (Micromeritics Instrument Corporation, Norcross, GA, USA) were used to measure particle distribution and particle density, respectively.

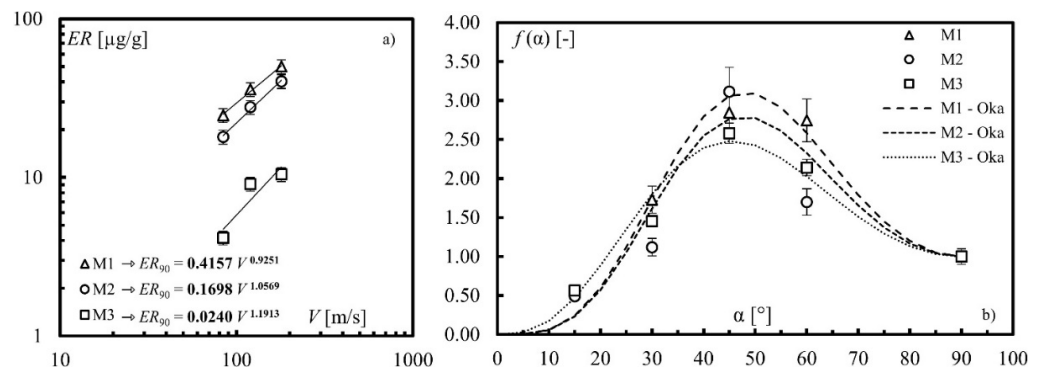
Figure 3. Results of the experimental test: (a) erosion rate at normal impingement angle, and (b) erosion rate over the angle (experimental values and Oka’s model interpolation).

Each impact angle and velocity combination is repeated on different specimens three times. An error band, calculated following the procedure reported by Schrade et al. [11], has been used to account for the variability related to the test procedure. The experimental results are depicted in Figure 3: Figure 3a reports the ER values at normal impact angle and the interpolation lines derived from Equation (1), while Figure 3b reports the experimental values of the angle function. The M3 plate confirms the higher resistance to particle wear. M1 and M2 have comparable wear resistance. The angle function shows a clear mixture of ductile- brittle behavior of the erosion process over the impact angle: the maximum of the ER is located at almost 45° . The three plate materials show similar angle function $f(\alpha)$ trends.

where n_1 and n_2 are numerical coefficients, and HV is the material hardness expressed in GPa. The results of Oka’s model interpolation are reported in Figure 3b as dashed lines, while the coefficients employed in Equation (3) are reported in Table 1 for the three tested materials.

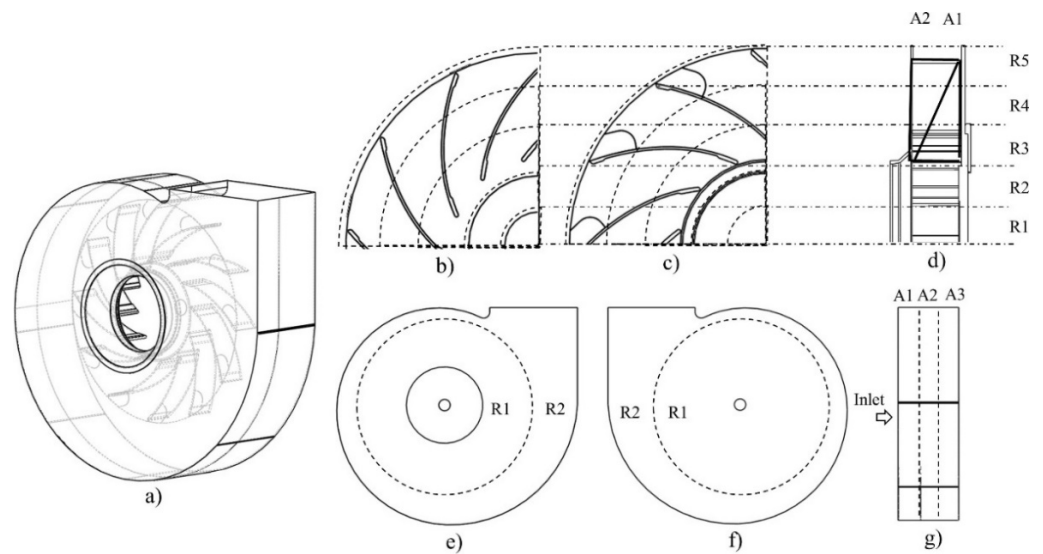
Figure 4. The strategy of fan surface patching: (a) fan model, (b) hub, (c) shroud, (d) rotor, (e) volute front side, (f) volute back side, and (g) volute lateral side.

To quantify the wear severity on specific zones, the machine is divided into patches, according to the scheme reported in Figure 4.

The impeller was divided into three zones: hub (back plate), shroud (front plate), and blades. Hub and shroud are divided according to radial discretization. The hub (Figure 4b) is divided into five annular areas, named progressively from R1 to R5, with thicknesses of 355 mm, 385 mm, 440 mm, 435 mm, and 435 mm, respectively. The shroud (Figure 4c) is divided into three circular areas named R3, R4, and R5. The sizes of R3, R4, and R5 are the same as the corresponding areas on the hub. The shroud patching also accounts for the additional wear protection plate (named TE) positioned on the trailing edge zone of the blade, in correspondence with the blade pressure side. Each blade has been divided into thirteen patches: one patch for the leading edge, six patches on the pressure side, and six patches on the suction side (Figure 4d). Both the pressure side and suction side of each blade have been divided into two axial zones (A1, and A2), and three radial zones (R3, R4, and R5). The radial division has been done following the R3, R4, and R5 divisions previously described on the hub and shroud.

The volute was divided into three main zones: the front side (inlet side), the lateral side, and the back side. The volute front and back sides were divided into two radial sectors named R1 and R2 (Figure 4e,f). The circular area named R1 is placed at the center of the volute and has a diameter of 4.40 m, slightly larger than the impeller diameter. The R2 sector comprises the remaining part of the volute front and back cases. The lateral side was divided into three axial sections (A1, A2, and A3), each of them with a thickness of 510 mm (Figure 4g). The volute cut-off is of great interest with respect to particle wear, since it is a zone that can be strongly affected by erosive processes. For this reason, the cut-off zone was isolated and analyzed separately.

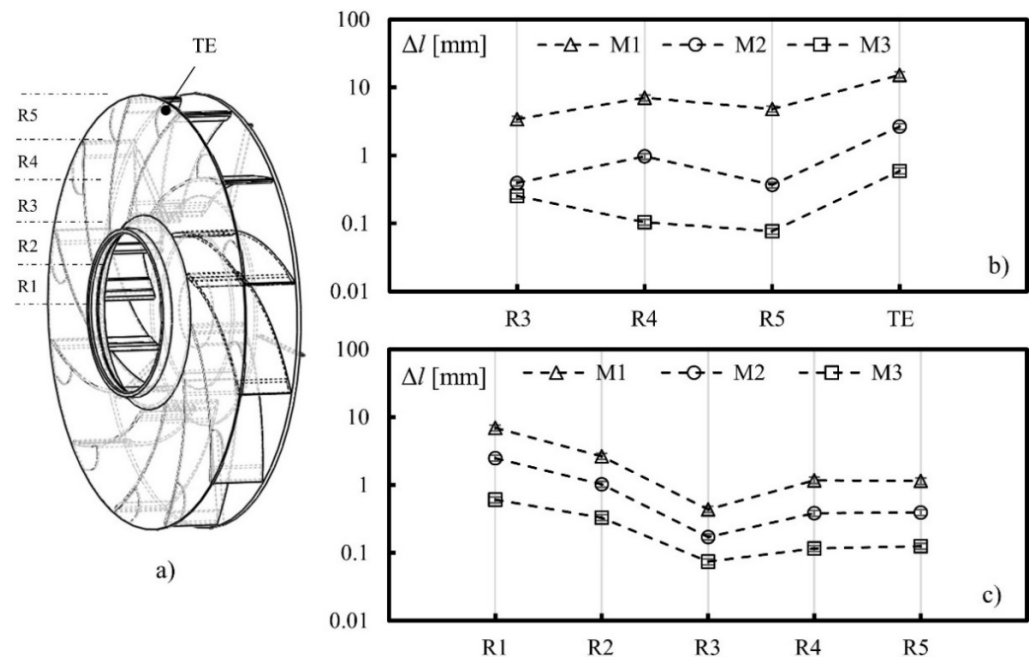
Figure 5. Rotor wear: (a) patches coordinates and material loss, (b) on the shroud, and (c) on the hub. R1, R2, R3, R4 and R5 are the radial annular areas, TE is the trailing edge.

Figure 5 reports the thickness reduction on the shroud (Figure 5b) and the hub (Figure 5c). Based on the experimental results, M1 shows the worst performance in terms of wear resistance. Looking at the shroud, the three materials have different trends in the radial direction. This is mainly due to the different angle functions measured during the experimental tests (Figure 3b). This effect is visible when comparing M3 and M1 over R3, R4, and R5. However, higher wear intensity is found in the zone near the trailing edge, named TE. For all of the materials, the wear on the hub is high in the R1 zone, decreases in the radial direction until R3, and slightly increases towards R5. The center of the disc (R1) is critical since its positioning in front of the inlet section promotes a high impact frequency in that zone.

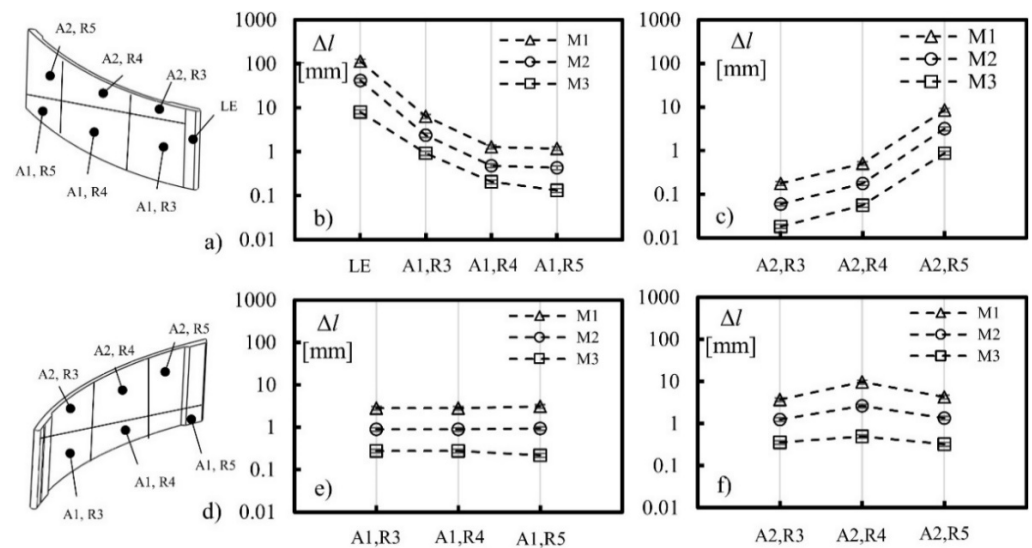
Figure 6. Rotor wear: (a) coordinates of the patches on the pressure side and material loss, (b) on the axial section A1 and (c) on the axial section A2; (d) coordinates of the patches on the suction side and material loss, (e) on the axial section A1 and (f) on the axial section A2. R3, R4 and R5 are the radial annular areas, LE is the leading edge.

Figure 6 reports the results for the blade pressure side (Figure 6b,c) and suction side (Figure 6e,f). The leading edge results are included in Figure 6b. Regarding the pressure side of the blade, the wear severity decreases in the radial direction for the portion of the blade near the hub (A1) and increases in the radial direction for the portion near the shroud (A2). However, the wear on the A1 zone is more severe than A2. In particular, the leading edge is the impeller zone, which experiences high material loss. The trends of Δl for the three materials in the radial direction are similar, but shifted on the y -axis, highlighting

the different wear resistance of the three plate materials. Regarding the suction side of the blade, the wear is almost uniform on the whole surface for a fixed plate material.

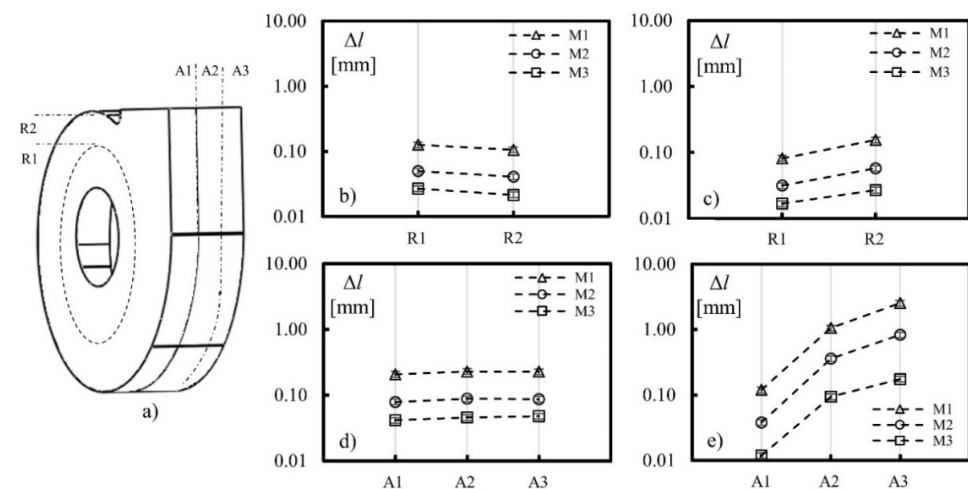
Figure 7. Volute wear: (a) coordinates of the patches on volute and material loss, (b) on the front side, (c) back side, (d) lateral side, and (e) cut-off. R3 and R4 are the radial annular areas, A1, A2 and A3 are the axial areas.

The results of the volute wear are reported in Figure 7 for the front side (Figure 7b), back side (Figure 7c), lateral side (Figure 7d), and cut-off (Figure 7e). The wear severity on the stationary parts is lower than that on the rotating part. This is mainly due to the lower particle impact number and impact velocity in these zones. The front side, back side, and lateral side have similar values of thickness reduction after 8000 h of operation. The cut-off is the most critical part of the volute: the wear severity increases over the axial direction. The maximum thickness reduction is found in the axial sector in front of the impeller outlet section, reaching a thickness reduction of 3 mm after 8000 h of operation over a cut-off radius of 175 mm.

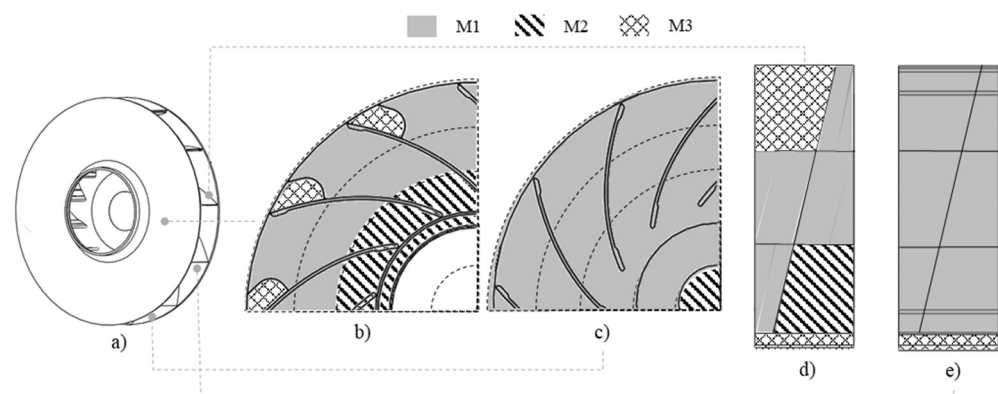
Figure 8. Optimized configuration of the wear-resistant plates on the rotor: (a) view of the rotor, (b) shroud, (c) hub, (d) blade pressure side and (e) blade suction side.

The optimized configuration for the impeller is presented in Figure 8 for the shroud (Figure 8b), the hub (Figure 8c), the pressure side (Figure 8d), and the suction side (Figure 8e). The plate materials have been positioned by combining their costs, their wear resistance, and the wear severity in the specific zone of the impeller. It can be noted that the material with the highest wear resistance (M3) is positioned only in the zones where the erosion severity does not allow the use of the cheapest materials (M1 and M2). Such zones are the leading edge (LE), a portion of the pressure side near the trailing edge (A2, R5), and a portion of the shroud corresponding to the trailing edge (TE). Similarly, M2 is employed in the center of the disc (R1), in the first radial sector of the shroud (R3), and the first radial sector of the pressure side (A1, R3). The remaining parts of the impeller were covered with M1. Looking at the stationary part, the low wear severity on the volute leads to the logical choice of using the material M1 for the front side, backside, and lateral side coverage. However, the high wear on the cut-off requires the positioning of the M2 material only in this zone. Even though such a solution can theoretically minimize the costs related to particle wear without compromising fan durability, it has to be highlighted that its implementation could be impractical due to compatibility issues that may arise when different hard-facing plates are welded together. However, the approach reported in the present work can be adapted to practical applications for only the coverage of the zones most affected by particle wear.
