A case of allergic contact dermatitis to (meth)acrylates in ECG electrodes

Contact dermatitis to acrylates in ECG electrodes

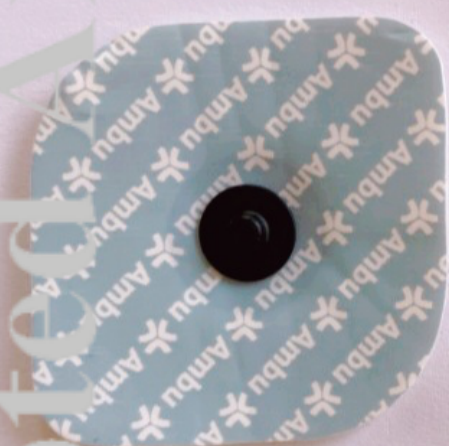
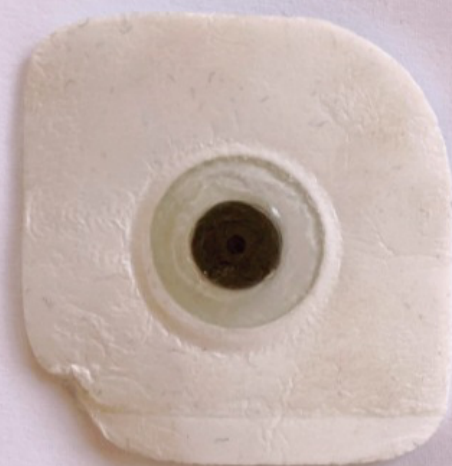
COD_13570_Fig 2.tiff

FIGURE 2 Ambu® WhiteSensor 4831Q electrode: outer adhesive side (a), inner adhesive side (b) and metallic central part (c)

In the cases of electrode ADC by acrylic acid reported in literature, acrylic acid was demonstrated in the electrode hydrogel part.³⁻⁵ Conversely, in the Ambu WhiteSensor 4831Q electrodes used by our patient there is no hydrogel part and acrylates are contained in the inner adhesive side, confirming the need for precise technical product data sheets, that include impurities as well.⁵
