6th International Building Physics Conference, IBPC 2015

Analysis of direct and flanking sound transmission between rooms with curtain wall facades

N. Zuccherini Martello^{a,*}, S. Secchi^b, P. Fausti^a, G. Cellai^b, A. Santoni^a

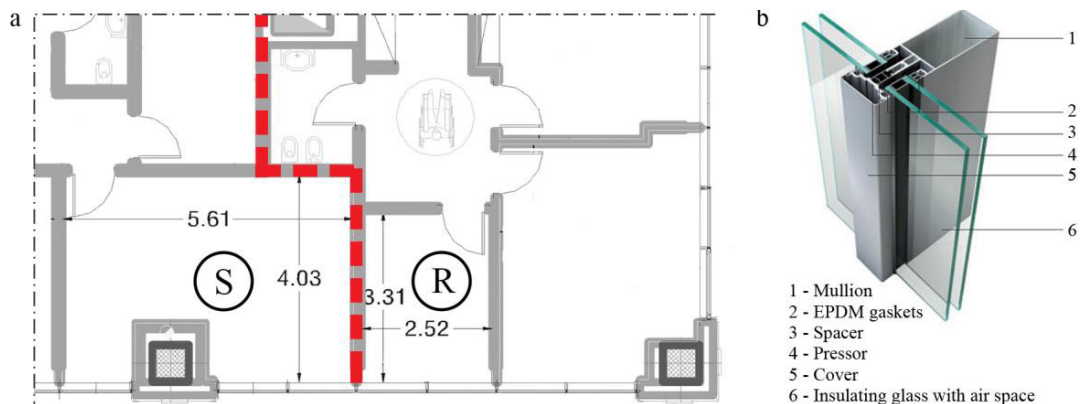
Fig. 1. (a) Plan portion of the building under test where: S = source room, R = receiving room, dashed line is the limit of two distinct properties; (b) detail of the curtain wall structure.

To better characterize the sound transmission through a curtain wall, the Apparent Sound Reduction Index of the partition between the adjoining rooms shown in Fig. 1.a was measured according to the procedure described by EN ISO 16283-1 [6], while velocity vibration measurements were carried out according to EN ISO 10848 [7].

The improvement interventions were realized in the junction between the separating wall and the curtain wall, where the wall thickness was reduced by the architects to allow the opening of the windows of the facade. Moreover, the curtain wall mullion was realized with a single aluminum section (Fig. 1.b).

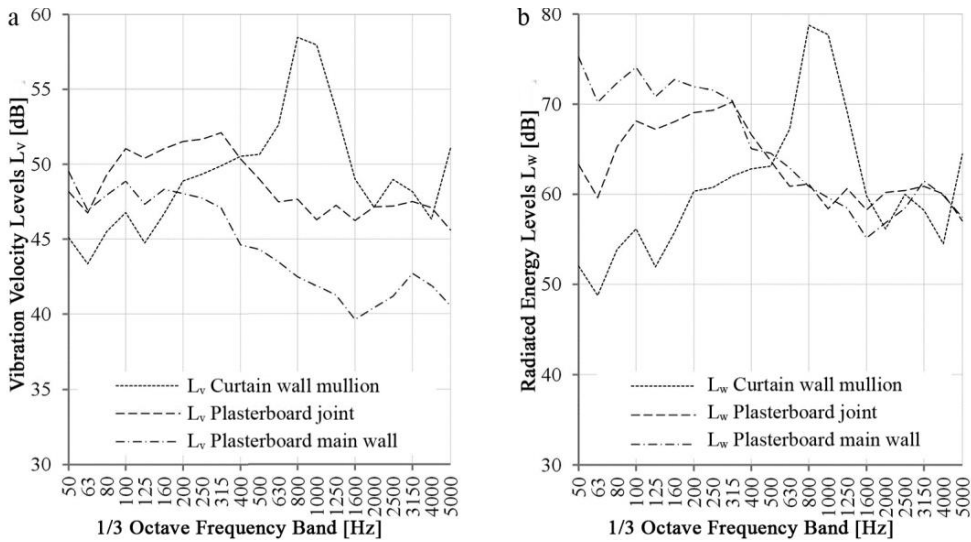
Fig. 2. (a) Measured velocity levels L_v in dB; (b) Estimated radiated energy levels L_w in dB.

Fig. 2.a shows the velocity vibration levels (dB ref. 10^{-6} m/s) of the three structures. Values are shown both as velocity levels (L_v in dB) in Fig. 2.a and as radiated power level (L_w in dB) in Fig. 2.b ($L_w=10\log_{10}(W/W_0)$, with $W_0=10^{-12}$ W), normalized to respective surfaces; in this comparison we have considered radiation efficiency $\sigma = 1$ at each 1/3 octave band and for all materials. Radiated power is calculated as follows:

Fig. 2 shows two main paths of sound transmission: transmission through the aluminum mullion of the curtain wall, and transmission through the reduced thickness plasterboard joint (three plasterboard layers directly connected to each other, see Fig. 4.a). It is clear that the sound insulation gap at 1000 Hz is due to the mullion of the curtain wall, although it has the smaller surface, compared to other components.

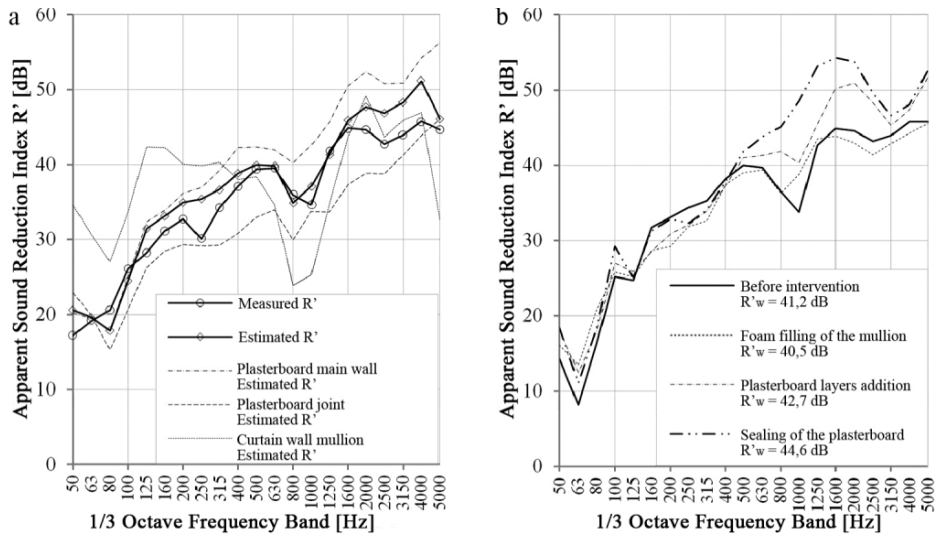
Using the approximations above explained, R' was calculated from the measured vibration velocity and compared to R' measured with EN ISO 16283-1 method. Only velocities measured over the main wall components were considered, due to the fact that flanking components have an average of 5÷10 dB lower L_v . Despite the approximations in the calculation of the radiation efficiency, a good agreement between the two R' curves is shown in Fig. 3.a. The continuous curve is R' estimated using the EN 12354-1 hypothesis; empty dots are the ISO 16283-1 measurement's values.

Fig. 3. (a) Graph of the Apparent Sound Reduction Index, R' , measured (EN ISO 16283-1:2014) and estimated with EN 12354-1, Appendix B.1 method. R' estimations for each element composing the wall are reported as well. (b) Graph of the Apparent Sound Reduction Index R' before (continuous curve) and after the interventions.

R' curve (Fig. 3.b) shows an irregular behavior around 1000 Hz: this kind of performance drop is usual to be expected around 2500-3150 Hz, which is the average coincidence frequency for plasterboard wall [9].

Errors between prevision and measurement are mainly included in a ± 3 dB range. Greater errors are presents at 250 Hz, probably due to the overestimation of the critical frequency f_c for the plasterboard joint. The used model

In spite of this, the apparent sound reduction index only increases at mid and high frequencies, as the graph in Fig. 3.b shows. This fact is due to different problems of the separating wall but mainly to the structural sound transmission through the metal mullion of the curtain wall. Moreover an increasing in the coupling between receiver and source side of the vertical aluminum mullion could be caused by the polyurethane foam filling: despite a lower dip at 800 and 1000 Hz, a wider frequency range, between 160 and 400 Hz, is affected by a significant worsening of the performance. This problem is only partially solved when a new plasterboard layer was added and sealed (dash-dot-dot line in Fig. 3.b).

Fig. 3.b shows that the lining of the vertical mullion of the curtain wall at the junction with the separating wall causes an average 3 ± 15 dB increasing of the apparent sound reduction index R' , at mid and high frequencies. The difference is instead not significant at lower frequencies where the resonance of the lining system described in Fig. 3.b reduces the acoustic performance of the partition. In particular it is interesting to note that the lining of the frame eliminates the insulation drop at 1000 Hz, which is probably due to a resonance of the mullion of the curtain wall. A similar problem was shown also in a previous study on this kind of junction [2].

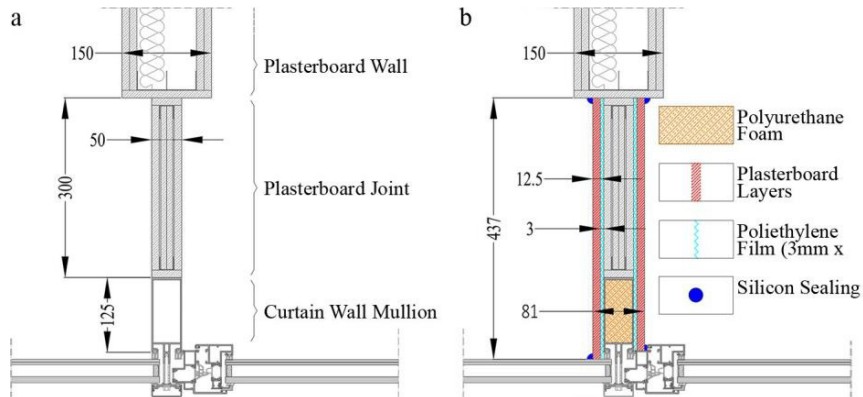
Fig. 4. The junction between the separating wall and the curtain wall before (a) and after (b) the improvement intervention. Dimensions are in mm. The main wall has a 5 cm mineral wool layer and an air gap of 5 cm.

The intervention was limited by the need not to increase the wall thickness more than 2 cm per side, to allow the opening of the windows. Two layers of closed-cell polyethylene film 3 mm thick and a layer of plasterboard on each side of the separating wall were applied (Fig. 4.b). Furthermore, the vertical mullion of the curtain wall was filled with polyurethane foam.

Velocity level measurements were carried out using 2 grams mono axial accelerometers, randomly placed over the surfaces. Plasterboard main wall, plasterboard joint and metal curtain wall mullion, illustrated in Fig. 4.a, were first analyzed. Other flanking noise paths (floor, glazing, ceiling) were investigated too, but they had much lower velocity levels, compared to those measured over the main wall. In consideration of this fact, velocity levels for flanking components are omitted for brevity.
