Crack Patterns Induced by Foundation Settlements: Integrated Analysis on a Renaissance Masonry Palace in Italy

**Claudio Alessandri, Massimo Garutti, Vincenzo Mallardo,
and Gabriele Milani**

10 This study presents some numerical results related to the analysis of the structural damage of a historic masonry building, Palazzo Gulinelli, in Ferrara, Italy. A detailed analysis of the inhomogeneities of the facade, historic documentation, and recent restoration interventions carried out in an adjacent building, suggest that the Palace underwent various modifications both on the structural configuration and on the borne loads. Such modifications might be the main cause of some differential settlements and of the consequent significant crack pattern on the load-bearing walls. Therefore standard linear and non-linear finite element (FE) analyses and a non-standard FE analysis with homogenized models are carried out to simulate the occurrence of a crack pattern on the facade, by applying to the discretized FE model suitable differential settlements somehow related to the changes occurred over time.

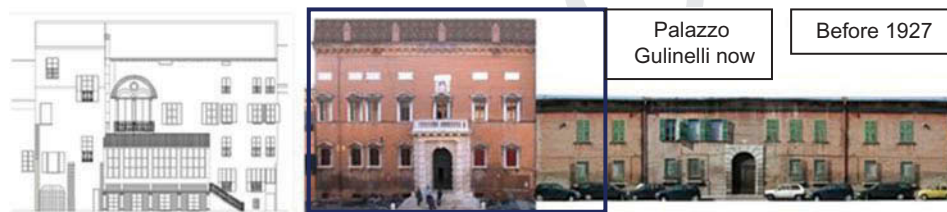
FIG. 4. The original facade and the corresponding one on the rear before the 20th century.

that the original structure was a compound of three *casseri*, the first three parts moving from the left to the right in Figure 2, Figure 3, and Figure 4 (where the term *cassero* stands for the typical unit building in Ferrara at that time and it is enclosed in two parallel continuous walls), plus a service wing. The portal was added at a later stage and it is commonly ascribed to Balbi on the basis of a stylistic comparison with the portal of Palazzo Paradiso, a coeval building located in the city center.

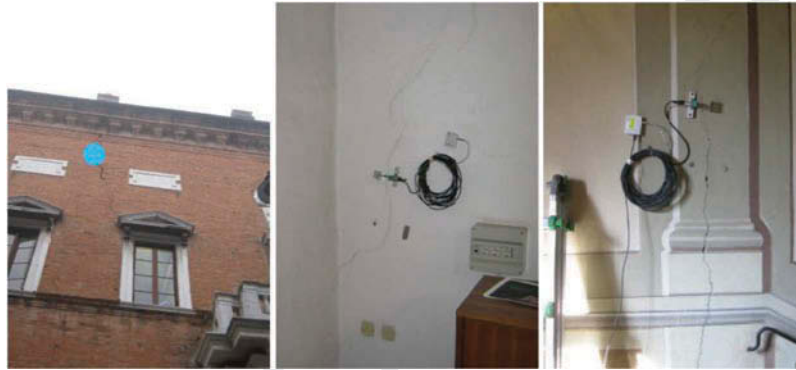
FIG. 9. Photographs showing the orientation of the cracks and position of the sensors in Figure 8: sensor A (left), sensor B (center), sensor C (right).

investigated more deeply. The position of such cracks and the corresponding photos, along with the monitoring sensors, are also depicted in Figure 8 and Figure 9, respectively. 265

The cracks monitored by the sensors A and B are strictly related to the behavior of the main facade, whereas the crack monitored by the sensor C is not linked to the main facade but instead turns out to be relevant with reference to the general structural safety of the palace. These three cracks were monitored in the period February 22, 2012, to January 15, 2013. The corresponding results are well described in the Figure 10 together with the variation of the external temperature in the same period. 270 275

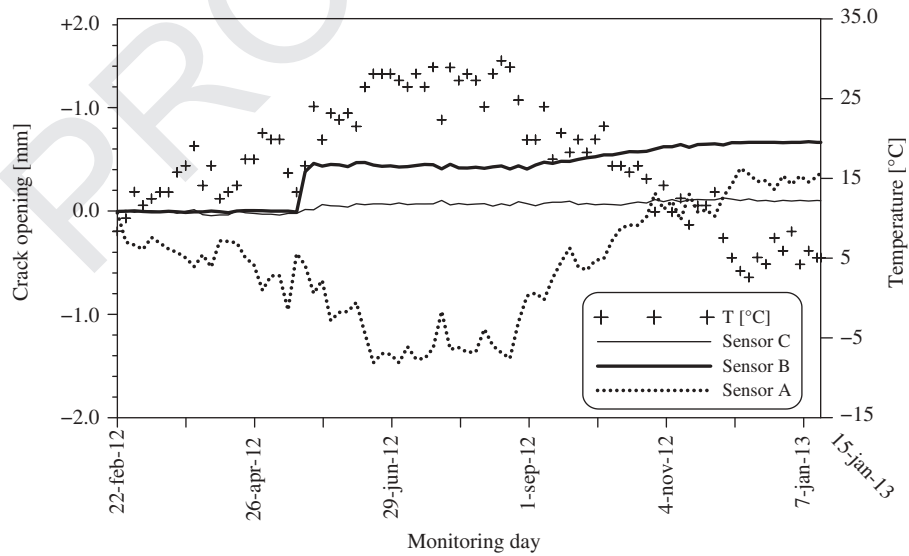
FIG. 10. Sensors monitored in the period from February 22, 2012, to January 15, 2013.

The jump in the monitored data, visible in Figure 10, is related to the seismic event that occurred in the region on the May 22, 2012. From the results depicted in the figure, it is possible to draw three main conclusions: 1) in the monitored period, the crack opening was not influenced by any foundation settlement, which means that it occurred previously and at the time of monitoring it was not in progress any longer; 2) the crack on the main facade is only influenced by the temperature variation during the year; this influence is clearly related to the fact that the crack monitored by the sensor A is the only one located externally and, thus, more influenced by the external climate; and 3) the jump in the crack opening occurring in the 280 285

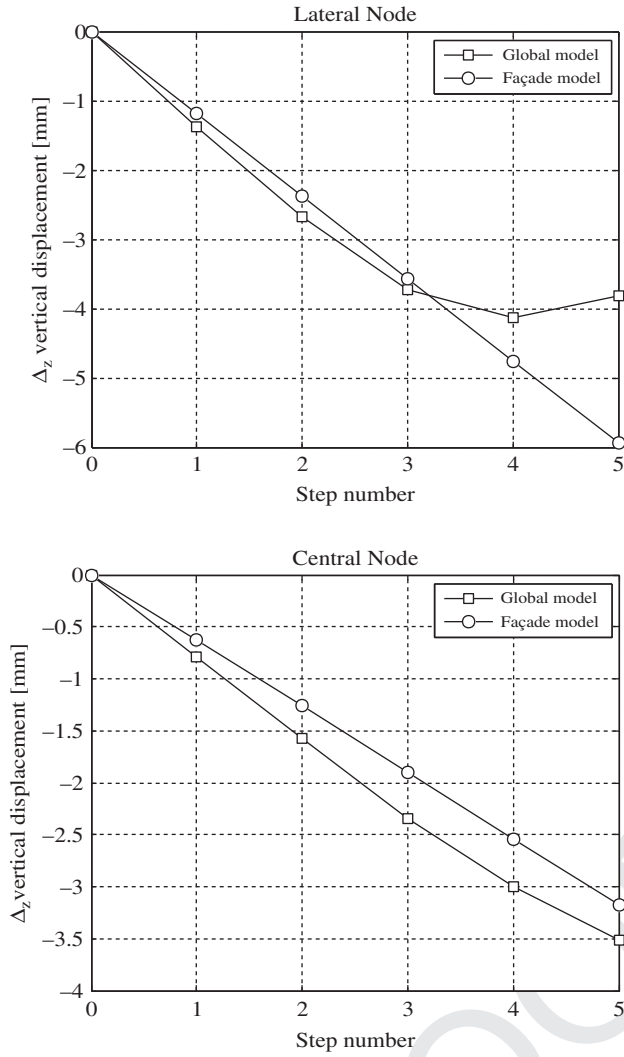
FIG. 16. Comparison between vertical displacements provided by the elastic-plastic global and partial models. Top: lateral node, last floor level. Bottom: central node, last floor level.

455 As can be noted, a similar trend of the displacement plots is obtained, with a similar final amount of vertical displacements, but with a more marked non-linearity of the global model, probably due to a relevant contribution of out-of-plane deformation not easily reproducible with the partial model.

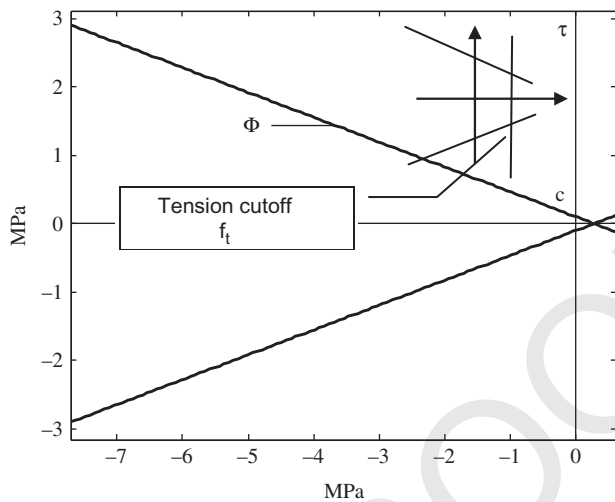
FIG. 18. Linearized failure surfaces adopted for mortar in the softening model with rigid elements and interfaces.

In order to model the failure of the joint, a classical Mohr-Coulomb type strength criterion is used with eventually a tension 530 cut-off (Figure 18). The parameters f_t and f_c are, respectively, the tensile and compressive Mode-I strength of the mortar or mortar-brick interfaces, c is the cohesion, Φ is the friction angle, and Ψ is the angle which defines the linear compression cap. 535

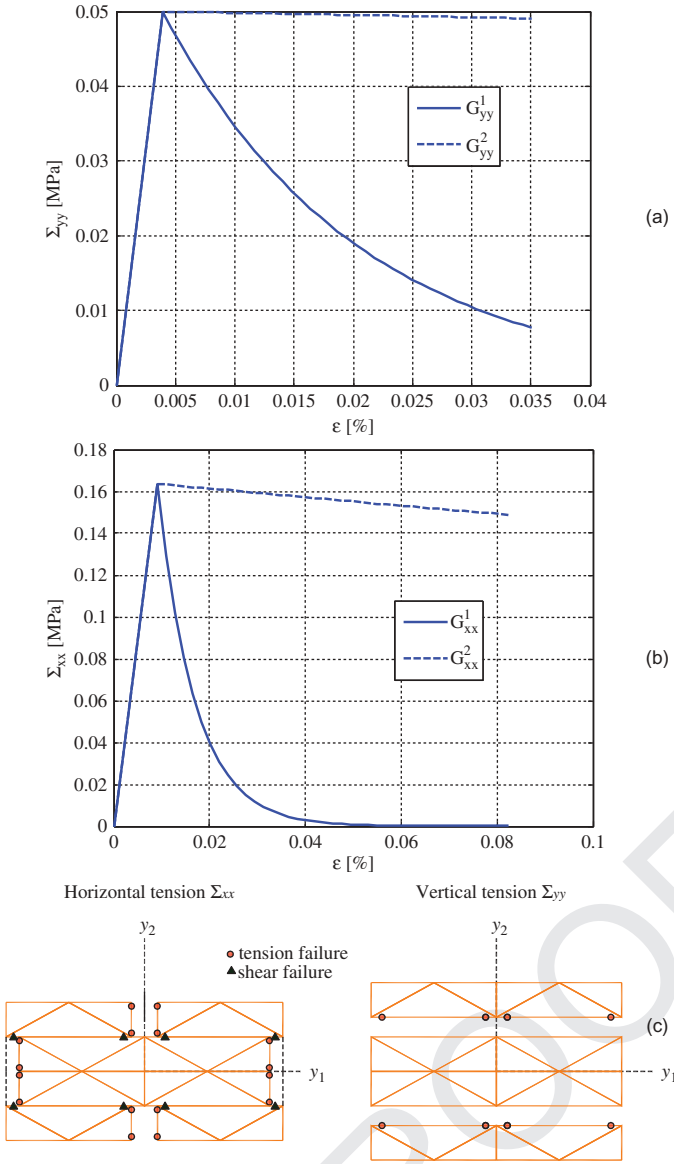
FIG. 19. a) and b) Uniaxial response of the homogenization model along vertical a) and horizontal b) tension for two values of fracture energy, c) representative element of volume (REV) deformed shape at collapse with indication of interface damage in horizontal tension (left) and vertical tension (right).

Two different values of the fracture energy G_I are assumed to test the inelastic behavior of the REV, the first corresponding realistically to existing masonry (Case A), the second approximating an almost perfect plastic behavior in tension (Case B). The behavior in uniaxial tension is depicted in Figure 19 for both horizontal (a) and vertical (b) tension. The anisotropy of the homogenized model is particularly evident and is mainly due to the contribution in horizontal tension of the bed joint, which fails in shear (REV deformed shape is represented in Figure 19c for the sake of completeness with the indication of the typology of failure registered by the code).

595 failure mechanism. Indeed, being the non-linearity mainly concentrated in joints reduced to interfaces, it can be noticed that for both vertical and horizontal stretching – as well as for shear – the response of the coarse mesh is expected to be the same of that obtained with a refined discretization.

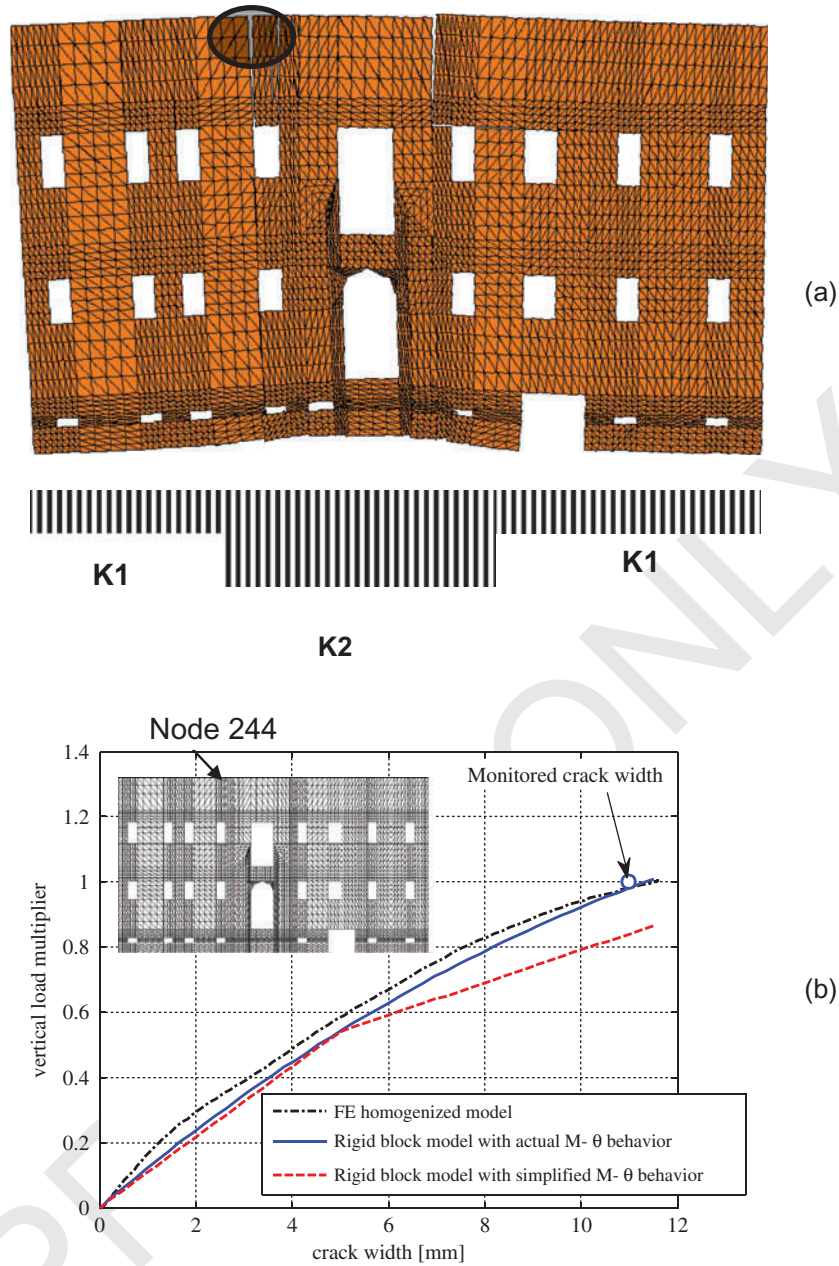
FIG. 22. a) Deformed shape of the facade at the end of the non-linear simulations (6880 triangular elements), b): crack width versus vertical load multiplier.
